# SUCCESS STORIES

Ultrasound Solutions

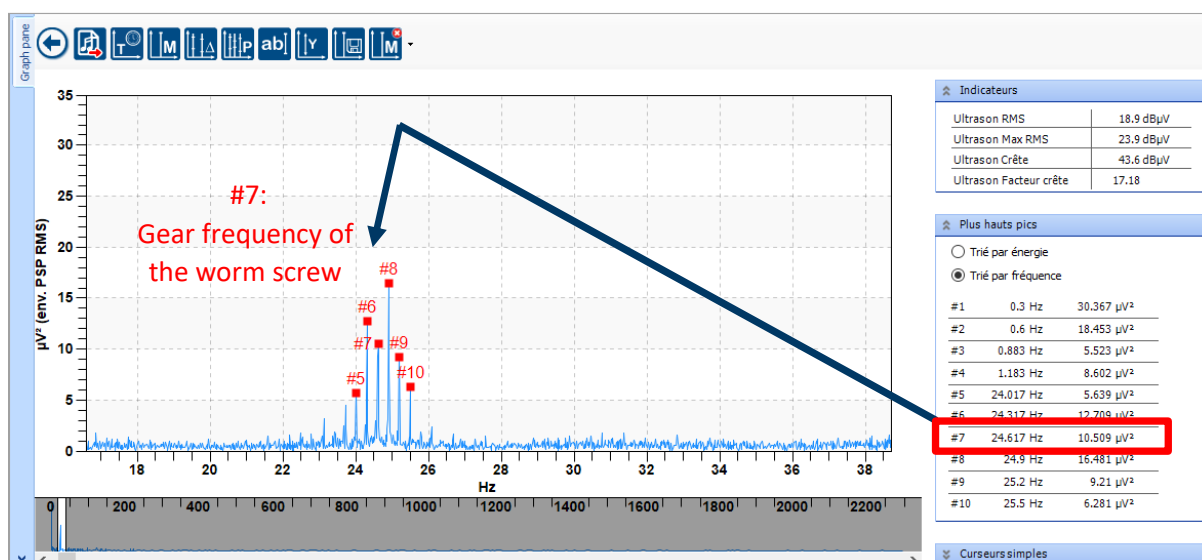
Measurement carried out on December 11, 2016

Zooming in on the envelope spectrum highlights the dissymmetry of the modulation around the meshing frequency, which is characteristic of a damaged gear mesh.

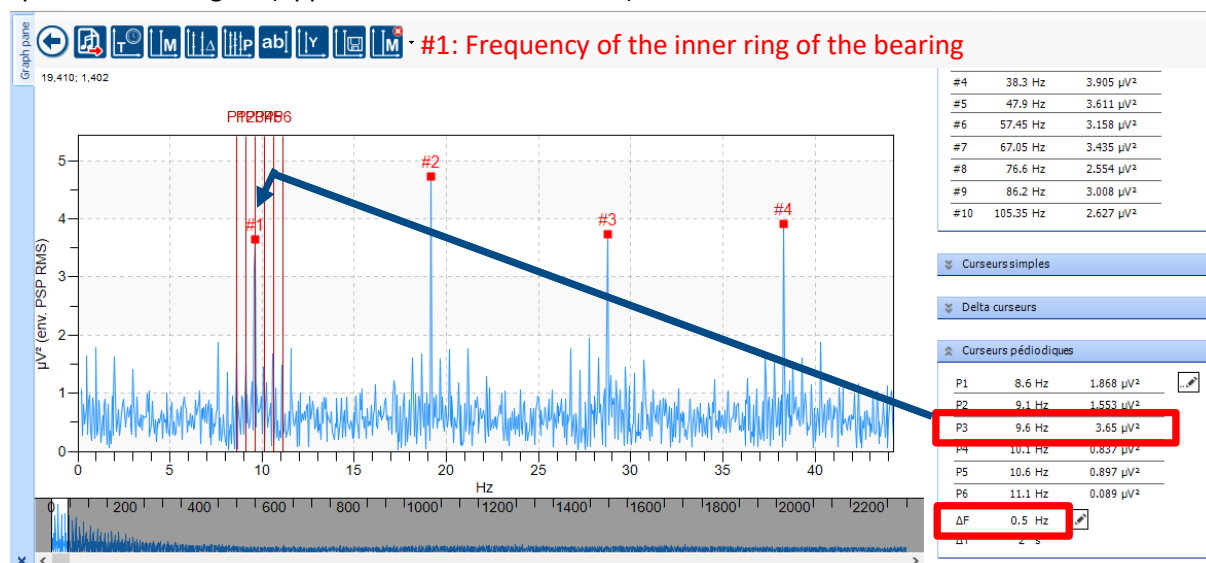
By looking at the envelope spectrum, one can observe repeated shocks at **9.756 Hz** (see the table of characteristic frequencies below) related to the frequency of the inner ring of the bearing of the low-speed reduction gear (opposite side of transmission).

The amplitude of the scaling-type defect is modulated at the fundamental frequency of the rotation speed.

On the spectrum, this is evidenced by a peak at P3 (#1) corresponding to the bearing defect modulated at  $\Delta F$  as confirmed on the harmonics: #2, #3, #4.

Replacement of the reduction gear during a scheduled production shutdown, which avoided an untimely breakdown which could have generated significant expenses due to production losses.

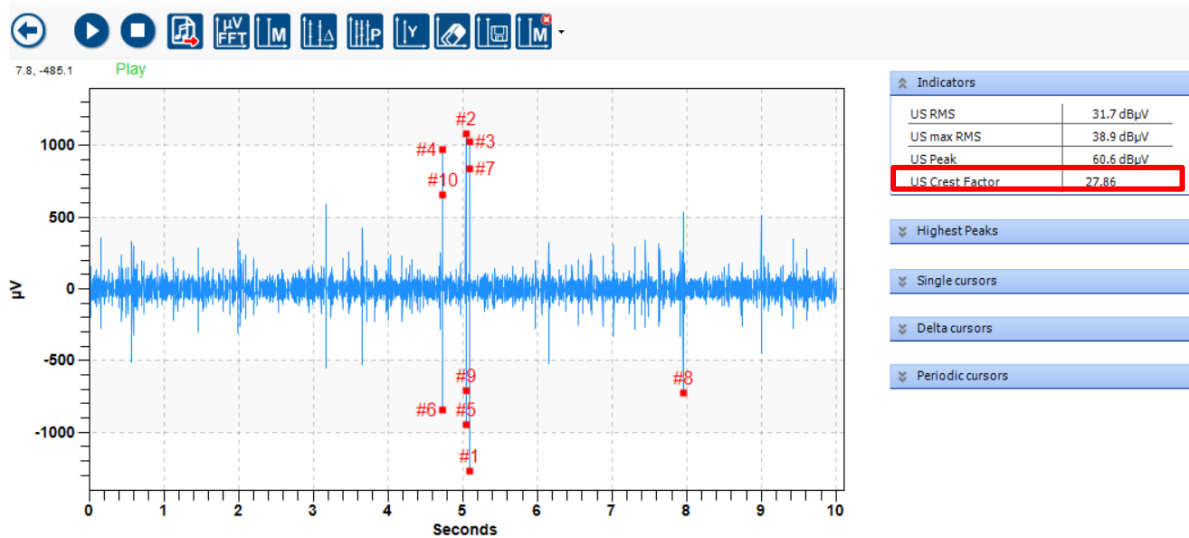
## February 4, 2019 – 3 days later

Recommended bearing replacement as soon as possible due to a signal containing high peaks indicating the lifetime span of the bearing.

Next available extended shutdown – April 15 – April 17. Bearing greased repeatedly until shutdown.

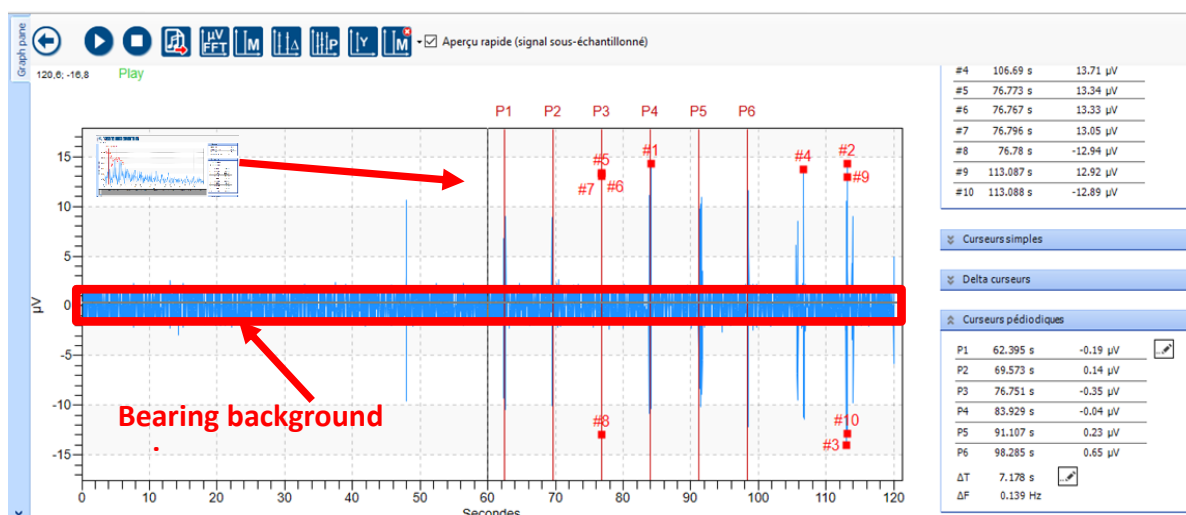
The spectrum shows an impact at the rotation speed (0.13 Hz) of the shafts of the rotating machine, along with its harmonics. Sub-harmonic frequencies can also be observed at 0.5 x the rotation speed, which is a characteristic spectrum for a rotational clearance due to friction or significant impacts. No impact due to bearing frequencies are observed. Our diagnosis is confirmed by the time waveform.

The graph shows that the observed impacts are indeed associated with the rotation speed of the shafts of the machine at 0.13 Hz, i.e., a rotation speed of 8 RPM.

The encountered problem is due to the wear of the shafts and of the disks that are mounted onto these shafts and generate abnormal friction.

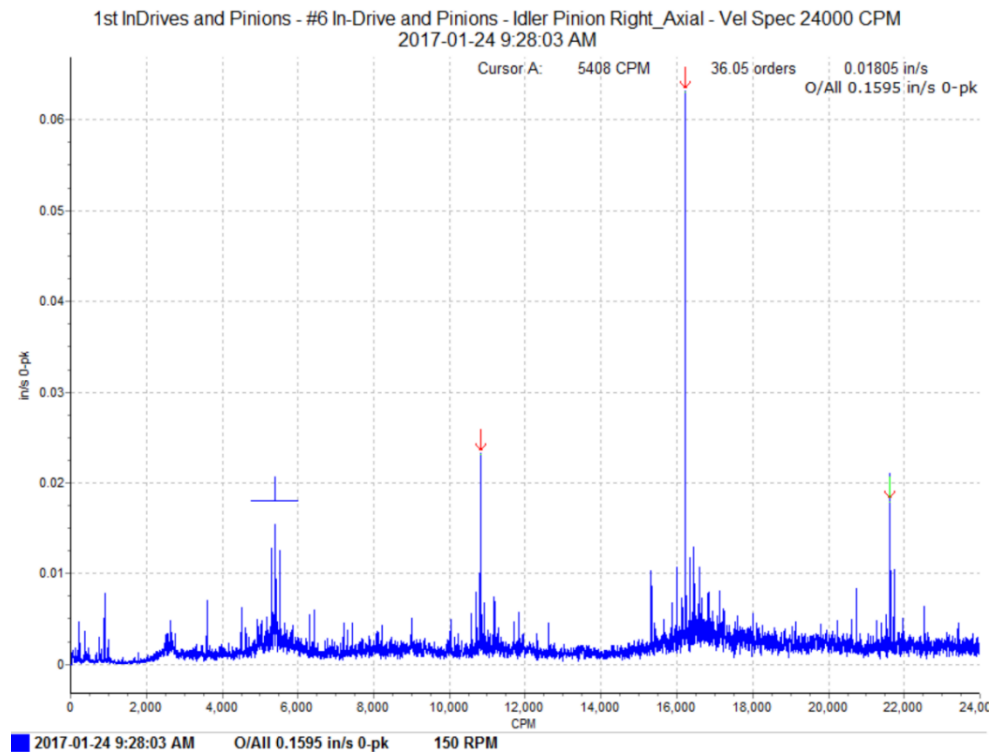
There is also evidence that there is a misalignment condition between the output of the gearbox and the In-Drive.

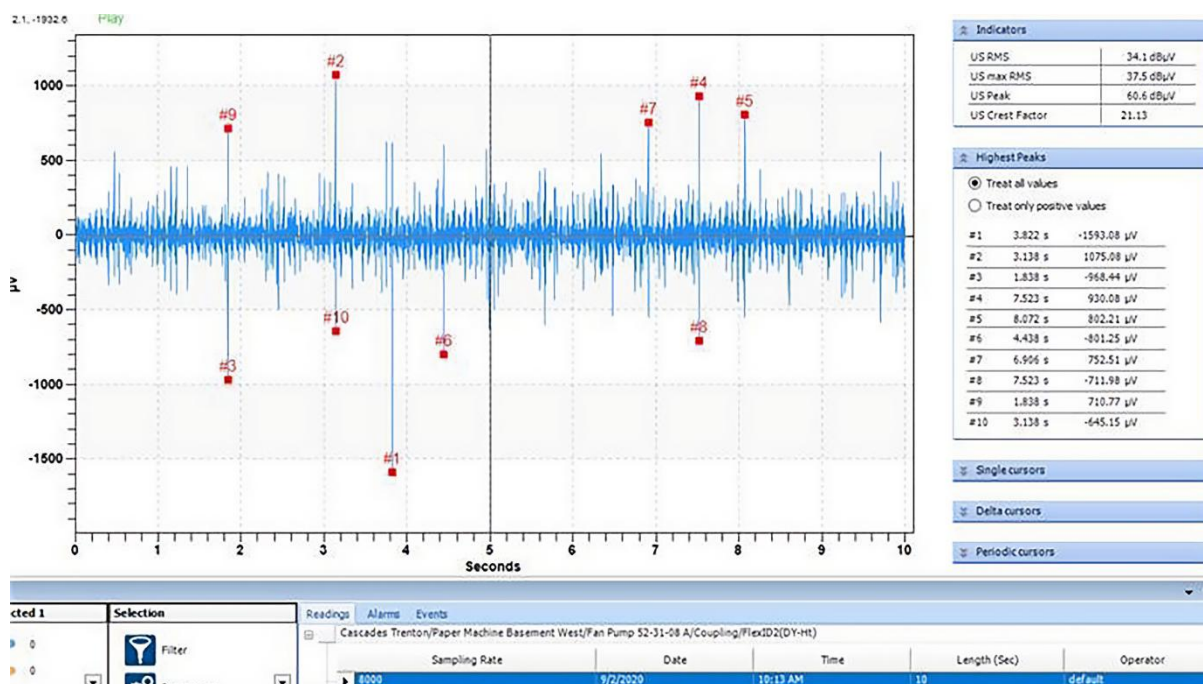
The following are the time-wave and spectra ultrasound measurements, and the vibration measurements taken on the coupling of a DC motor connected to a fan pump. By using two technologies we were able to fully diagnose everything wrong with this asset.

First, let's start with the ultrasound readings. As you can see in the time-wave measurement, this coupling appears to be in bad shape with lots of impacting at its regular run speed. When you look at the spectra you can note something strange, because of recurrences clearly identified with the periodic cursors. After making this discovery our data collectors from the Partnered Ultrasound team decided to utilize vibration analysis where we discovered the motor run speed was fluctuating.

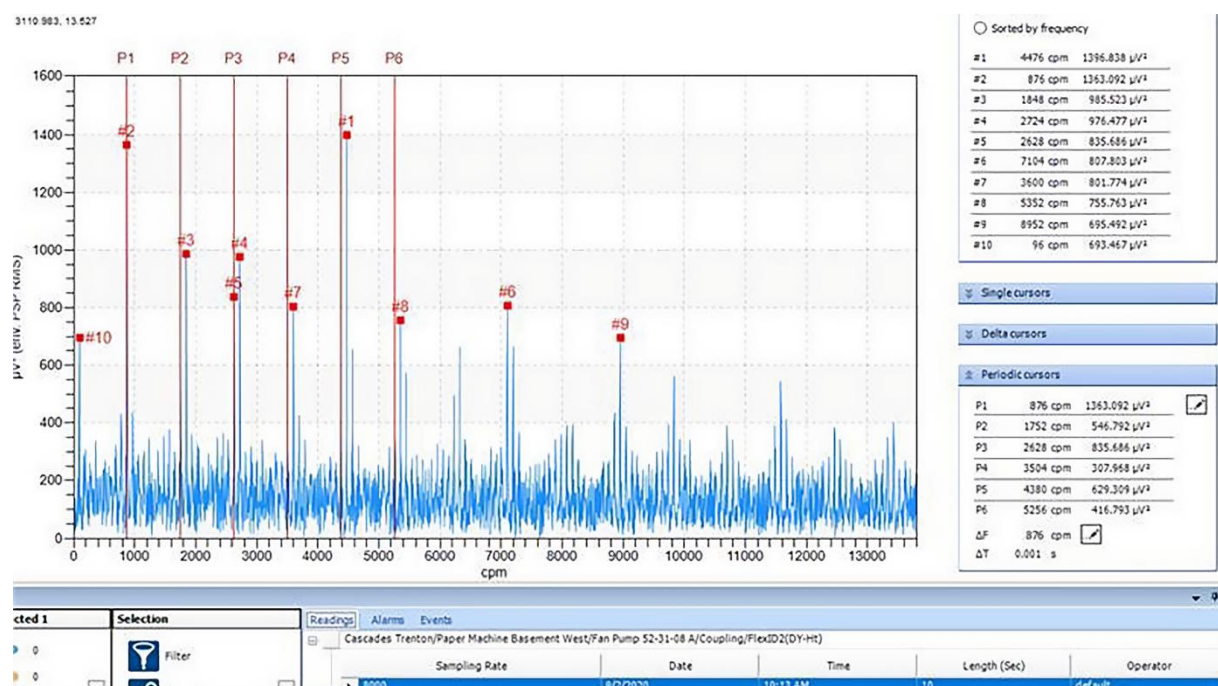
Fan Pump 52-31-08 A - MTR DE - Axial - Vel Spec/Wfm 120000 CPM  
9/2/2020 11:10:55 AM

Using two condition monitoring technologies our Partnered Ultrasound Team was able to fully diagnose the problem on this asset. Ultrasound to find the broken coupling and vibration to find 4 blown fuses out of the 6 on the DC motor.

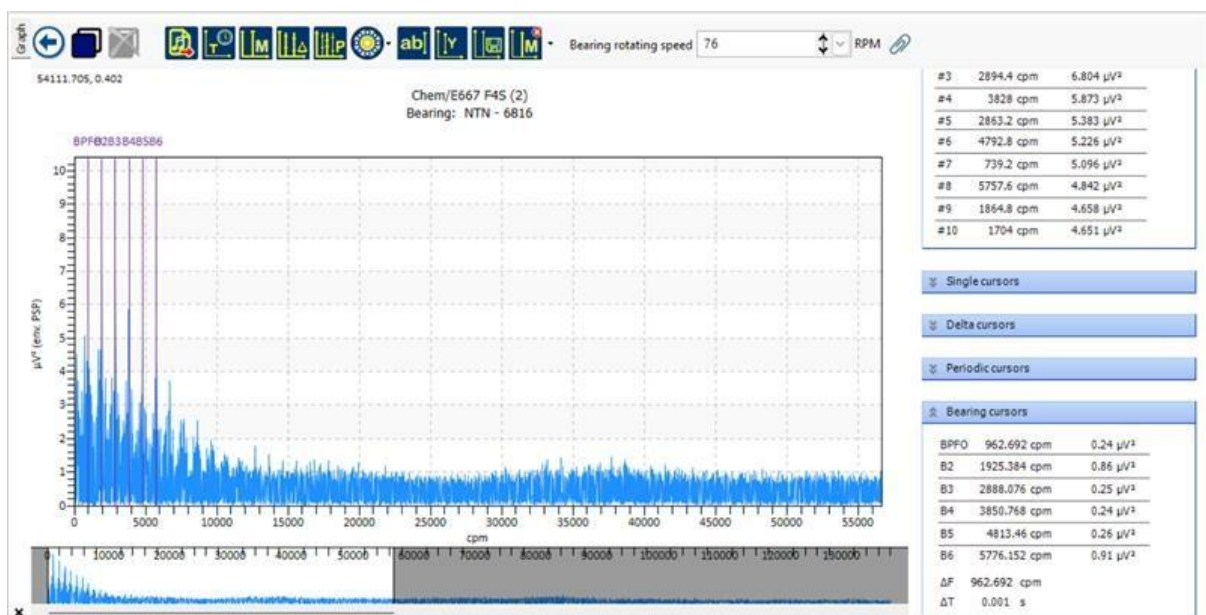
Further analysis using the Bearing Toolbox found that the impact was caused by an outer race defect.

Failed Bearing 2 – Figure 2 – UAS3 Bearing Toolbox, BPFO Fault Frequency Cursors.

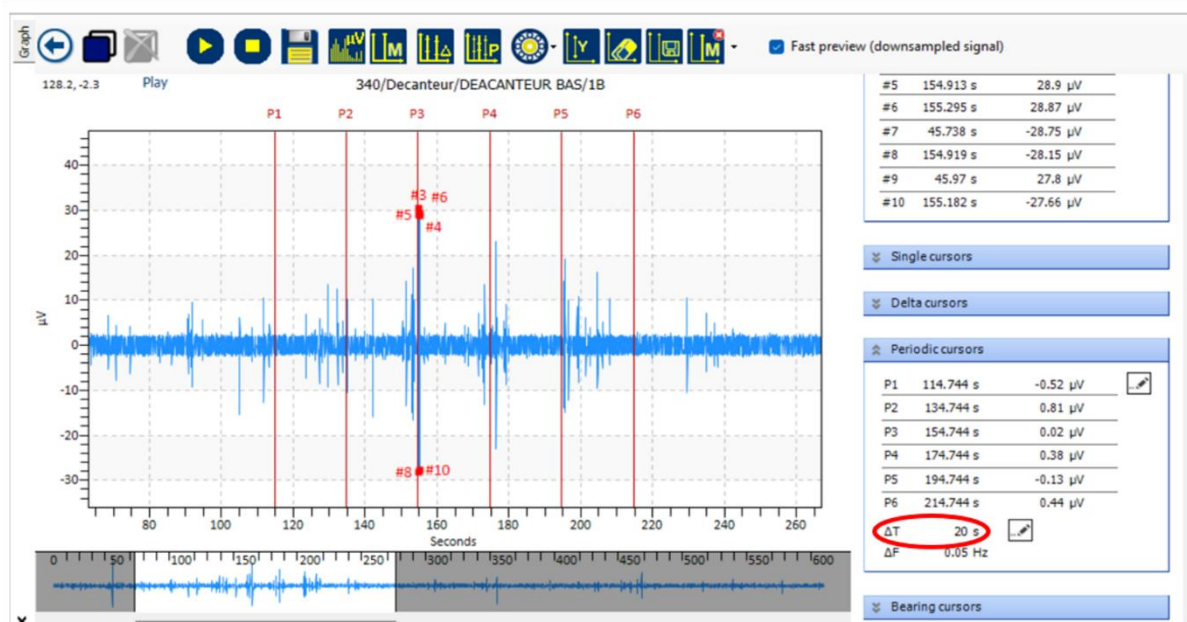
**Figure 1 - 10 Minute Time Waveform of Wastewater Decanter Centrifuge Pinion**

Observed in Figure 1, we can see a similar pattern to that in Figure 2. There is a pronounced spike every time the problem tooth tries to mesh with the teeth of the bull gear. The time between impacts corresponds to 1/RPM of the gear with the tooth problem. This data analysis lead SDT's Reliability Technicians to believe there is a cracked/broken tooth on the pinion gear.

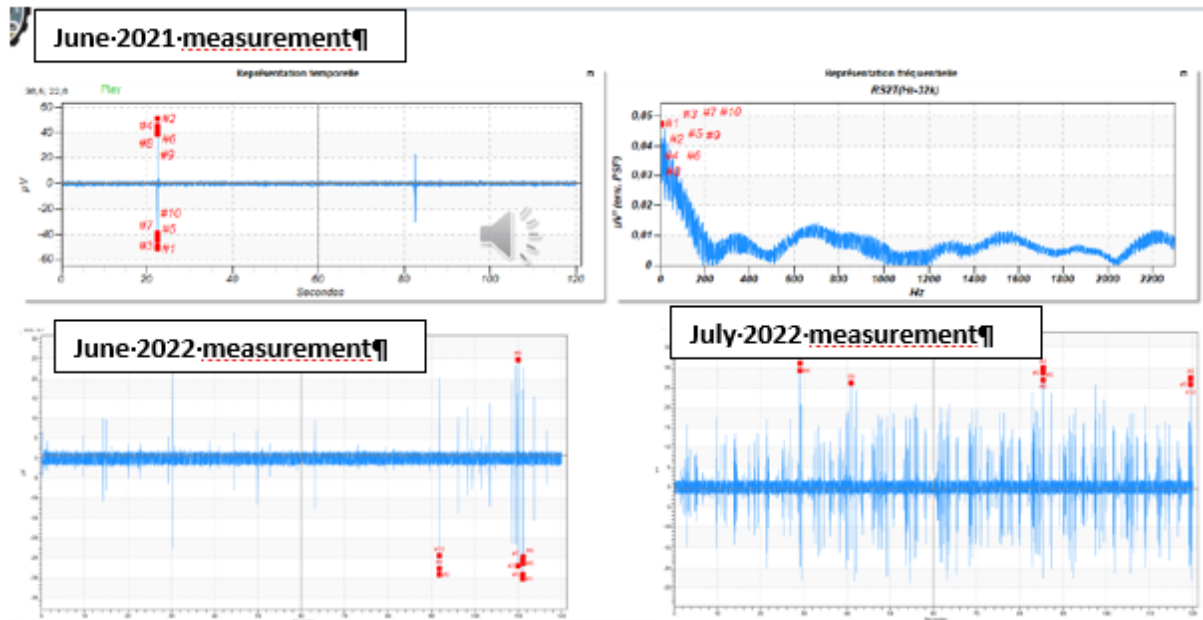
The image above shows a rather evolutionary time waveform. Relatively normal measurements in June 2021 gradually shift towards the beginnings of unusual shocks in June 2022, culminating in a much more serious situation the following July.

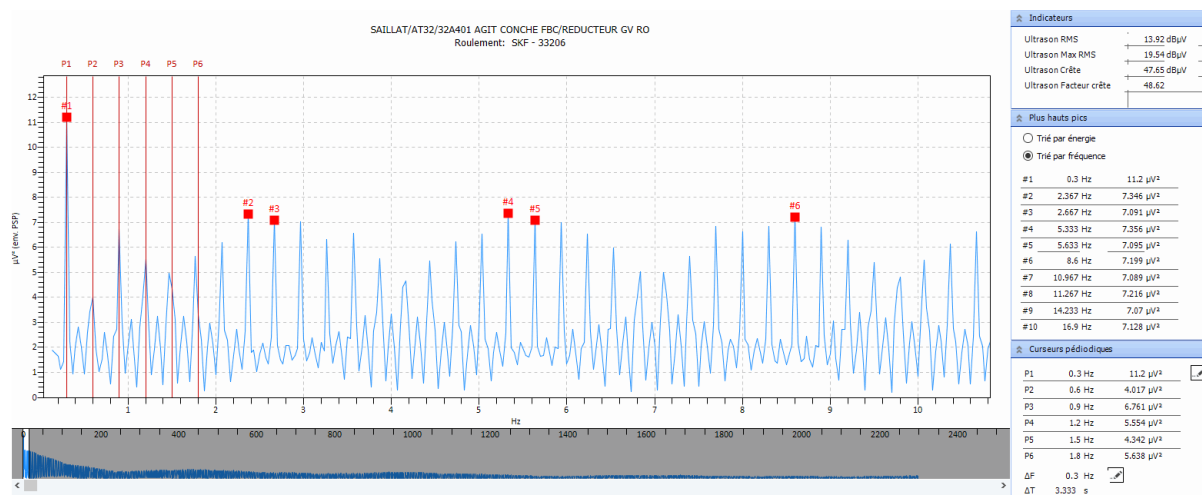
The time waveform and frequency spectrum clearly showed a clear impact at 0.3 Hz on the GV and PV points. The maintenance team then focused their attention on the coupling location, as this was where the noise seemed to originate.

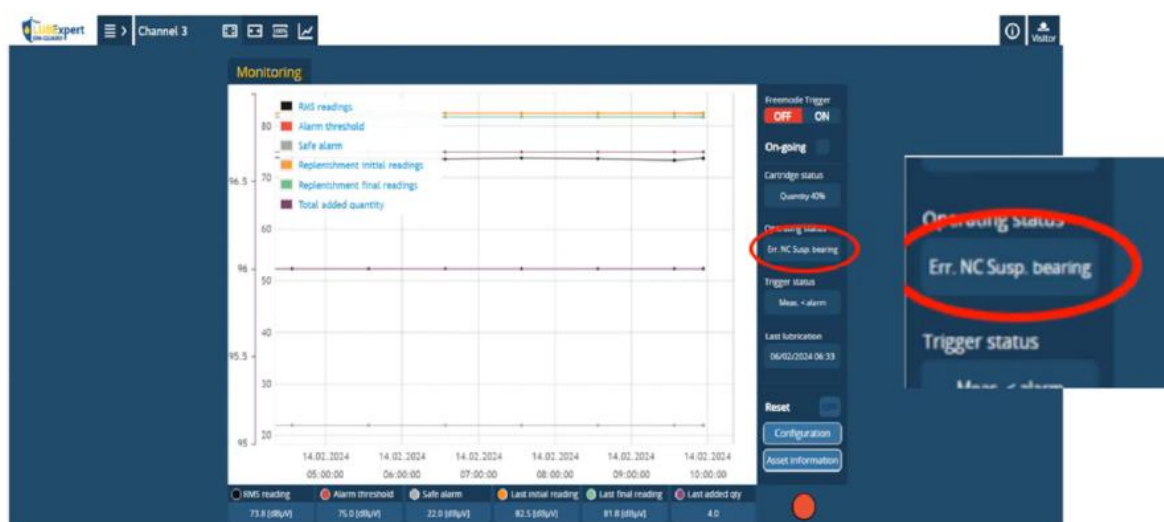
The data collected on the NDE by the ON-GUARD as seen in Figure 2 came back with a suspected bearing failure. We can observe this in the ON-GUARD Dashboard in Figure 3.

Figure 3: ON-GUARD Browser-Based Dashboard signally Suspected Bearing Failure

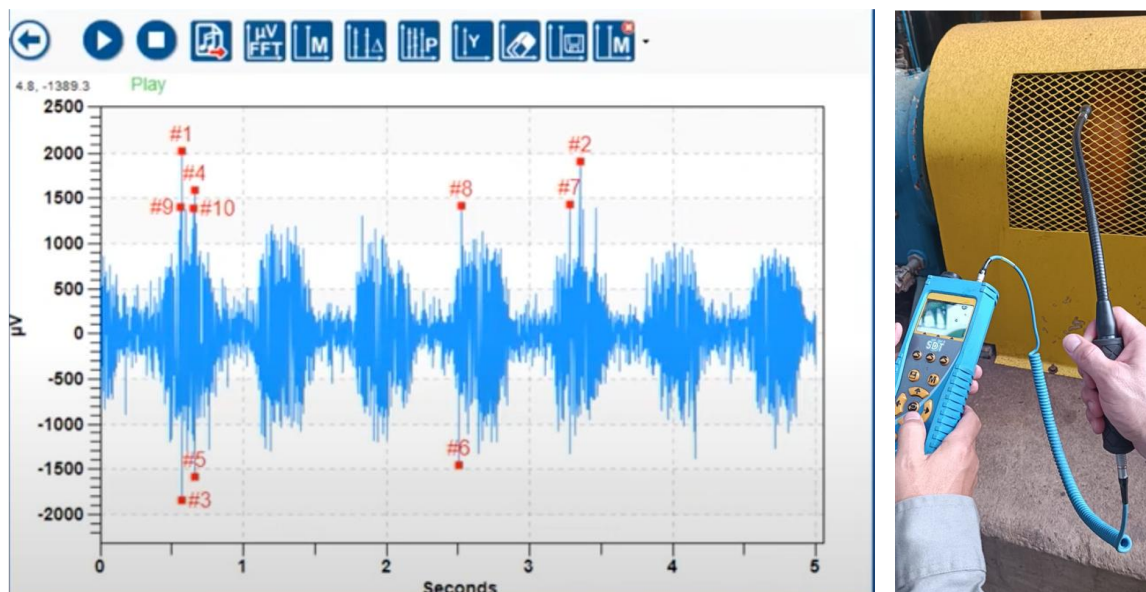
Figure 2 is an ultrasound signal captured of a slow-speed coupling that is misaligned. Every rotation there is a large peak. There is noticeable difference in the  $\mu\text{V}$  between the two ultrasound time wave forms.

**Figure 2 – Slow-Speed Coupling with Misalignment Time Wave Form**

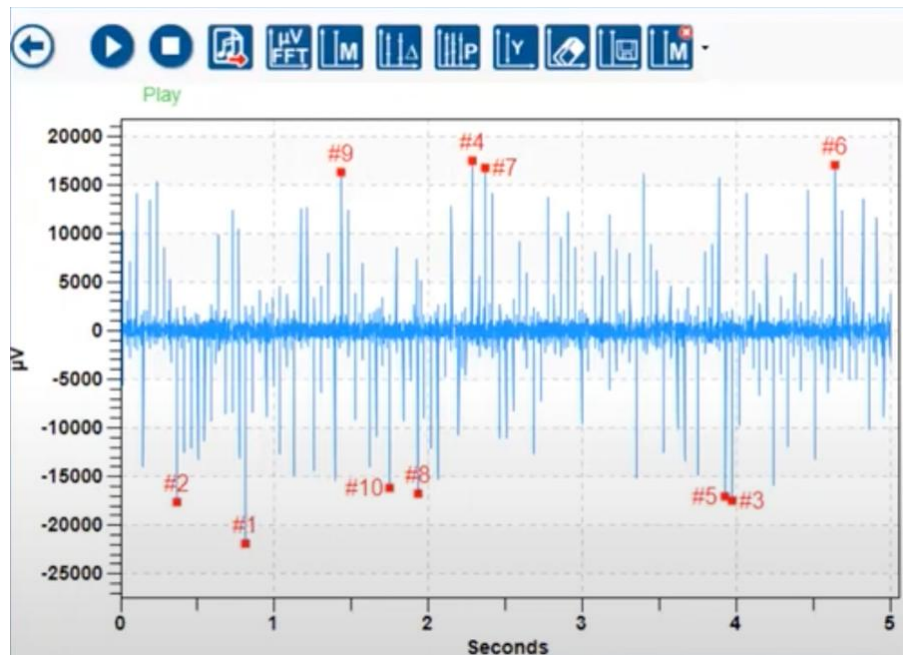
Figure 5 – Damaged Coupling Time Wave Form

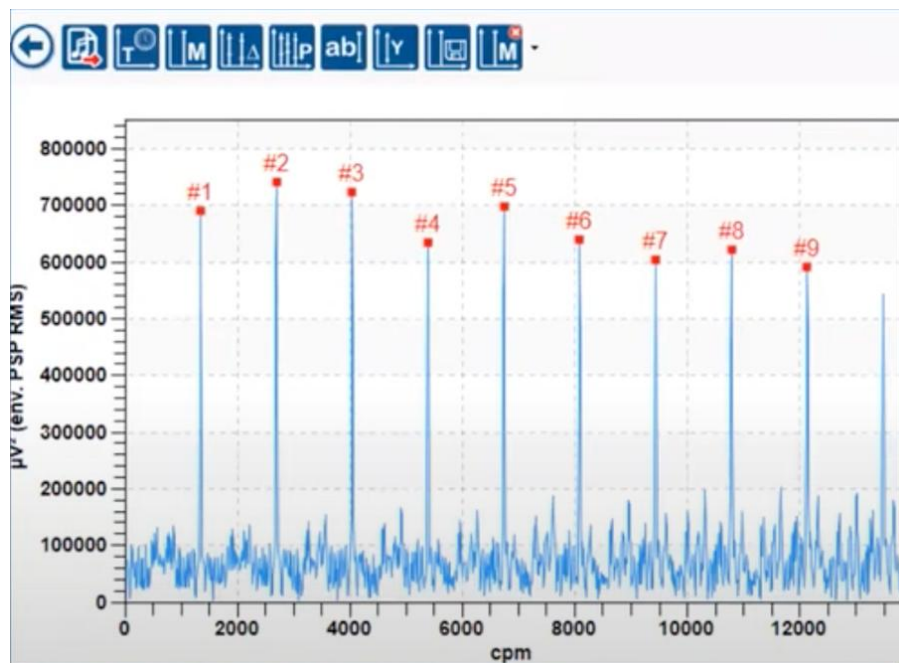
Figure 6 – Damaged Coupling FFT

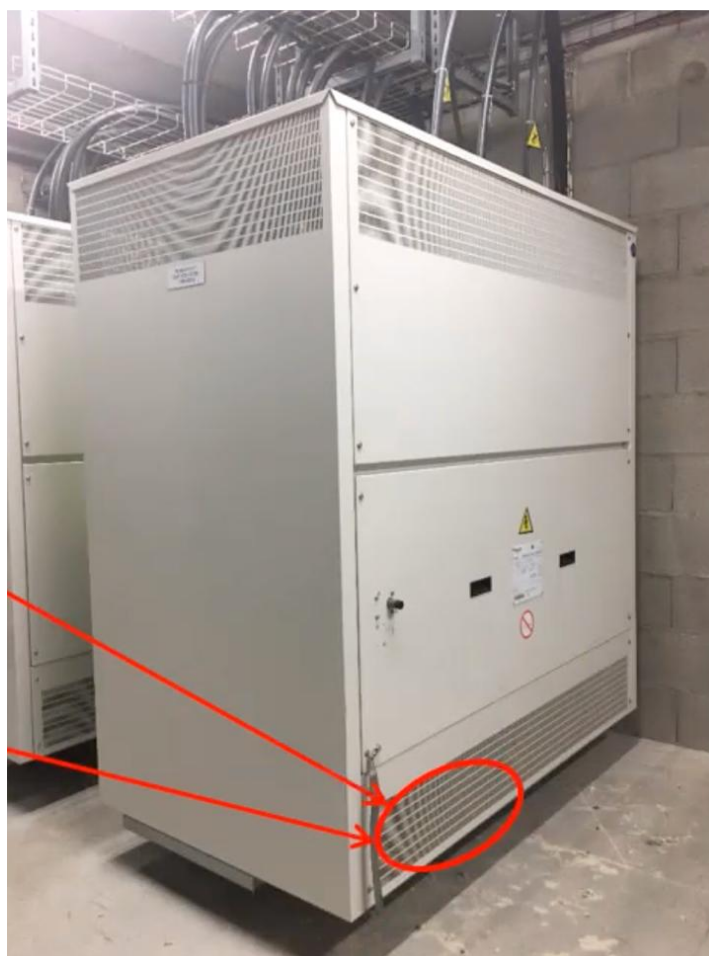
Figure 1 – Transformer in Question, highlighted is the area where the technician found the fault.

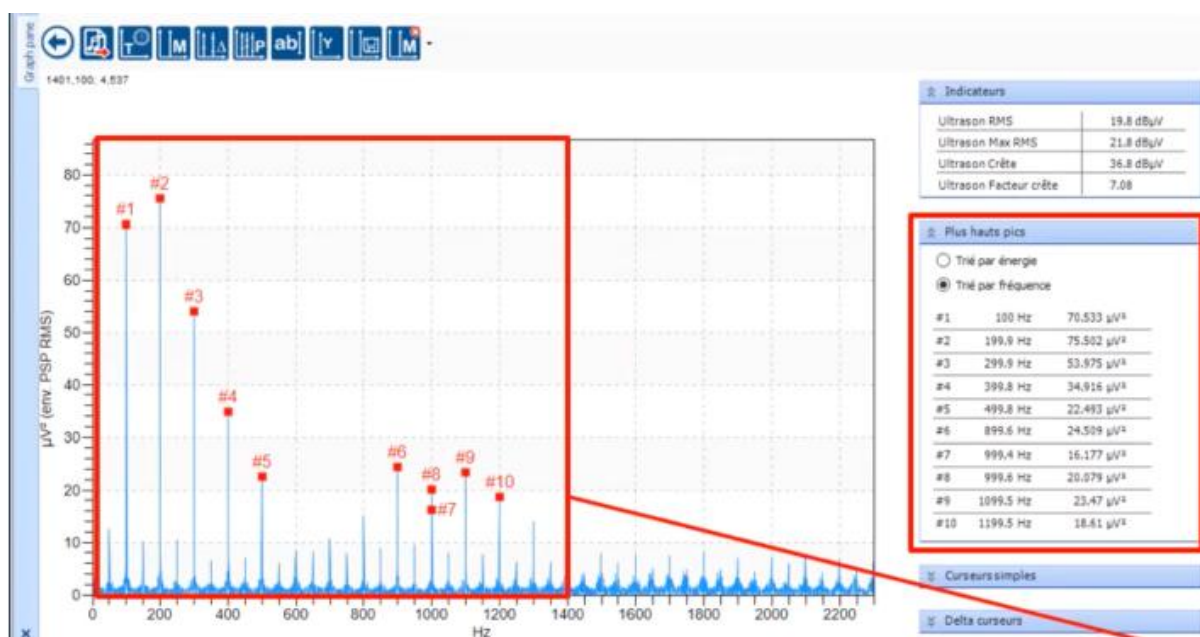
Figure 2 – Ultrasound Spectrum – Peaks at 50Hz

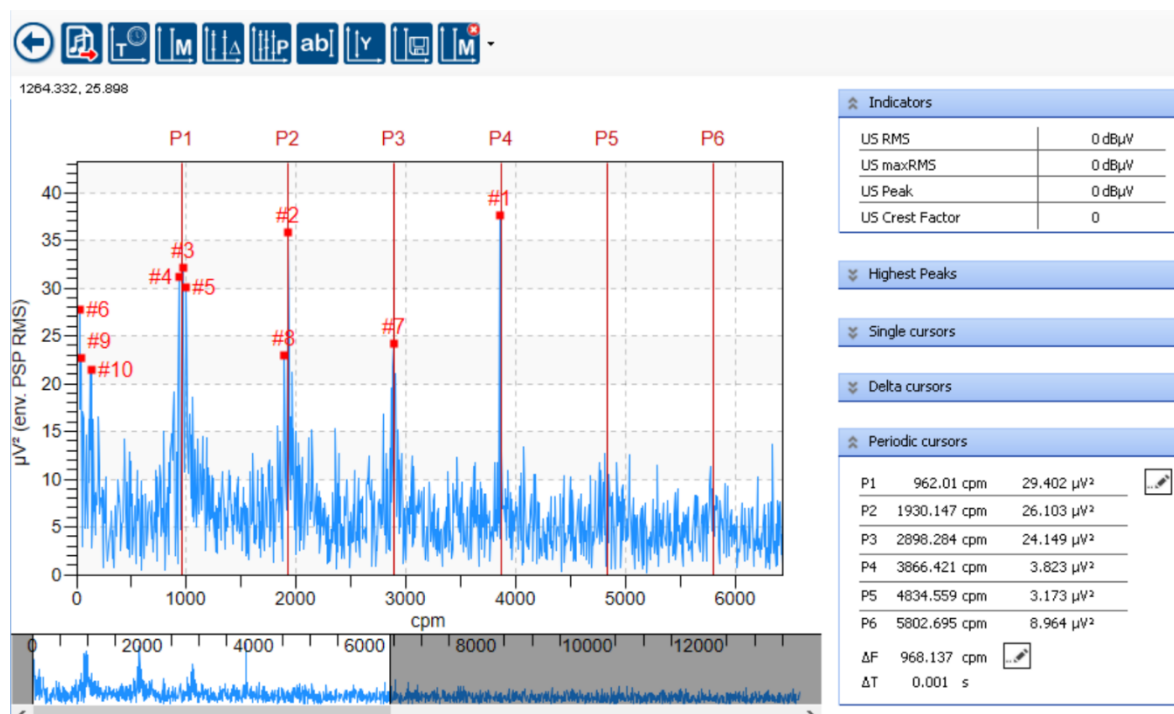
1 X RPM harmonics in ultrasound spectrum from bearing shows looseness. Bearing fit tolerances are out.

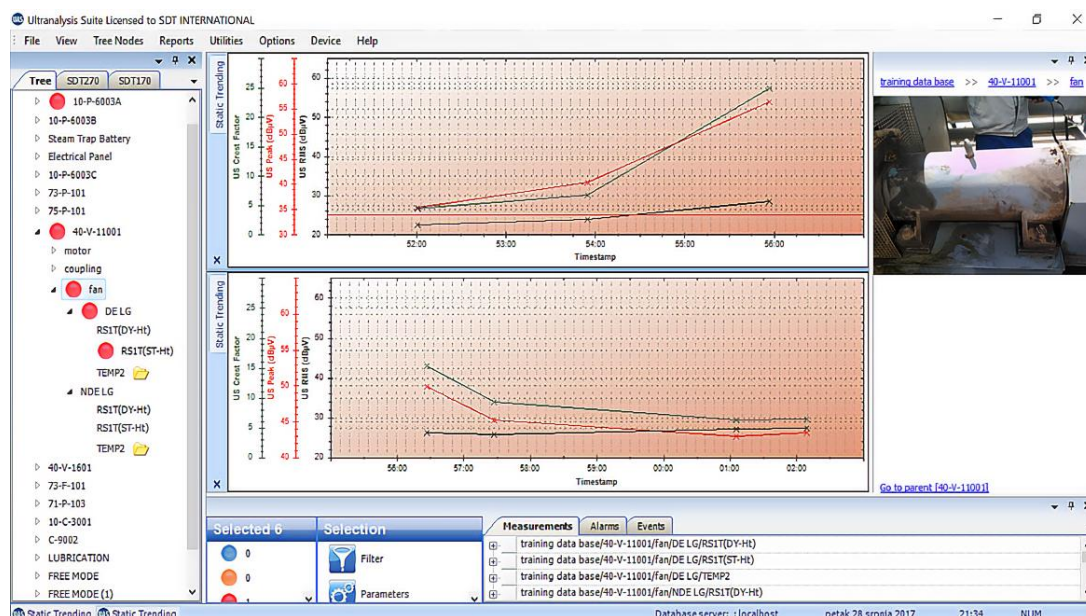
**Figure 5 - Top trend graph illustrates drive end bearing after lubrication. It is badly.**

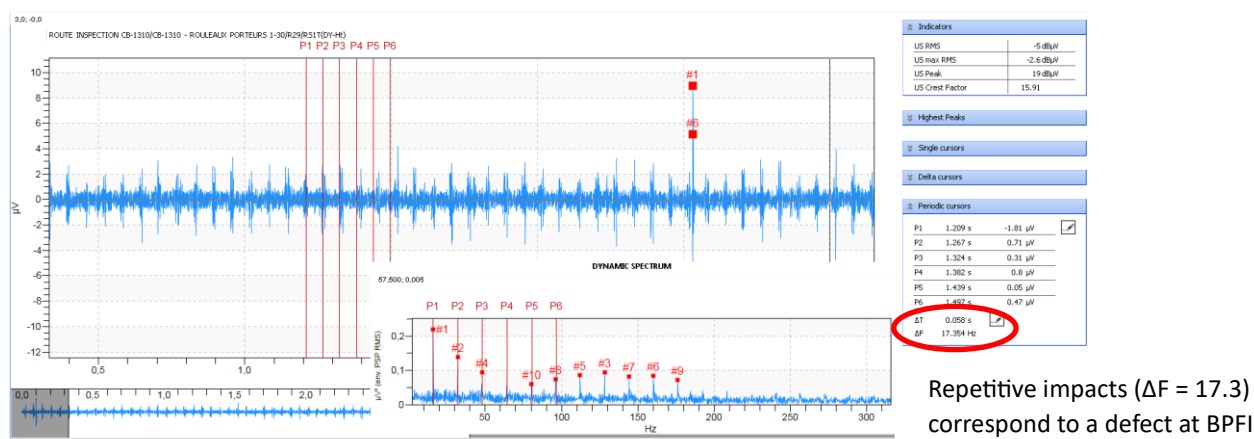
January 3, 2018: Roller Bearing R29 Internal Rolling Cage Failure (BPFI)

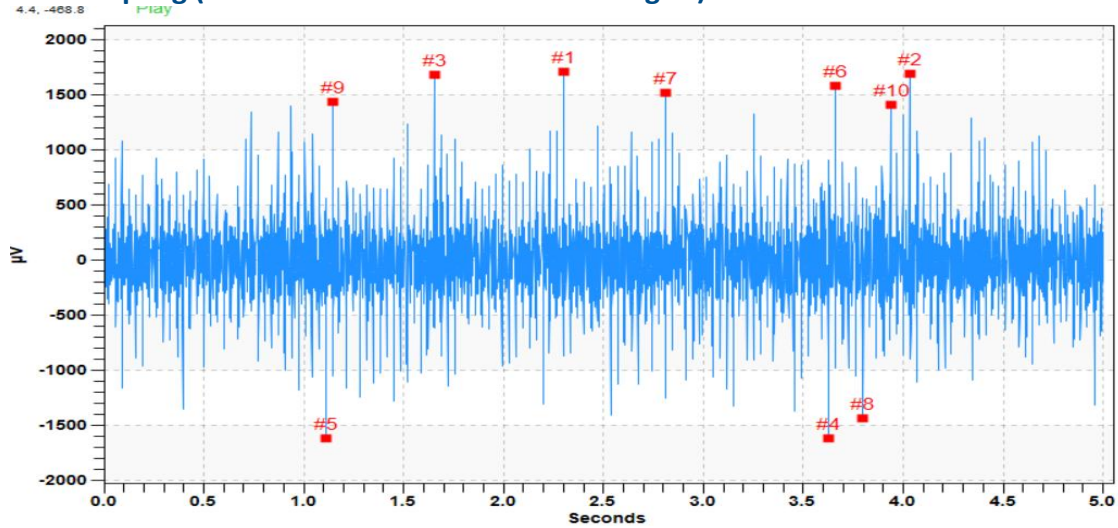
### Grid coupling (Lack of lubrication and worn-out grid)

Impacting seen at 1 x Running speed with multiple harmonics.

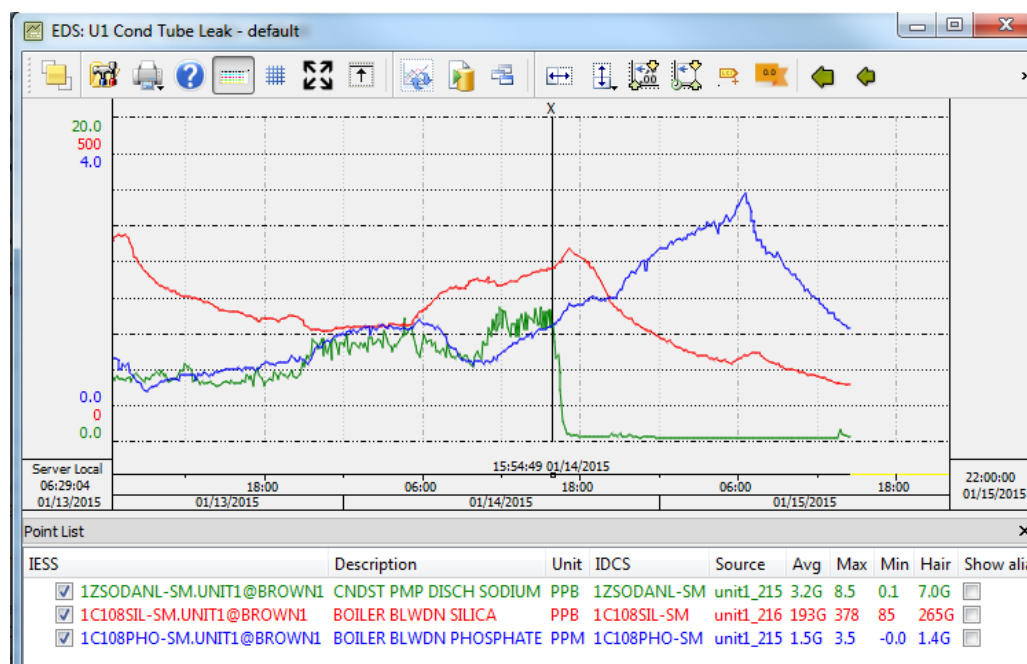
**Figure 4 – Rising sodium and silica leaks in Unit 1 indicate small tube leaks. Condenser flushed on January 14, 2015, restored normal levels for now.**

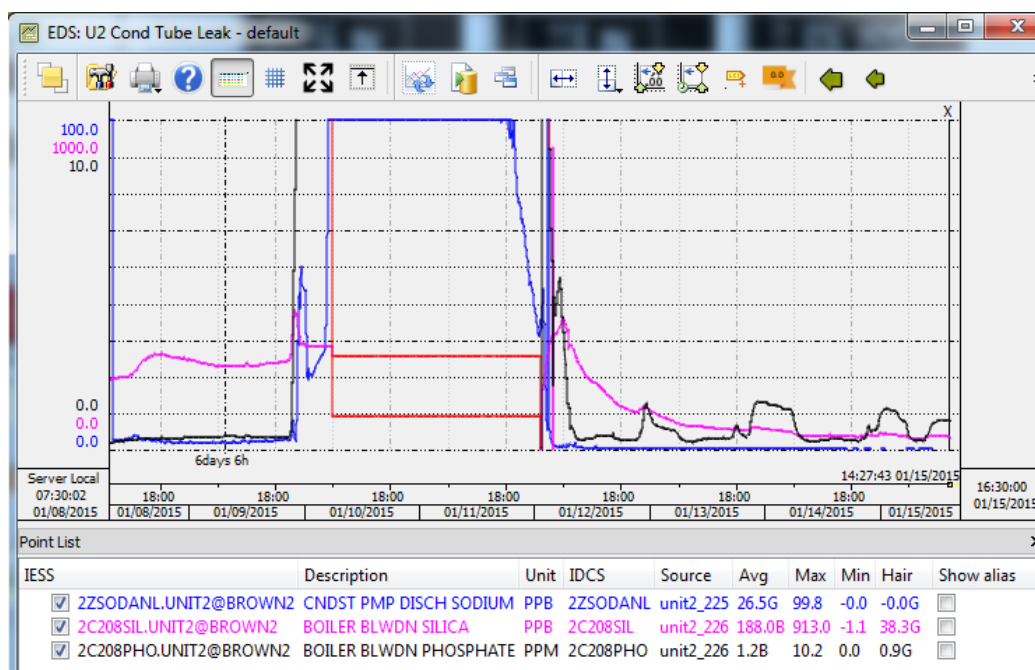
**Figure 5 - Significant tube leak on Unit 2 caused reduction in output. Unit was shut down on January 10<sup>th</sup> and 11<sup>th</sup> for dye test. Leaks were found and isolated. Silica levels restored to normal by January 13<sup>th</sup> and 14<sup>th</sup>.**

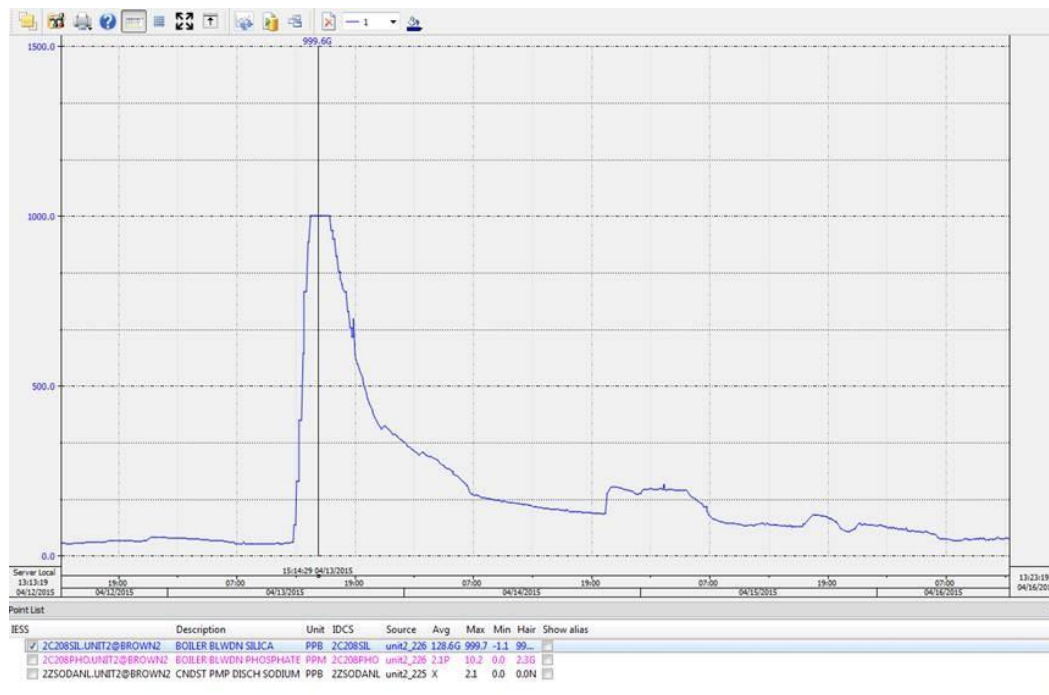
**Figure 8 - Silica levels spiked on 04/15 indicating new and significant leaks on Unit 2 226.**
