# SUCCESS STORIES

## Paper Mill

# Implementation of an ultrasound-based preventive maintenance program on rotating machinery

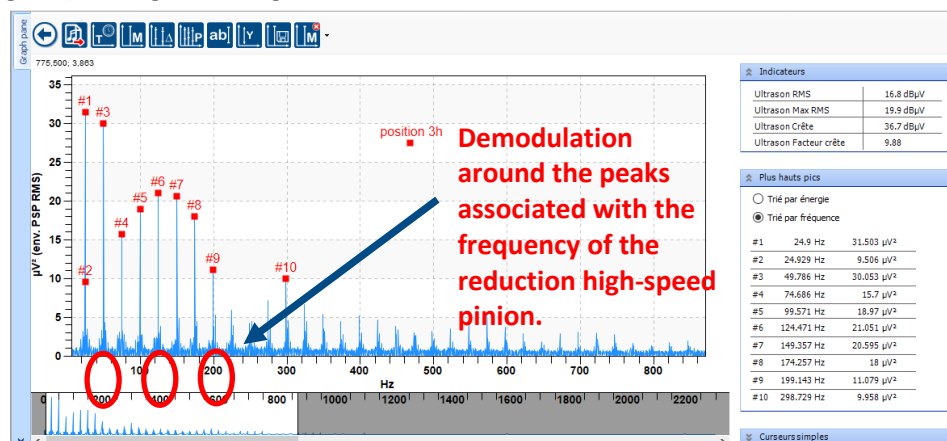
Based on SDT criteria, this increase corresponds to the early failure of a mechanical part of the reduction gear (bearings and/or gears).

Listening to the bearing and analyzing the frequency spectra (see chart below) has allowed to confirm this diagnosis by observing the emergence of significant peaks associated with this gear damage.

We can observe repeated shocks associated with the frequency of the high-speed input drive pinion of the reduction gear (24.93 Hz and its harmonics) with demodulation at each peak. Broken tooth and teeth clearance. Replacement of the reduction gear during a scheduled production shutdown, which avoided an untimely breakdown which could have generated significant expenses due to production losses.

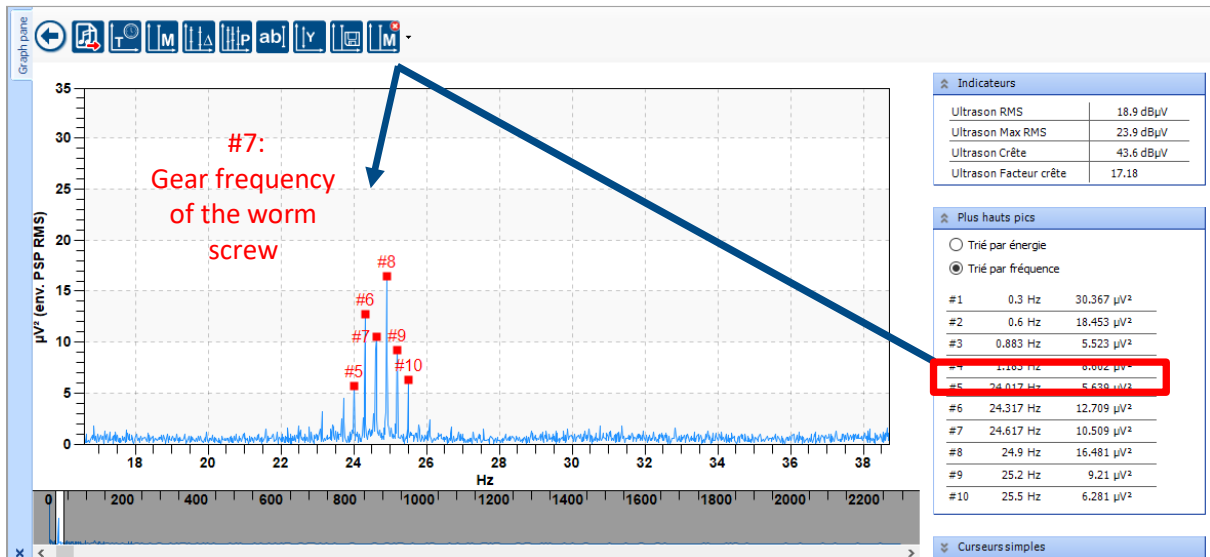
Measurement carried out on December 11, 2016

We can observe that between each revolution of the worm screw, there is a phenomenon occurring, which can be heard through the ultrasound detector as a sliding of the gear (worm screw/bronze wheel).

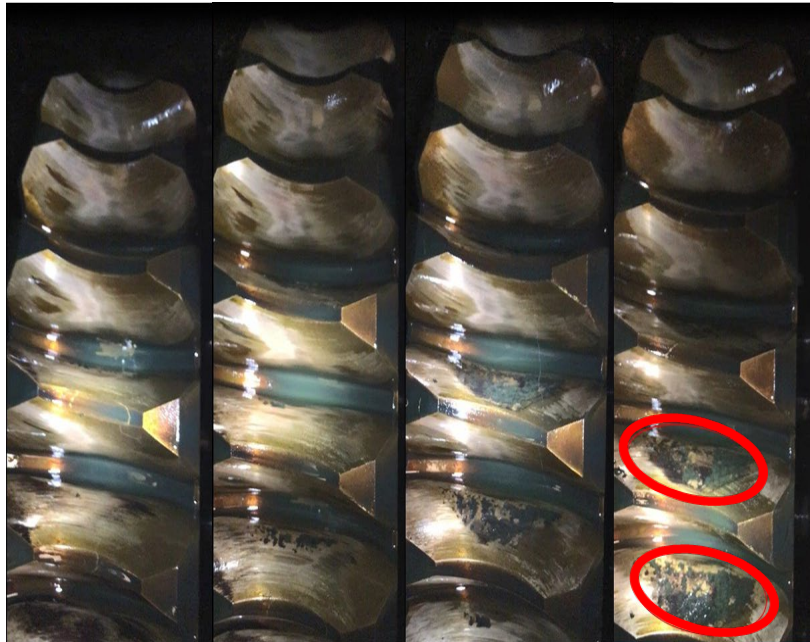
Zooming in on the envelope spectrum highlights the dissymmetry of the modulation around the meshing frequency, which is characteristic of a damaged gear mesh.

The endoscopic video inspection of the worm screw of the reduction gear confirmed the ultrasound diagnosis.

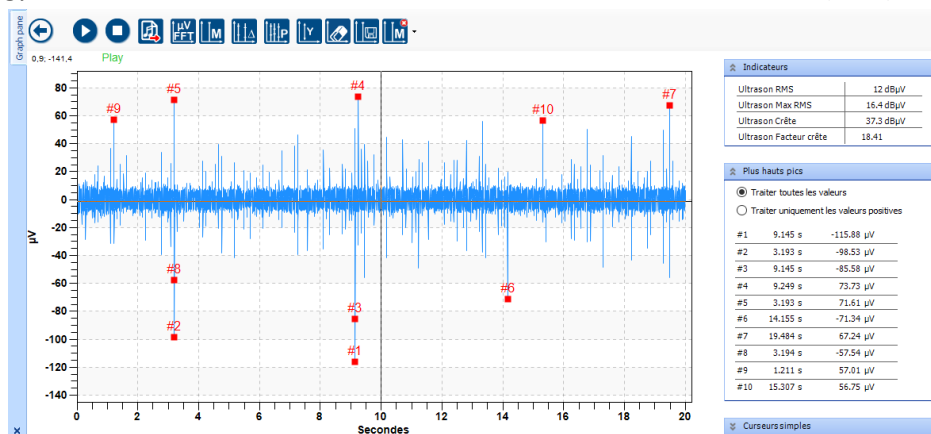
From the beginning of the monitoring of this reduction gear (August 2018) using ultrasound technology, the occurrence of shocks can be observed on the time waveform (TWF).

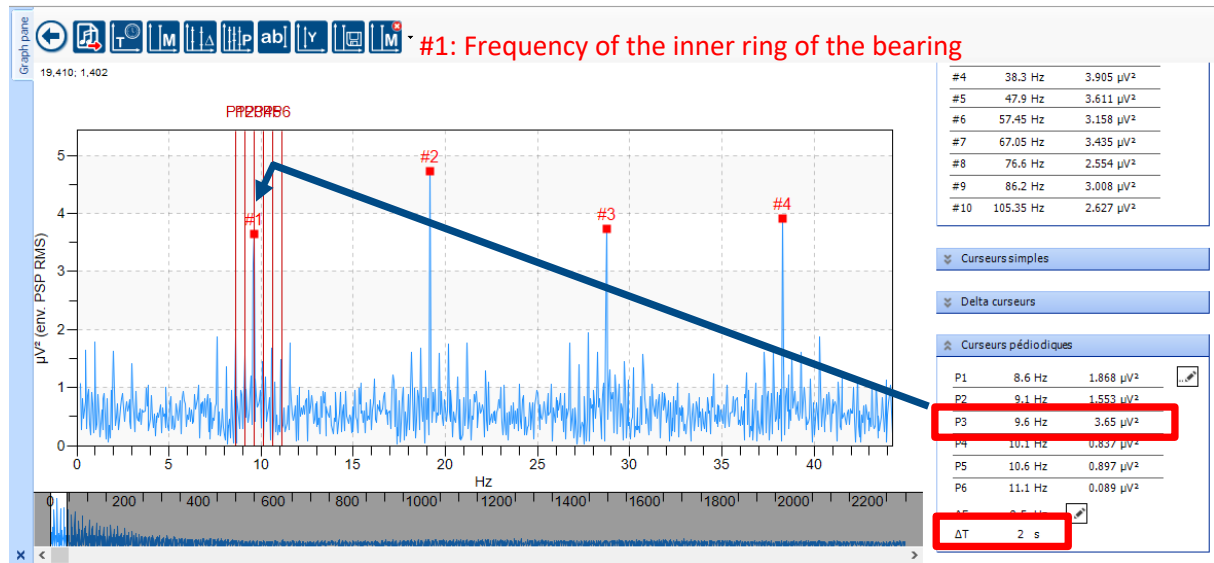
By looking at the envelope spectrum, one can observe repeated shocks at **9.756 Hz** (see the table of characteristic frequencies below) related to the frequency of the inner ring of the bearing of the low-speed reduction gear (opposite side of transmission).

The amplitude of the scaling-type defect is modulated at the fundamental frequency of the rotation speed.

On the spectrum, this is evidenced by a peak at P3 (#1) corresponding to the bearing defect modulated at  $\Delta F$  as confirmed on the harmonics: #2, #3, #4.

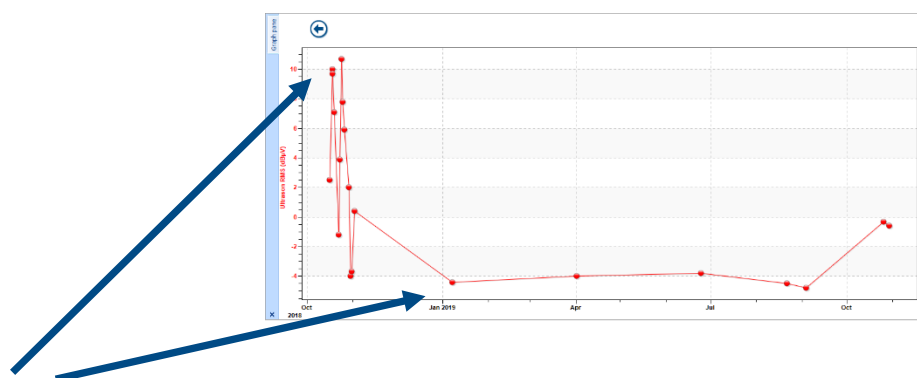
On the trend, one can observe the occurrence of high value in the RMS right from the beginning of the monitoring of this bearing. After replacement of the bearing, all shocks disappeared. The rolling elements were no longer held in their housings.

The trend curve shows the decrease of the RMS value after servicing (**from +10.7 dBµV in October 2018 to -4.4 dBµV in January 2019**).

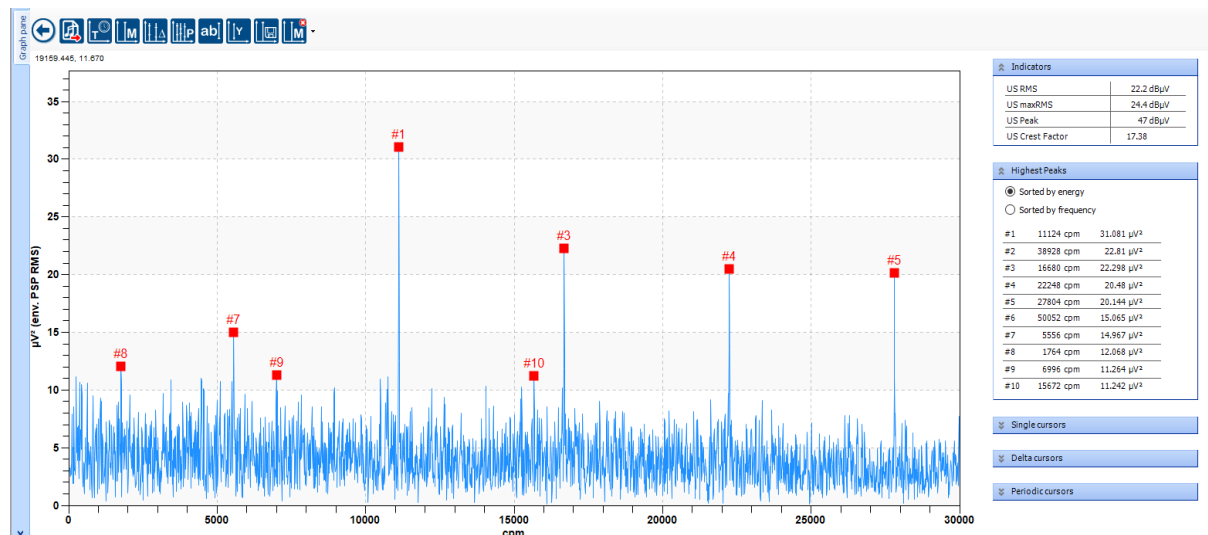
Images of bad bearing – no secondary damage occurred:

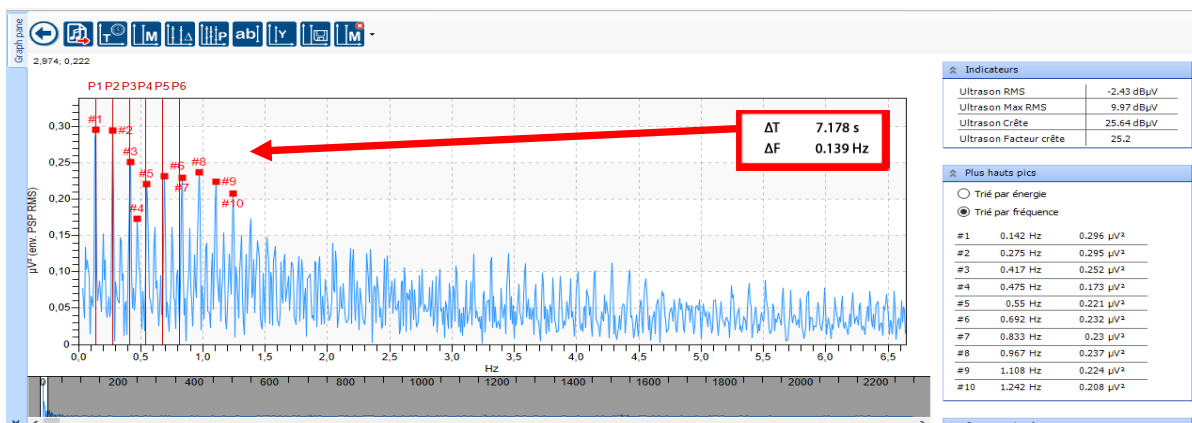
The spectrum shows an impact at the rotation speed (0.13 Hz) of the shafts of the rotating machine, along with its harmonics. Sub-harmonic frequencies can also be observed at 0.5 x the rotation speed, which is a characteristic spectrum for a rotational clearance due to friction or significant impacts. No impact due to bearing frequencies are observed. Our diagnosis is confirmed by the time waveform.

The encountered problem is due to the wear of the shafts and of the disks that are mounted onto these shafts and generate abnormal friction.

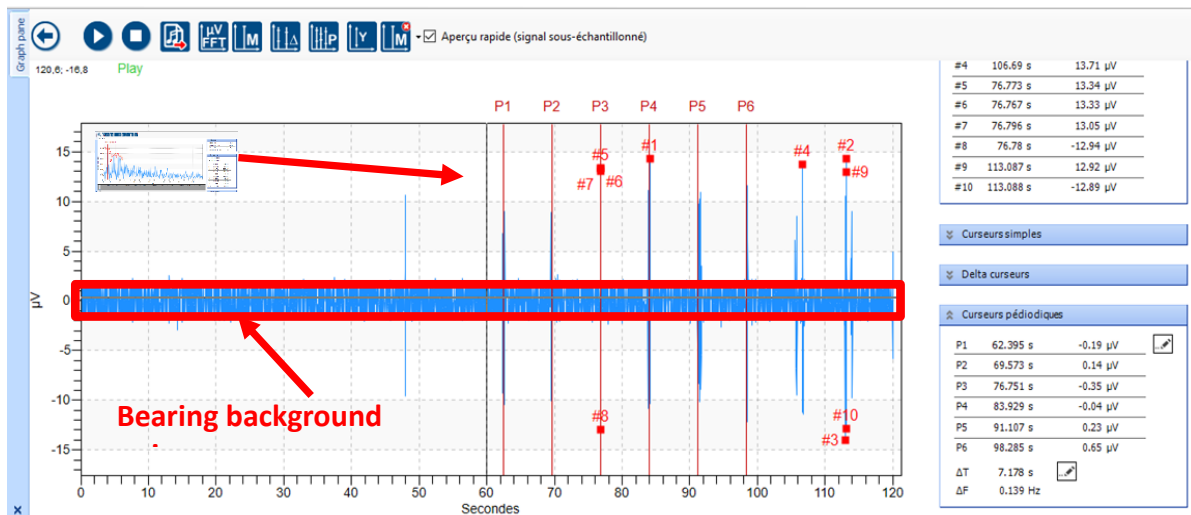
The graph shows that the observed impacts are indeed associated with the rotation speed of the shafts of the machine at 0.13 Hz, i.e., a rotation speed of 8 RPM.

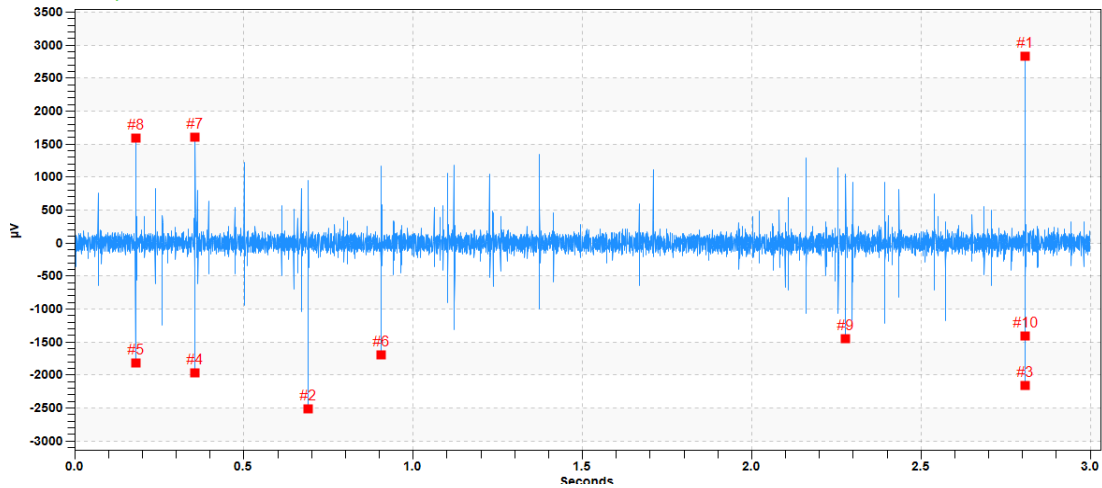
Ultrasound reading on November 28<sup>th</sup> (still containing high peaks as November 2nd):

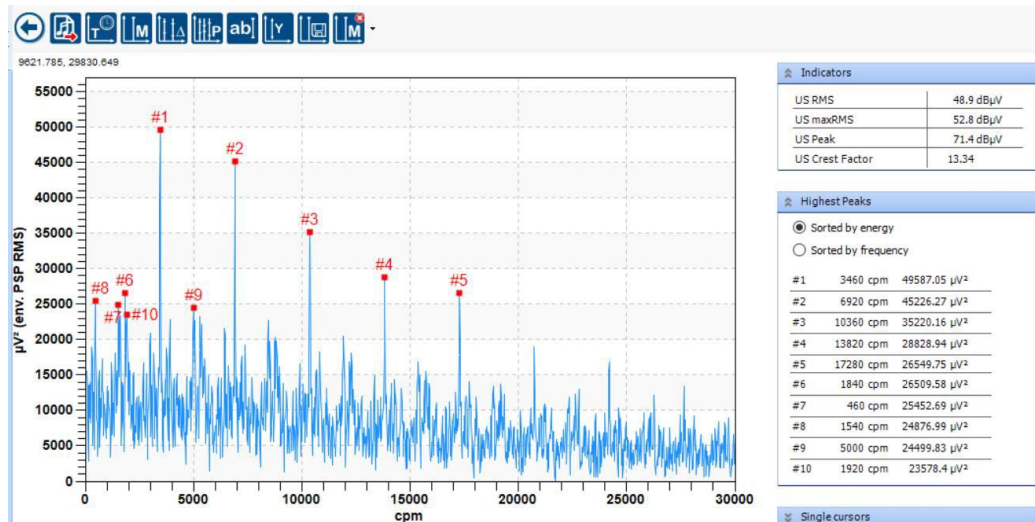
Levels rise back up. Bearing defect is very clear:

Defect clearly visible. The bearing is finished.

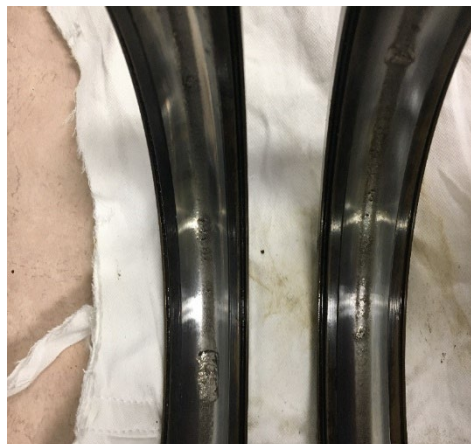
Figure 3 Outer race damage (BPFO)

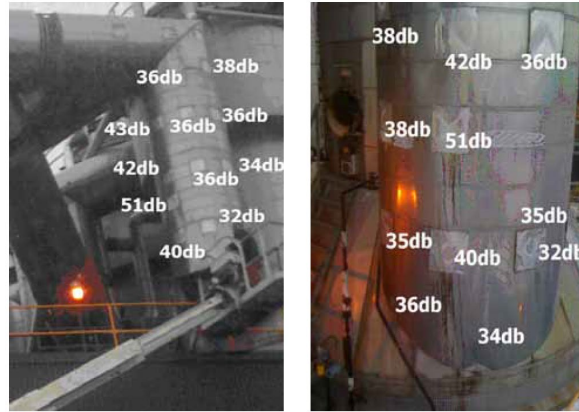
**Diagram shows dB levels mapped out using SDT RS1 Contact Probe. Vacuum leaks detected through 4" insulation and outer sheet steel. Loudest areas were cut away and patched with Gor-Tex™ patches.**

With airborne ultrasound leaks, a large leak usually registers at 65-75 dB or around 15' away from the source. Since no other points had anything higher than 51 dB, we decided to return to that location and investigate further.

As the additional pictures below will show, there was a strong correlation between the locations of the leaks and the thinning of the wall of the stack. At the location of the highest ultrasound, 51 dB, the wall was found to be 0.091" thin. The thinnest area found on our initial survey.

Mr. Rose recommended applying Gor-Tex™ sheets sealed with silicone to affect a strong, yet temporary repair. The decision was to strengthen and seal the holes so that the process could continue until a planned outage in March 2010. At that time a complete repair/replacement could be implemented.

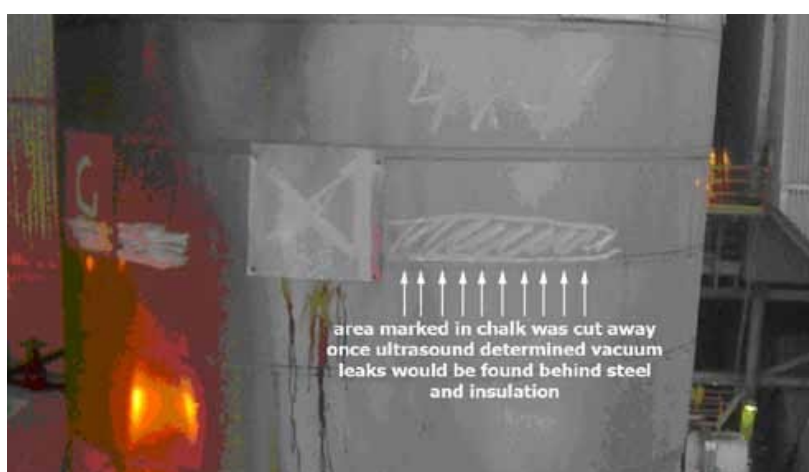
Opening the access door allowed further pinpointing with RS1 ultrasound probe along the underside of the metal flange area.

The exact number of holes was too numerous to count. Also, many of the holes had blended together from the corrosion.

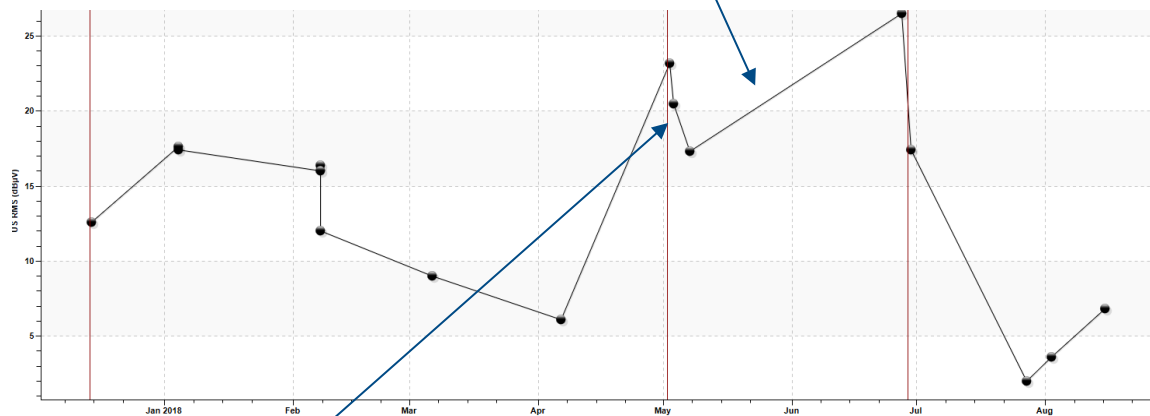
Greasing the bearing on May 3<sup>rd</sup> reduced the friction as seen by the drop in RMS over a few days and masked the impacting, but the impacting returned as seen by the Crest factor going back up to 11.88 by the May 7<sup>th</sup>. This is indicative of the bearing having a defect.

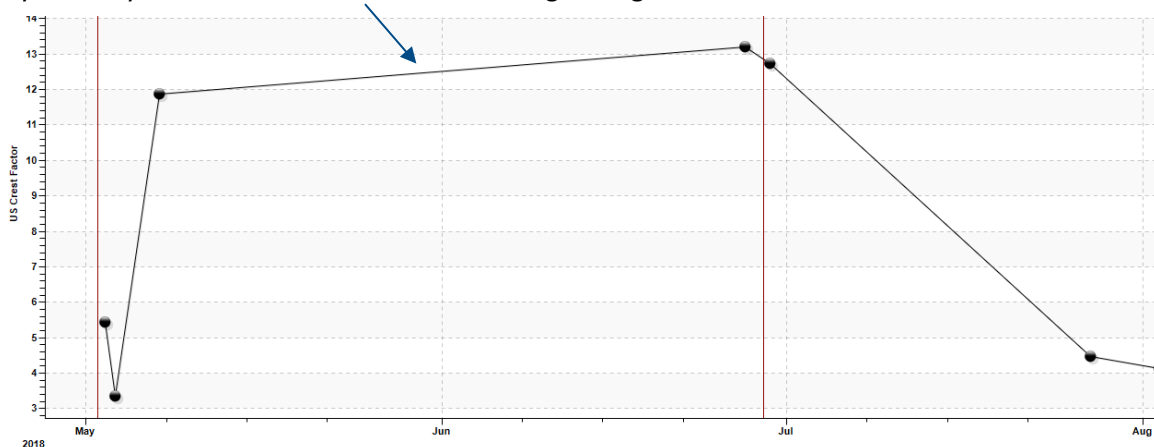
May 2<sup>nd</sup> – First Indication of increased friction & Impacting in Ultrasound.

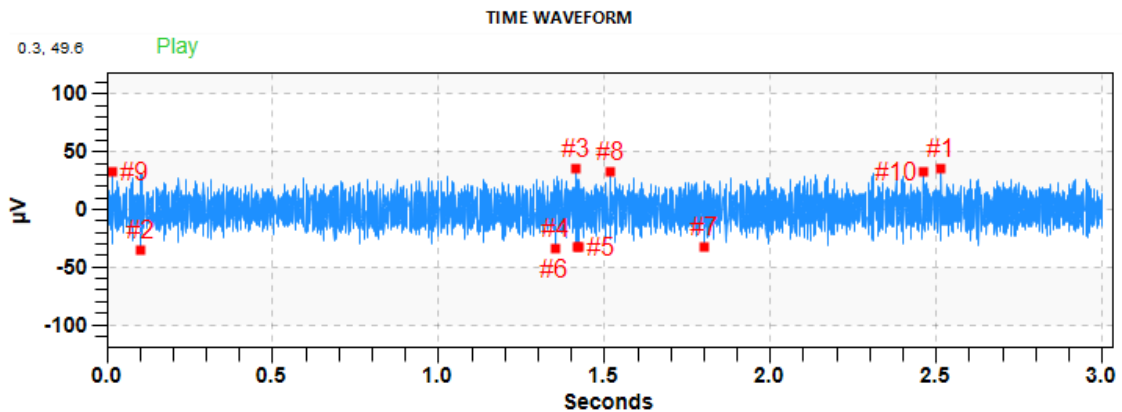
May 7<sup>th</sup> – Impacting back four days after greasing. Bearing has a defect.

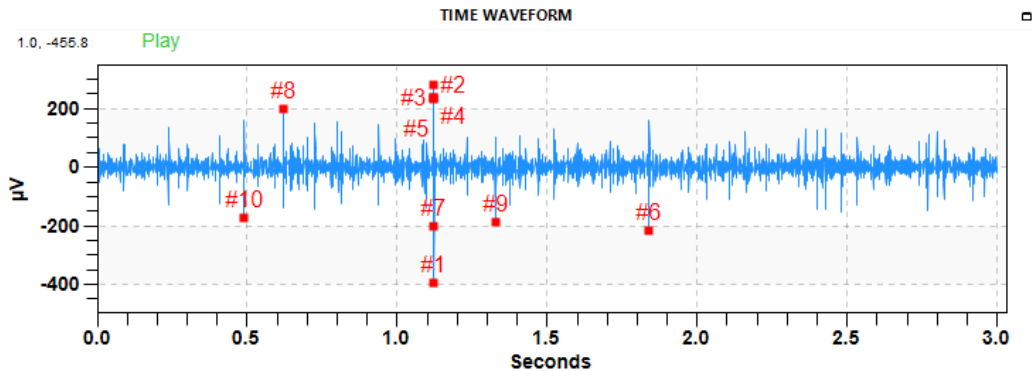
June 27<sup>th</sup> – Bearing being monitored and greased regularly but by end of June Impacting significantly worse. Scheduled for swap at next shutdown on July 24<sup>th</sup>.

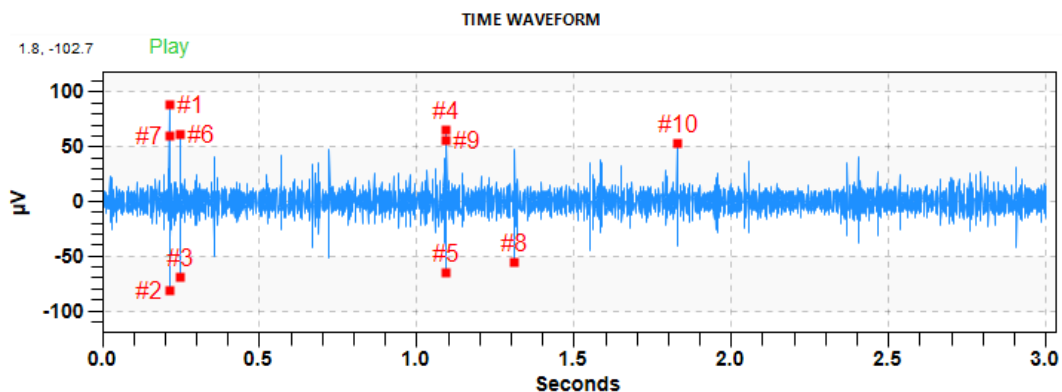
July 27<sup>th</sup> – New Ultrasound reading after bearing replaced.

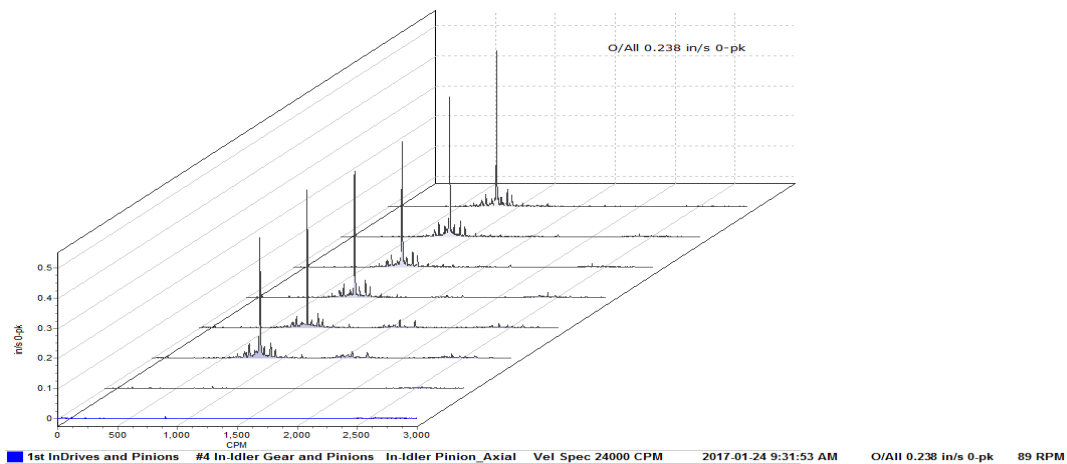
During the investigation, we used a strobe light to verify the speed of the DC motor. Usually under normal operating conditions the strobe light would make a reference mark (key or keyway) appear frozen. In our observation, the reference mark would vary its position 30 degrees continuously. This could be caused by either a continuous change in load or DC motor control problem. This variation could be causing a hammering on the gear train which could be causing the appearance of the 900 CPM peak as a natural frequency of one of the gears.

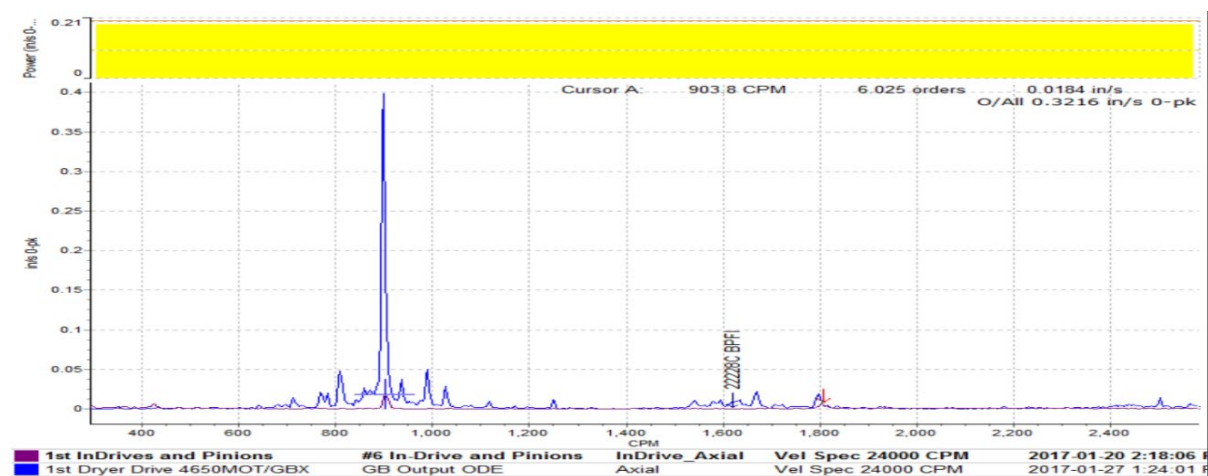
The two spectrums below illustrate the variation in speed on the motor. The first is on the DE and the second is on the ODE vertical.

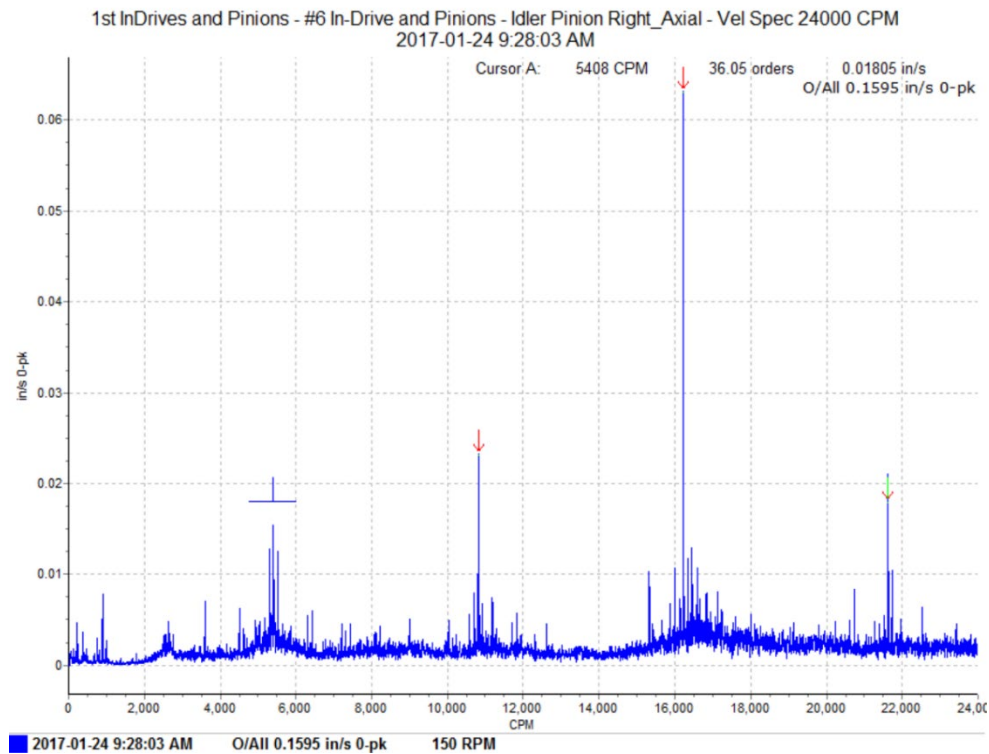
There is also evidence that there is a misalignment condition between the output of the gearbox and the In-Drive.

Gear Misalignment is probably the most prevalent cause of gear failure. Typically, this results from coupling misalignment between the input and/or output drive systems and the mating components. This produces Gear Mesh Frequencies (GMF) and sideband frequencies, spaced out at the rotating speed of the faulty gear. Gear misalignment can also occur internally if the gear shaft support bearings are not properly aligned with respect to one another. While not common, this problem will usually lead to premature bearing failure before gear problems are considered severe.

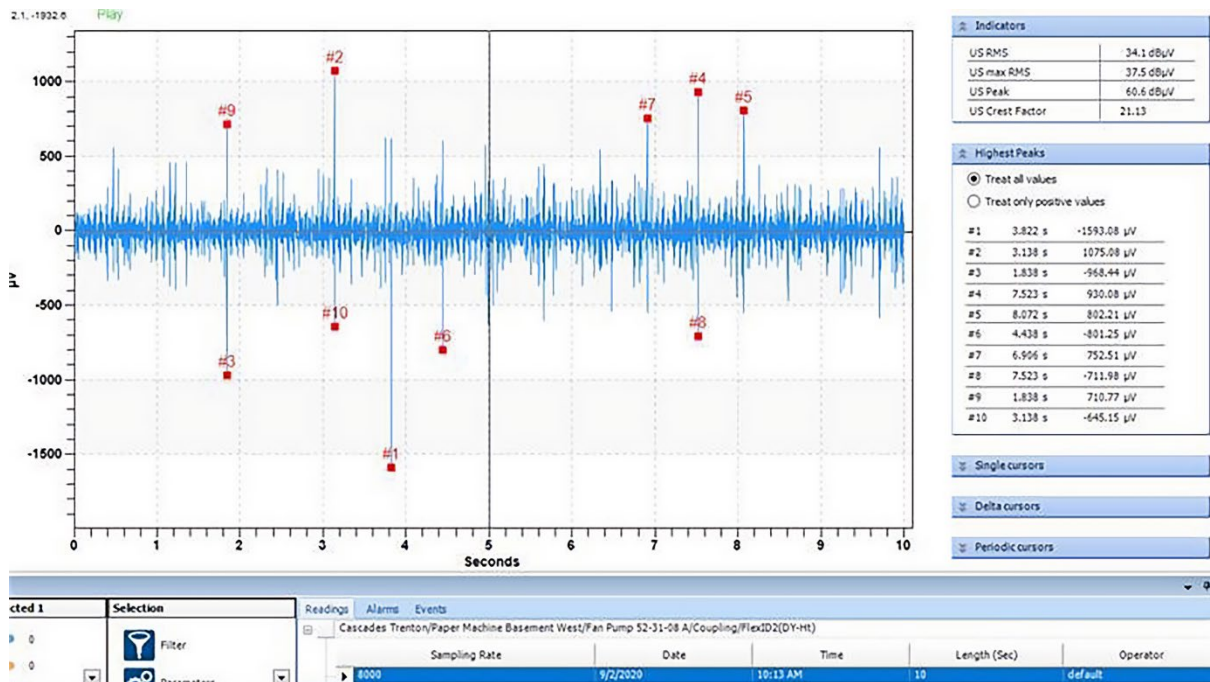
First, let's start with the ultrasound readings. As you can see in the time-wave measurement, this coupling appears to be in bad shape with lots of impacting at its regular run speed. When you look at the spectra you can note something strange, because of recurrences clearly identified with the periodic cursors. After making this discovery our data collectors from the Partnered Ultrasound team decided to utilize vibration analysis where we discovered the motor run speed was fluctuating.

When a firing card fails, then 1/3 of the power is lost, resulting in momentary speed changes in the motor's rotation. This can lead to high amplitudes at 1/3X and 2/3X SCR frequencies. As you can see on the vibration measurement this motor was firing at 1/3X SCR which is 7200 CPM meaning 2/3rds of the firing cards were faulty.

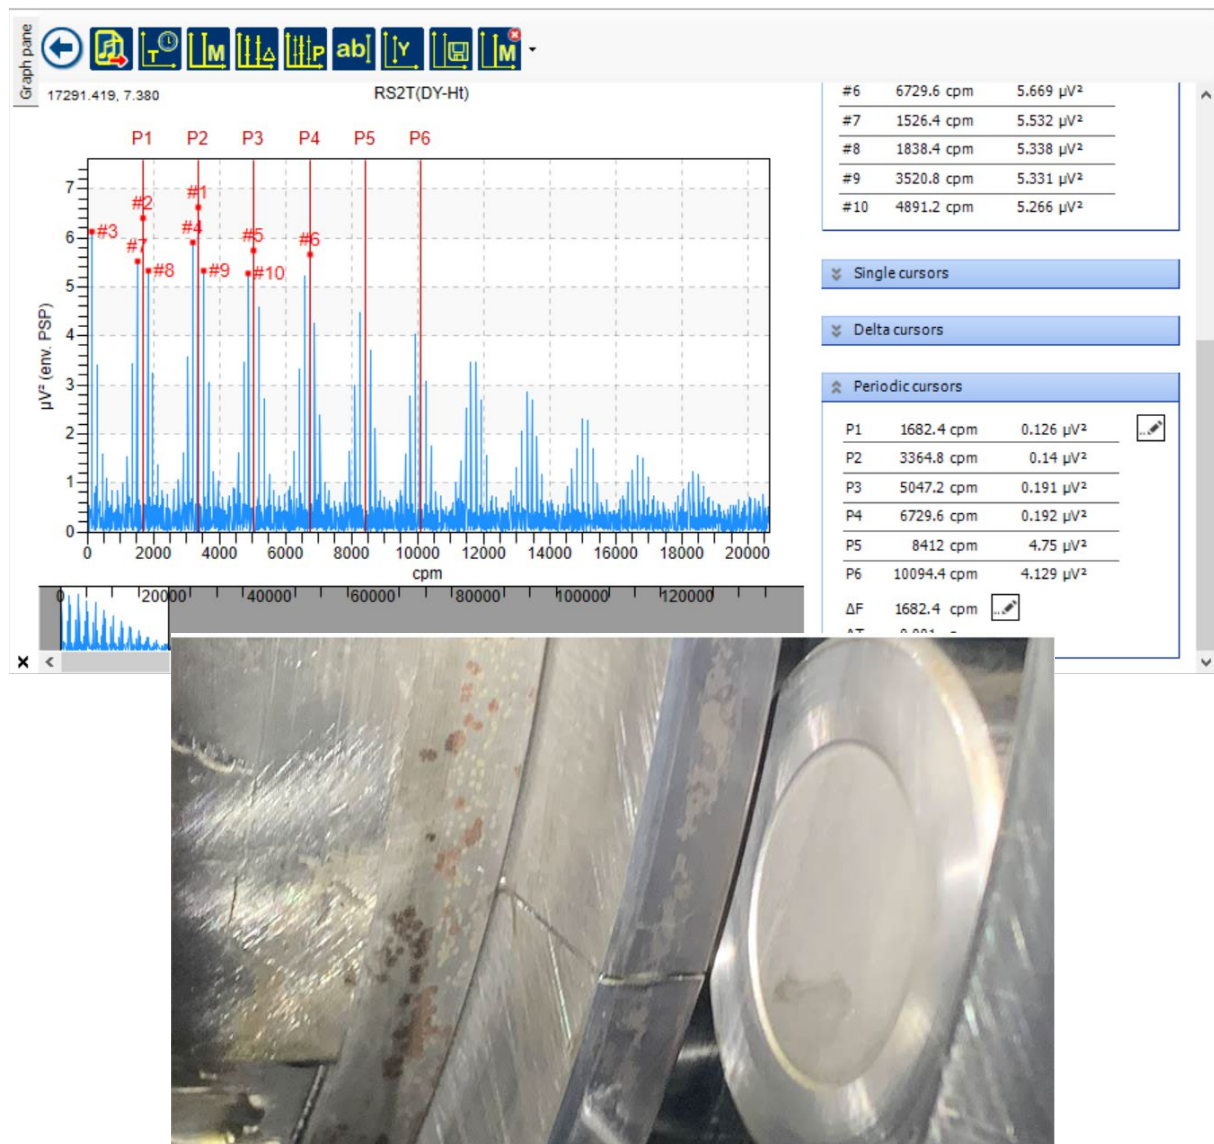
The following is the spectrum of a slow-speed bearing (150 RPM), on a large roll (4-foot diameter), in a paper machine. Gilles Lanthier, our Partnered Ultrasound Senior Analyst found this defect using his SDT340 and performed analysis using UAS3 software. This find was then confirmed using vibration analysis.

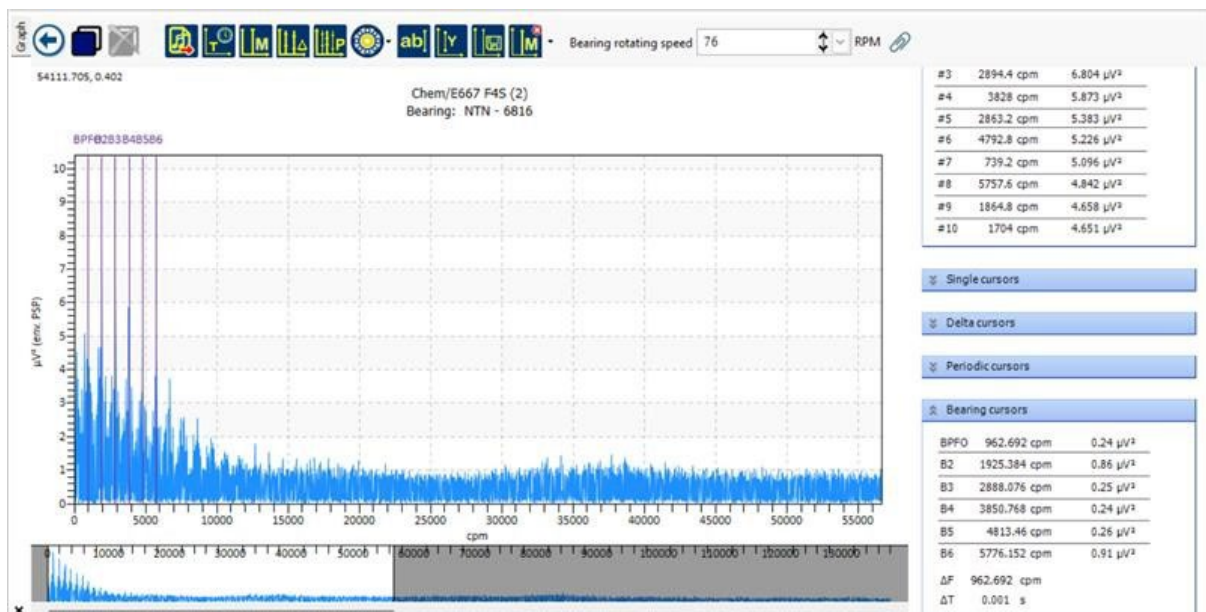
Failed Bearing 2 – Figure 2 – UAS3 Bearing Toolbox, BPFO Fault Frequency Cursors.

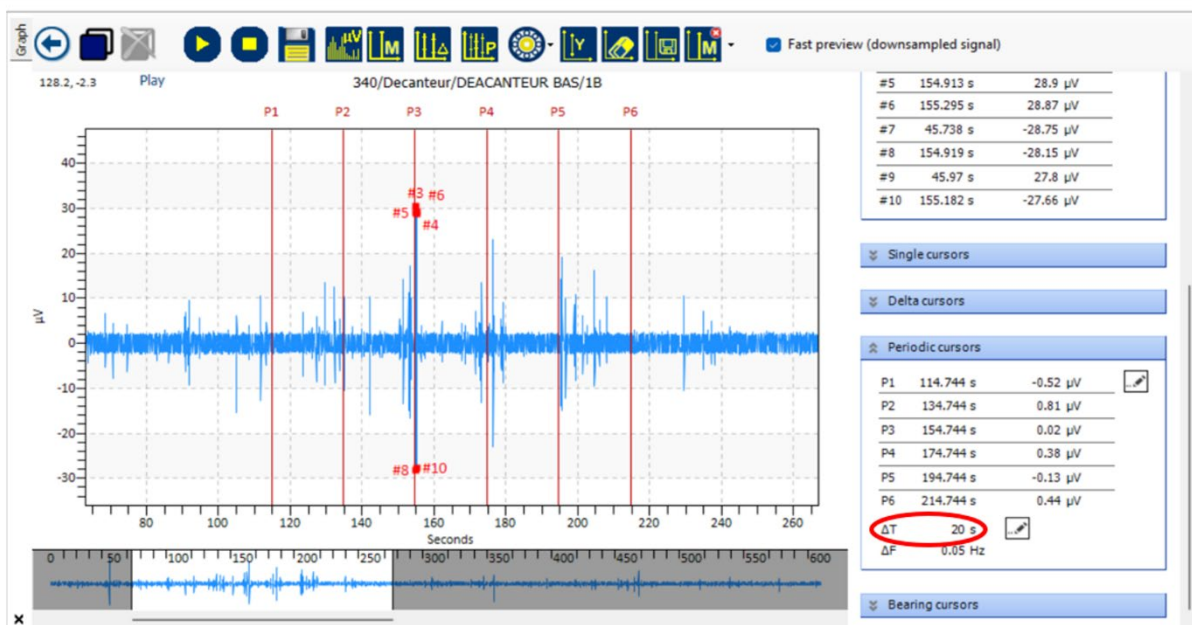
**Figure 1 - 10 Minute Time Waveform of Wastewater Decanter Centrifuge Pinion**

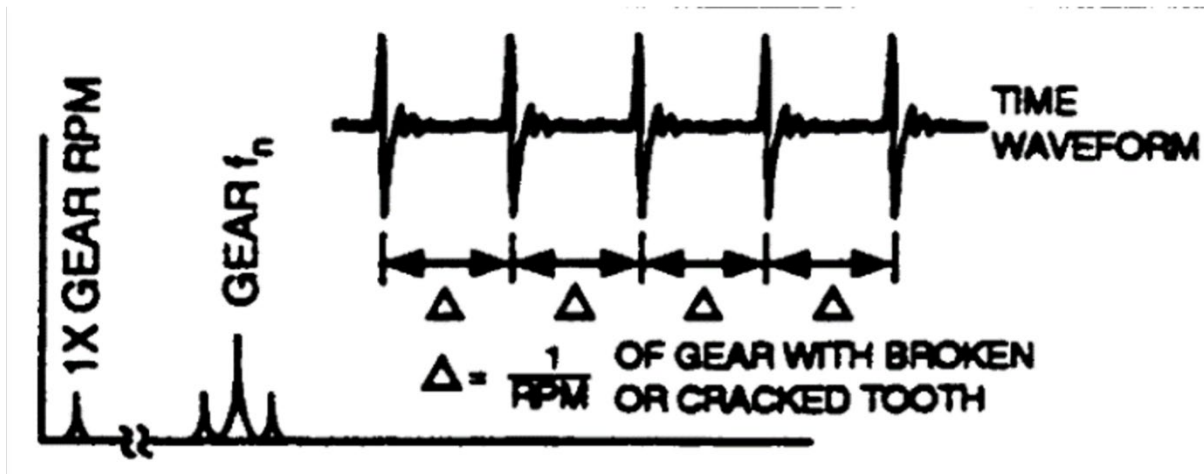
Figure 2 - Cracked or Broken Tooth

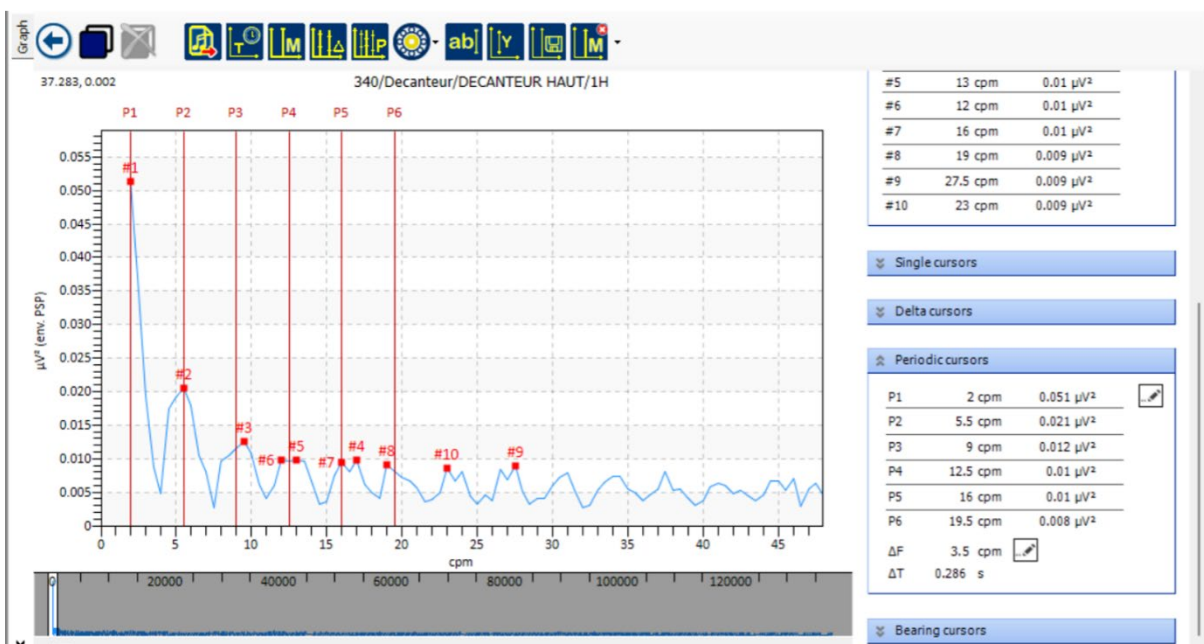
Figure 3 - FFT on the Pinion

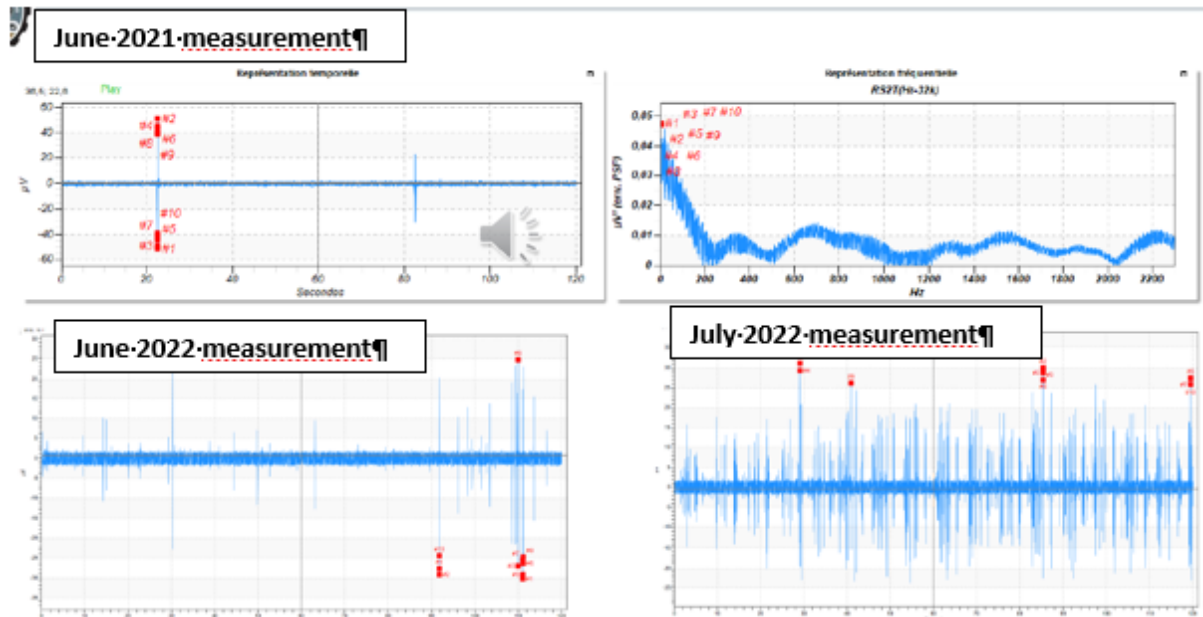
The image above shows a rather evolutionary time waveform. Relatively normal measurements in June 2021 gradually shift towards the beginnings of unusual shocks in June 2022, culminating in a much more serious situation the following July.

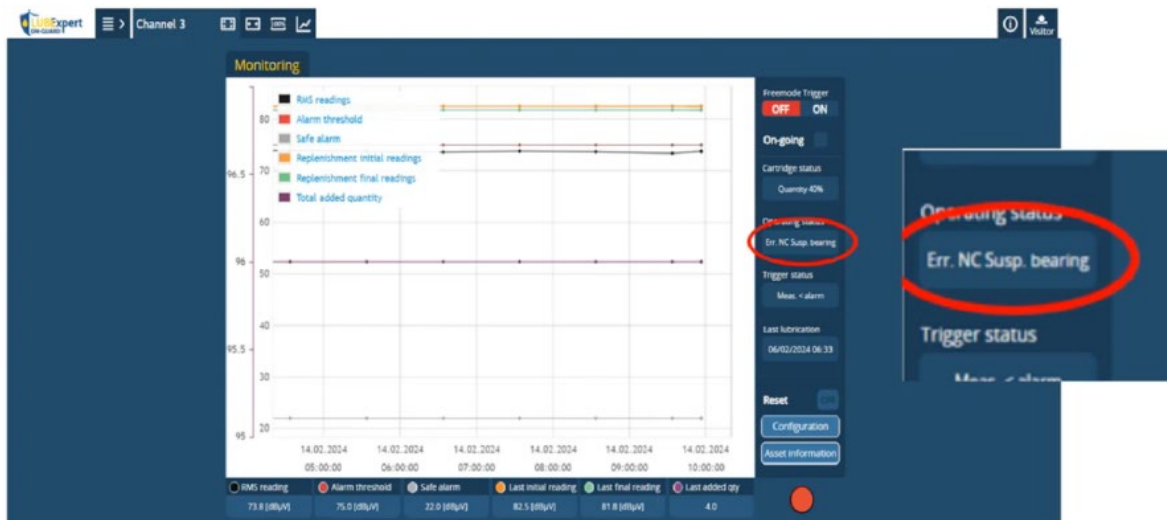
Figure 3: ON-GUARD Browser-Based Dashboard signally Suspected Bearing Failure

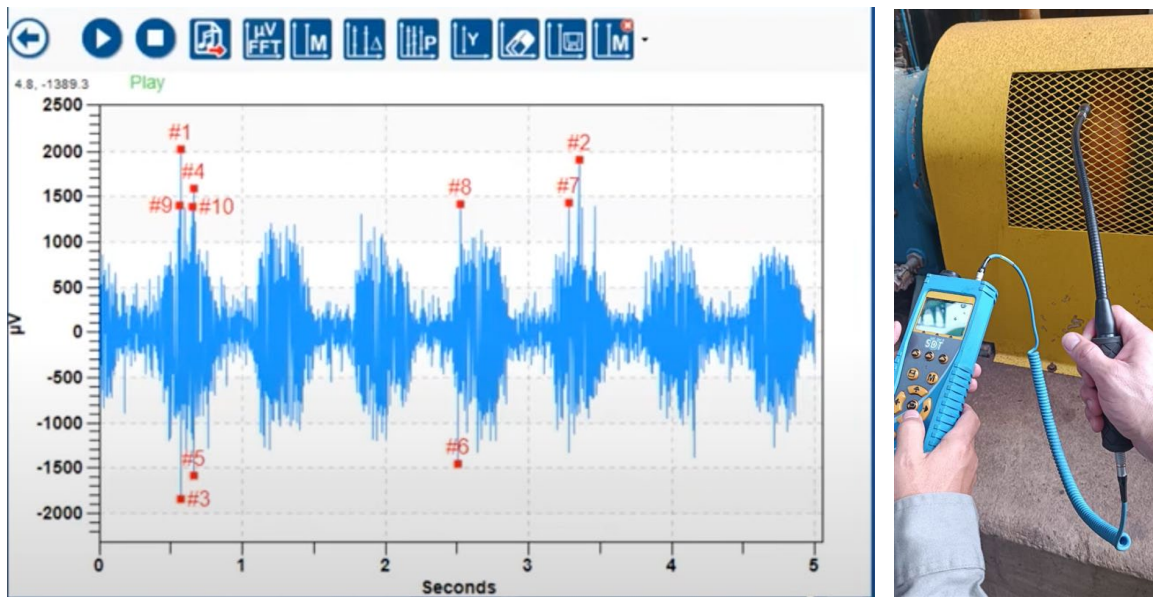
**Figure 2 – Slow-Speed Coupling with Misalignment Time Wave Form**

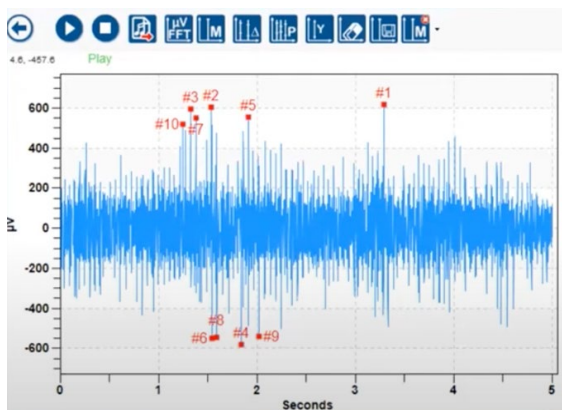
**Figure 3 – Coupling that Requires Lubrication & Follow-Up Measurements Time Wave Form**

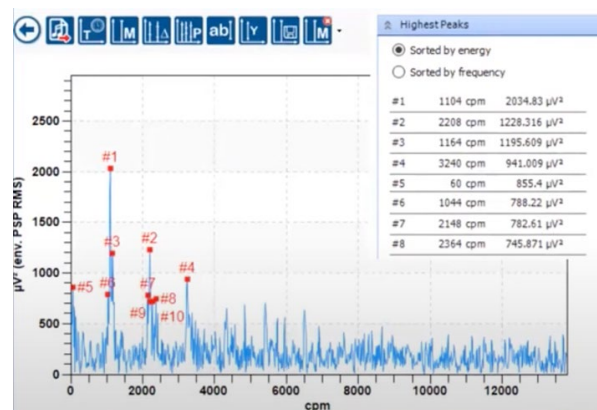
**Figure 4 – Coupling that Requires Lubrication & Follow-Up Measurements FFT**

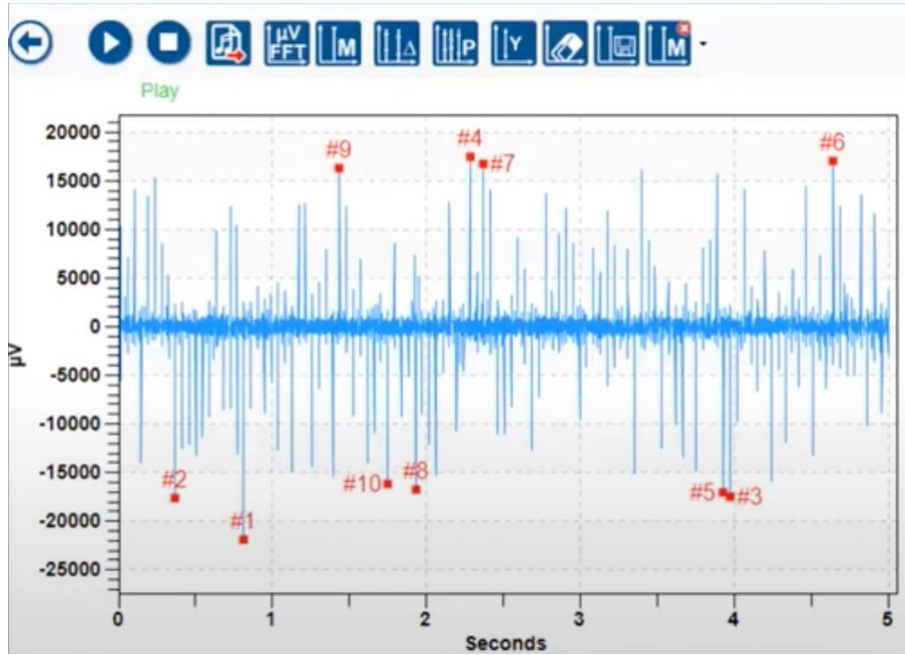
Figure 5 – Damaged Coupling Time Wave Form

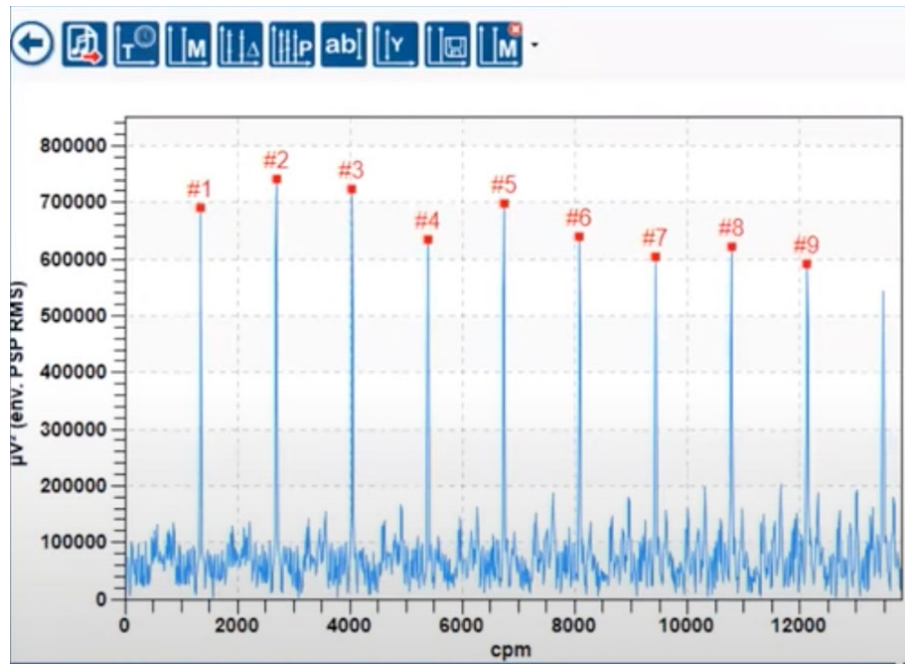
Figure 6 – Damaged Coupling FFT

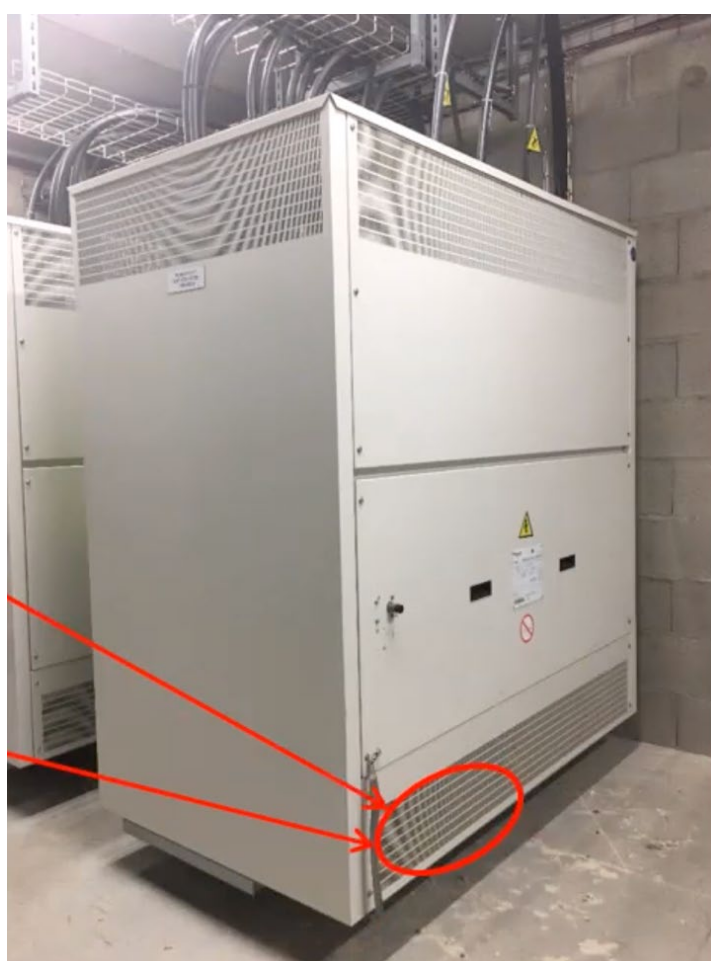
**Figure 1 – Transformer in Question, highlighted is the area where the technician found the fault.**

It was recommended that the transformer be thoroughly cleaned.
