# SUCCESS STORIES

## Paper Mill

# Implementation of an ultrasound-based preventive maintenance program on rotating machinery

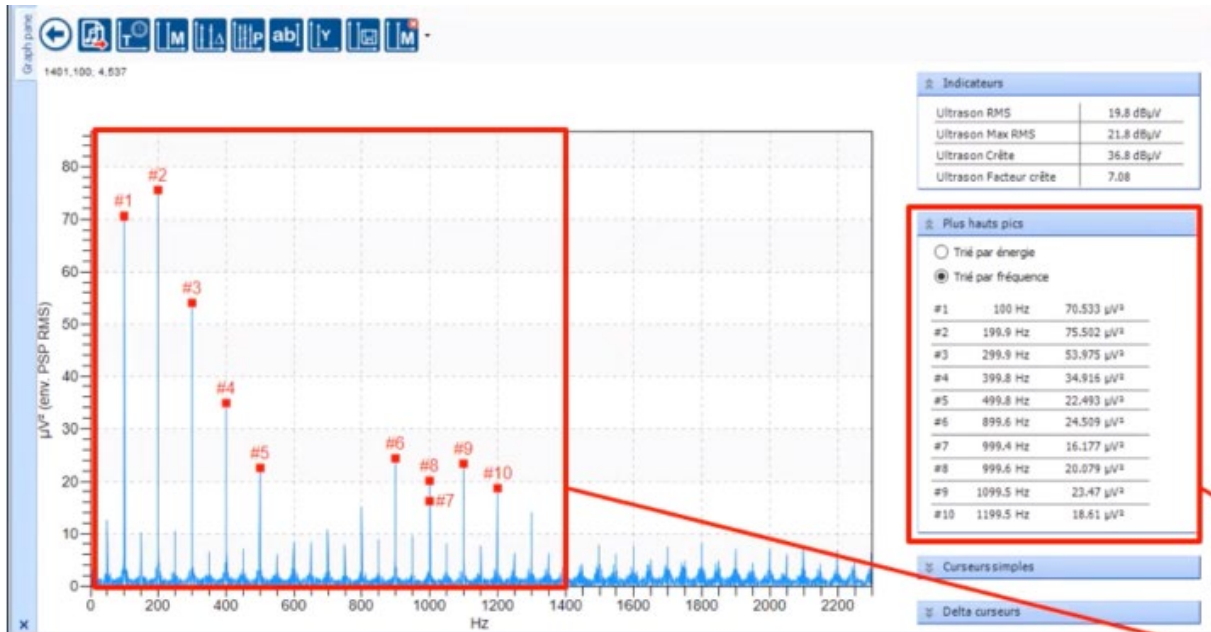
Figure 2 – Ultrasound Spectrum – Peaks at 50Hz
