# SUCCESS STORIES

## Steel

# John Garrison Main Hoist Input Shaft Bearing on Crane

# Predicting and preventing transformer outages in a steel mill

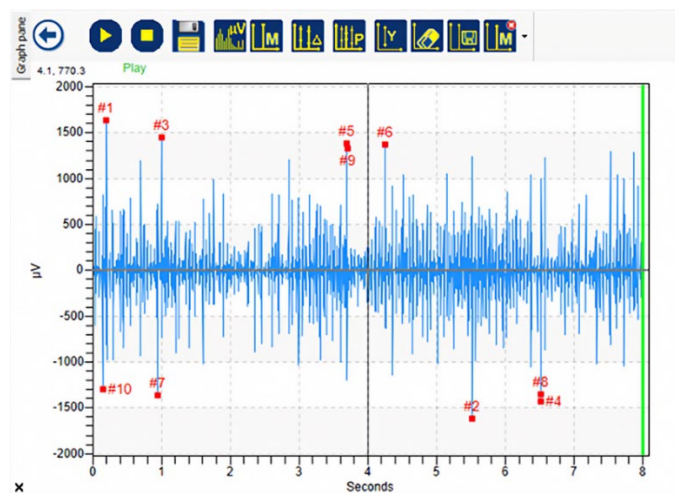
Upon arrival to the crane, he began listening to the bearings on the input shaft and the brake drum side of the gear box. Immediately, John recognized something didn't sound right. He made it known to the crane technicians and went to upload the data to UAS3 so he could perform an analysis. John immediately recognized very high peaks in the wave form as well as an audio signal full of impacts.

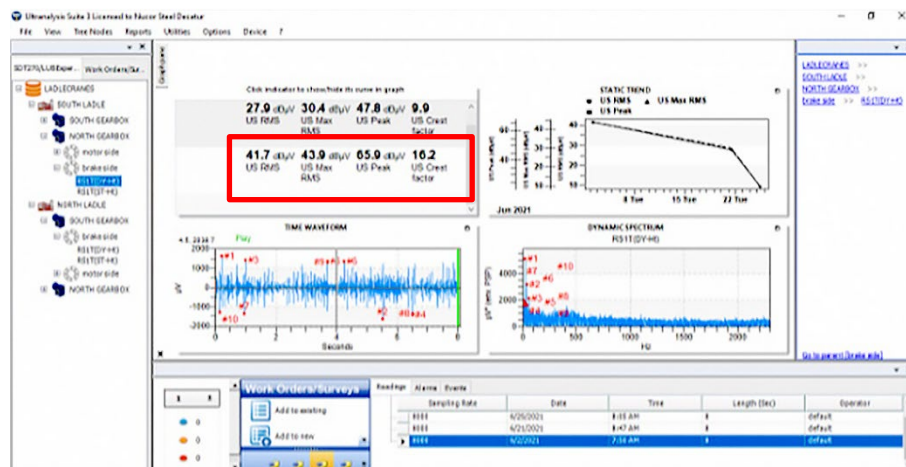
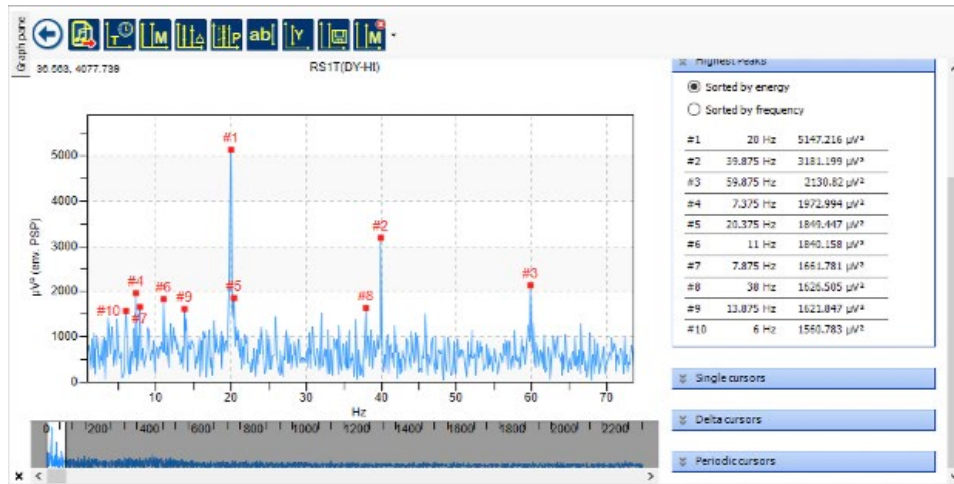
He immediately went back to the crane technicians to review with them the data he had found. John briefed them on the 4 condition indicators (41.7 dBµV rms, 43.9 dBµV max rms, 65.9 dBµV peak, and 16.2 crest factor).

The crane crew technicians had two reservations... One that John hasn't been doing ultrasound analysis long, and the other was that this was the newest bearing on the crane being installed less than a month ago. The resulting action was that the bearings weren't changed even though the following week was a down day and the repair could have been planned.

Unfortunately, it wasn't and two weeks later the bearing failed. The unplanned downtime to repair the damaged input shaft and replace the bearing took approximately 6 hours. The loss of production was expensive enough, not to mention the cost of parts and labor.

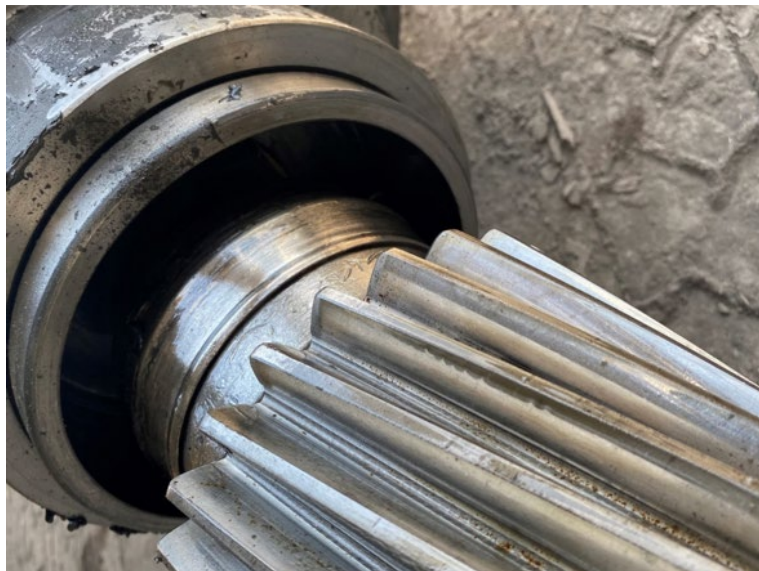
Below is the input shaft bearing right after being pulled out of the gearbox. As you can see all the rollers are gone and had to be fished out of the bottom of the gearbox. Fortunately, they didn't get caught in the gears causing further problems.

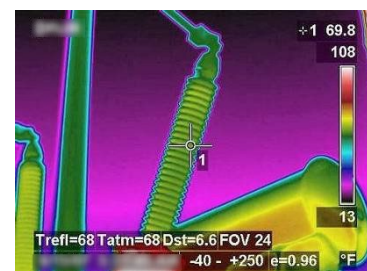
During an inspection, Skip Young detected the existence of a partial discharge on a phase of a transformer head using his SDT270 collector. By comparing the 4 condition indicators obtained after collecting static measurements, he was able to conclude that this was not a minor defect like nuisance corona. The thermogram showed no hot spot. Skip concluded that it was not a resistive defect of the arcing type.

The thermogram showed no hot spot.

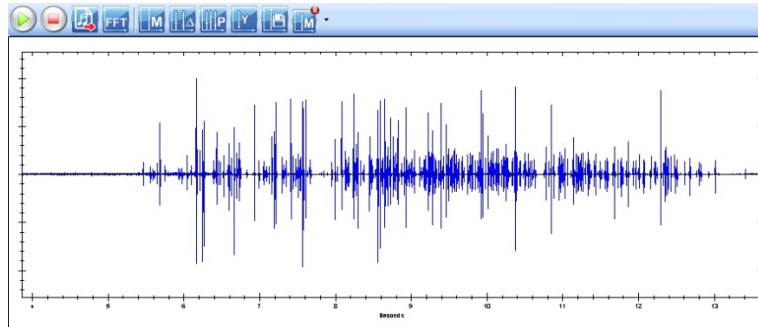
The time signal shows the presence of short-lived successive flashovers that are not repetitive and are typical of tracking.

After analyzing the data originating from the static measurements and time and frequency representations, the company decided upon scheduling a maintenance operation during the next shutdown planned for the transformer. It simply consisted in cleaning the transformer head.

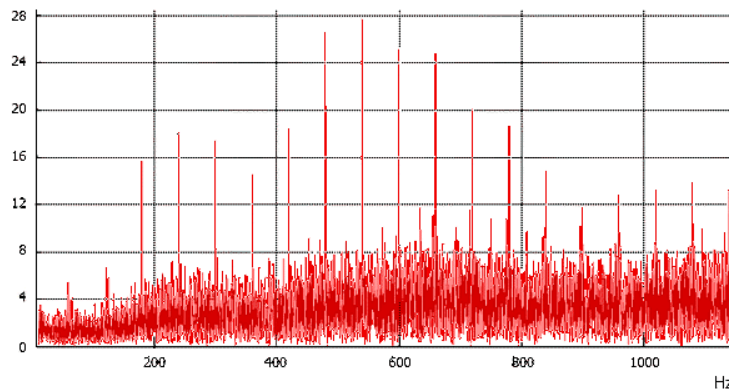
Tracking was confirmed by analyzing the spectrogram. However, it also revealed the presence of a destructive corona.

The frequency signal shows peaks at the fundamental frequency (60 Hz) and at its harmonics, which is typical of a destructive corona. It also shows noise between the peaks, which is typical of tracking.

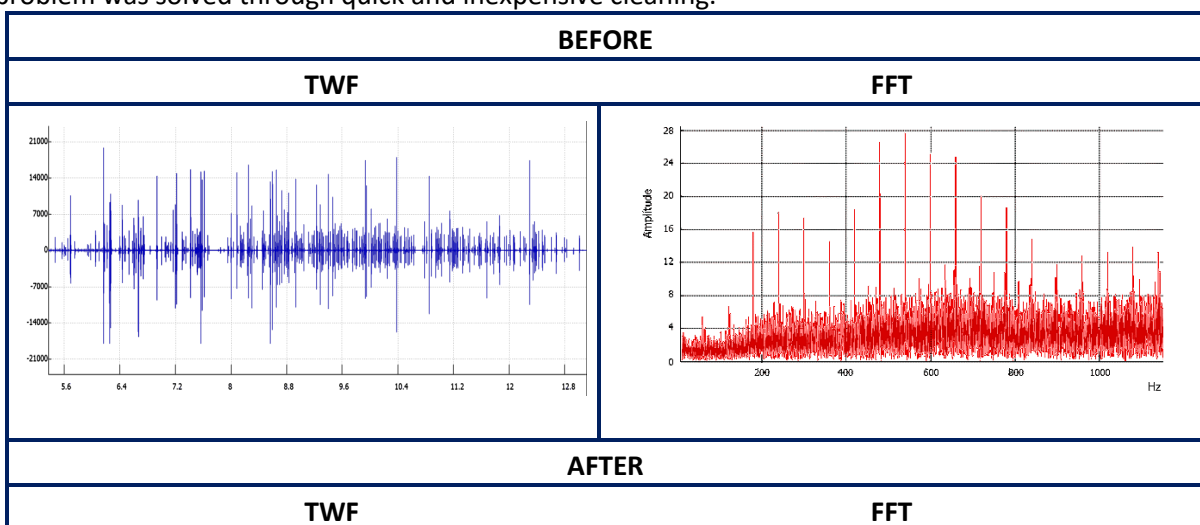
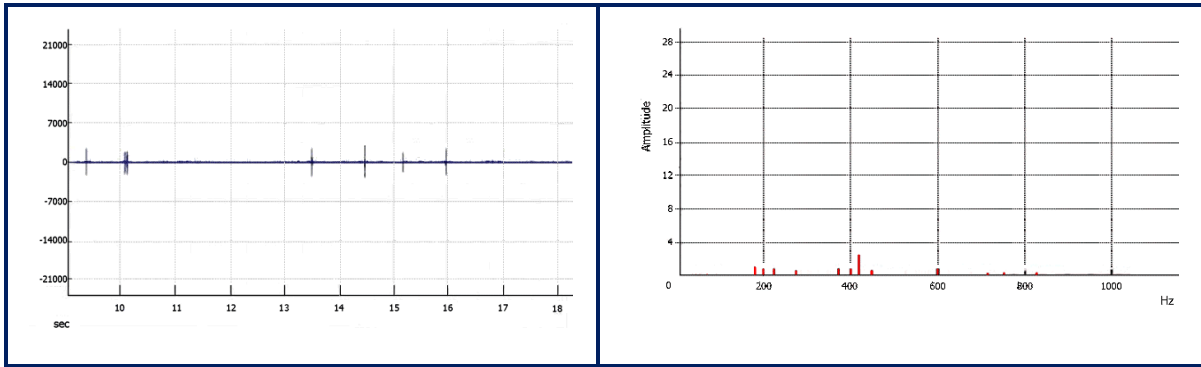
Finally, a new data collection was carried out after restarting the system. The curves below show the results obtained before and after the maintenance operation. They clearly demonstrate that the problem was solved through quick and inexpensive cleaning.

**Top: measurements prior to maintenance. Bottom: after maintenance. Please note that time and frequency representations are on the same scale.**

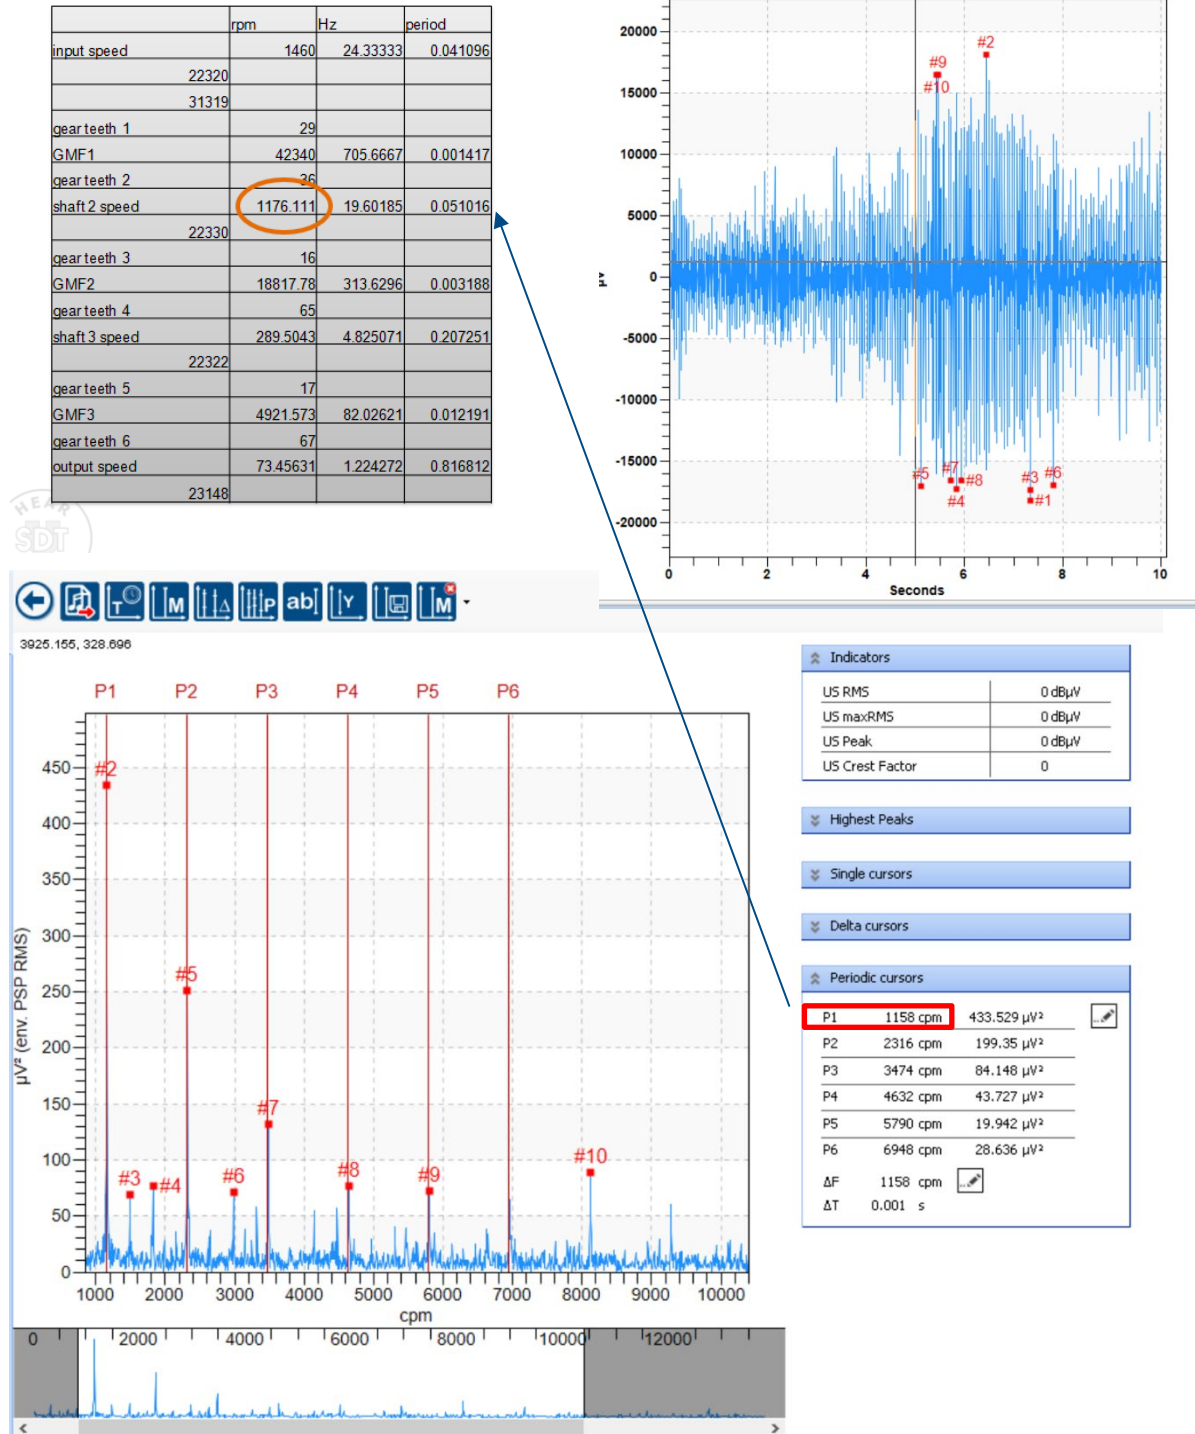
Bad gear on shaft 2

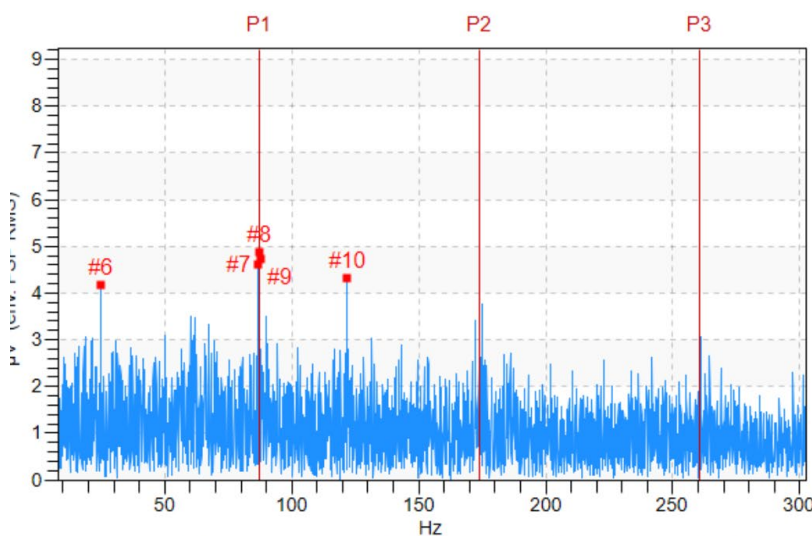
Possible bearing problem. Harmonics of 86 Hz.

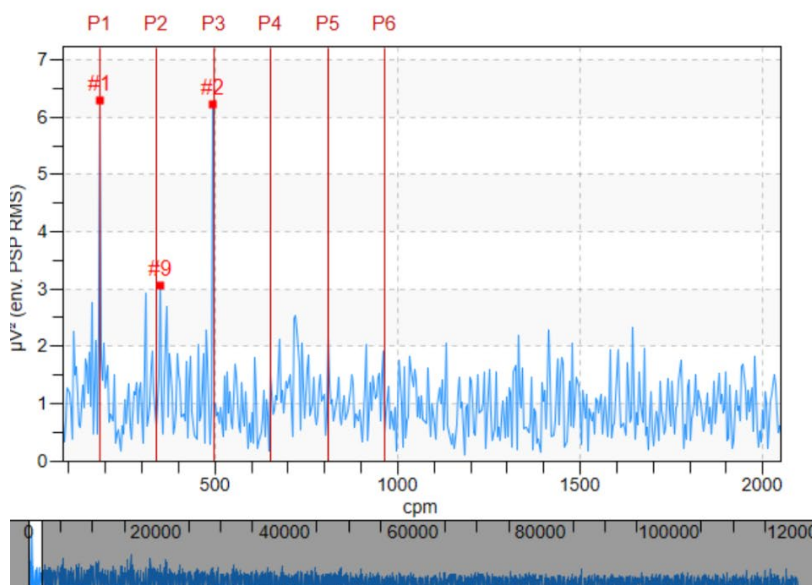
Random impacts. No exact multiple harmonics. Lubrication issue.

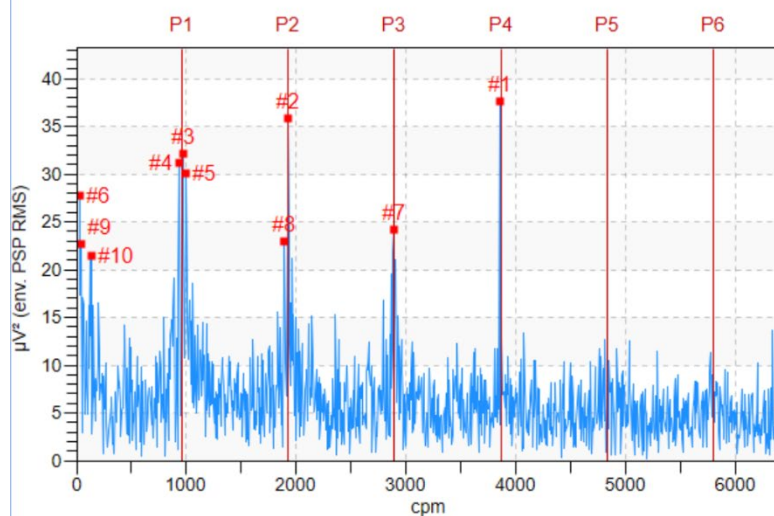
1 X RPM harmonics in ultrasound spectrum from bearing shows looseness. Bearing fit tolerances are out.
