# SUCCESS STORIES

## Chemical & Petrochemical

# Time-Based greasing? Sure?

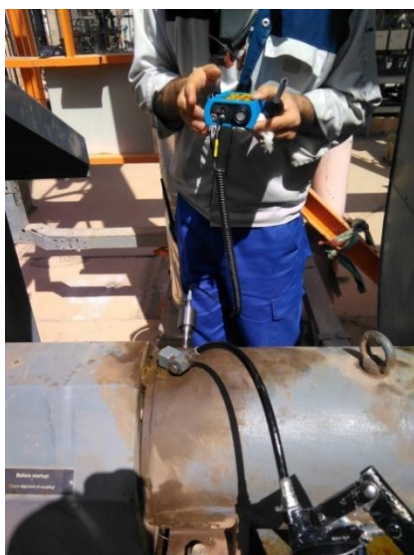
**Figure 1 - Collecting ultrasound data with SDT270 while replenishing lubricant.**

“During the training, we performed measurement practice on several machines (Figure 1). One of the machines was a fan, scheduled for re-lubrication in a few days” recalls Haris. “The customer’s standard greasing practice is to follow manufacturer’s recommendations for both interval and amount. In other words, they grease on a time-based schedule and trust the motor manufacturer to guide on quantity.”

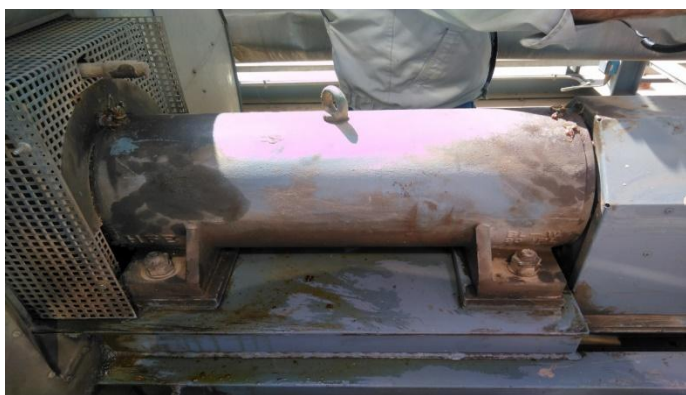
**Figure 2 - Two fan bearings with different load. Why do they share the same grease replenishment protocol?**

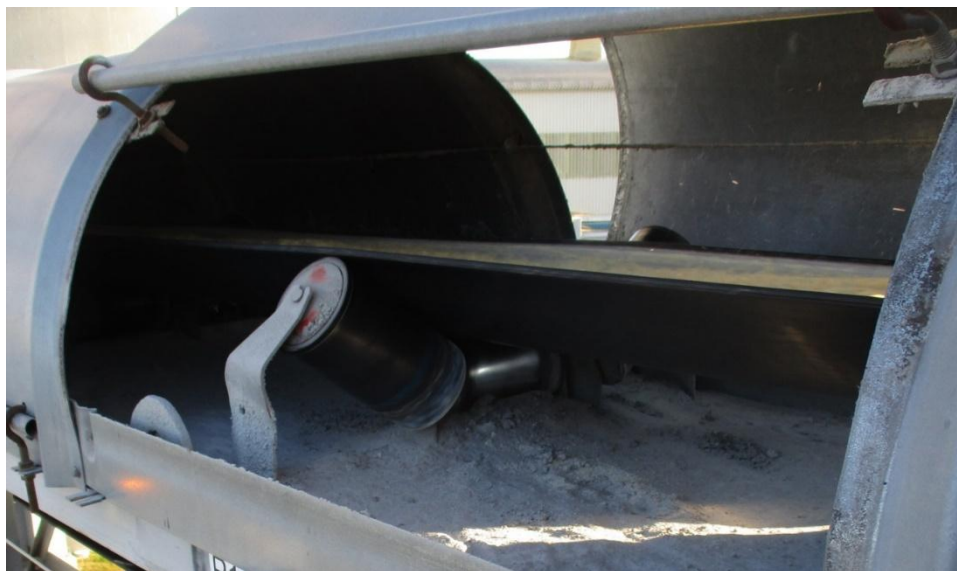
Since our vibration program is important in the plant, I wanted to integrate ultrasound into our existing predictive maintenance practices. That's when we came up with the idea of using it on our CB-1310 conveyor. At first, in 2016, we built a route only at the level of the return rollers. A reading on the roll frame gave us good signal quality for the application.

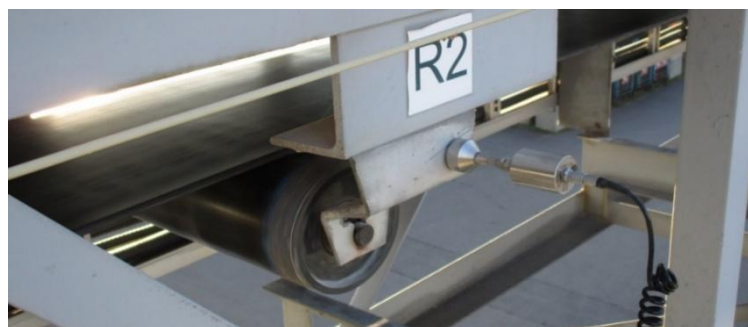
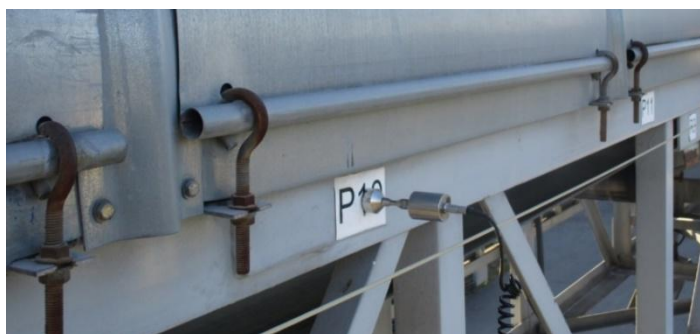
At this time, the previously established preventive maintenance route was still performed. We used these latest inspections to establish a basic level of alarm based on the provided ultrasound indicators. By comparing the two routes for a few months, we arrived at similar results. Subsequently, we refined our alarms to make sure we could see the problems in advance. Following the satisfactory results obtained, we applied the same method on the carrier rollers without even opening the covers.

After a dozen collections, we can say today that the results are very promising. One year ago, since implementing this new ultrasonic strategy, we no longer need to do the preventive maintenance route.

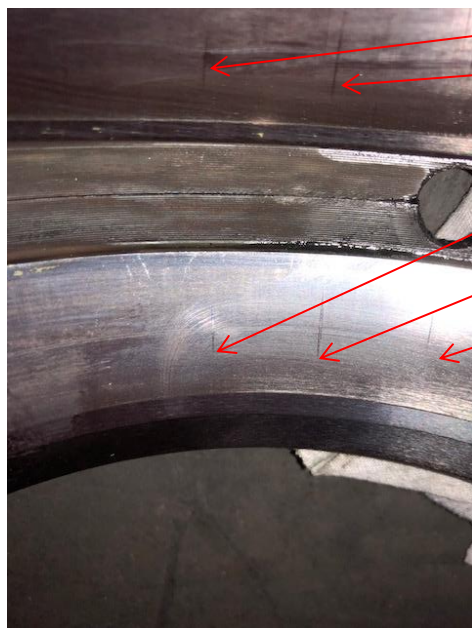
Below is a picture of the outer race of the bearing when taken out and inspected.

Grooves are worn into the outer race, and this is what the ultrasound was detecting as each rolling element contacted it. Eventually this would lead to a failure of the bearing.

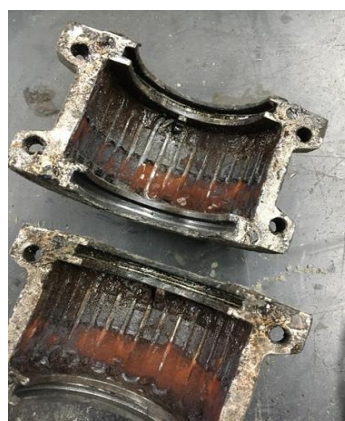
## Grid coupling (Lack of lubrication and worn-out grid)

Impacting seen at 1 x Running speed with multiple harmonics.

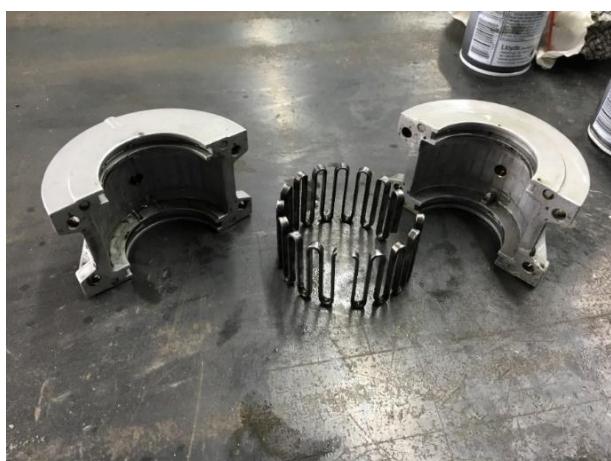
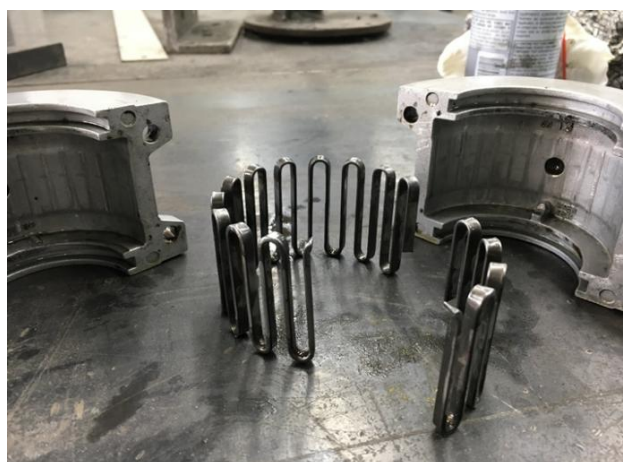
## Grid coupling (broken grid)

Impacting seen at 1 x Running speed with multiple harmonics

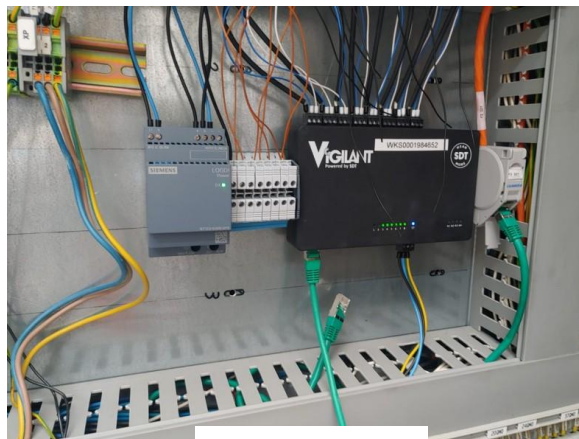
*The Vigilant System is an 8-Channel Online Condition Monitoring Solution that combines the versatility of ultrasound and the analytics of vibration. Vigilant comes standard with its own embedded software that any member of the reliability team can access using the correct network credentials.*

*The Vigilant provides reliability teams with a means to continuously monitor critical assets that are heavily guarded, or in this case as they near their end of life.*

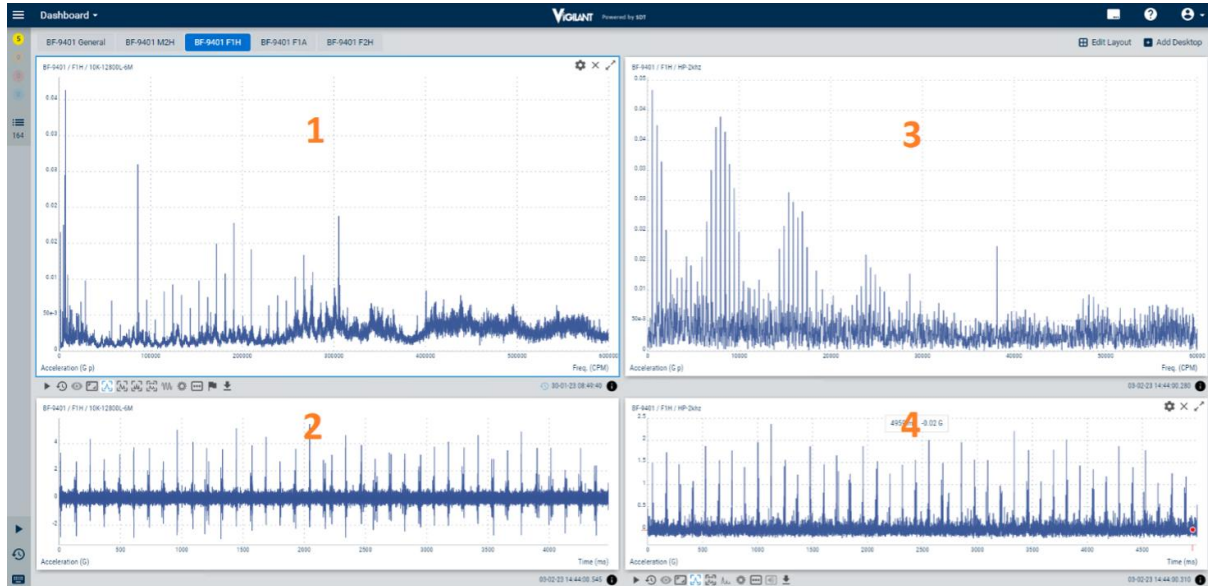
The reliability team's focus was monitoring data collected by the F1H Accelerometer. Monitoring technicians split their windows into 4, all with different lines of resolution as to see rapid changes as well as changes over a long period of time.

Figure 4 – Vigilant Window Configuration

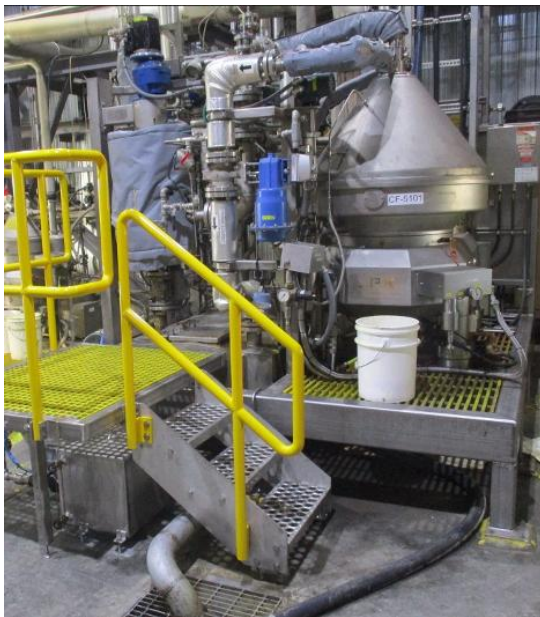
**Figure 1 - Centrifuge - Greenfield Ethanol**

This centrifuge in question rotates at 5250RPM, and it has a suspected bad bearing. The following Figure 1 & 2 depicts the bearing & the asset.

A similar situation arose at his plant. He discovered a bad bearing on a centrifuge using his SDT Ultrasound Data Collector. The fault was not yet visible with his vibration analysis tools. No cause for concern yet, the bearing had a lot of life left, but it was in the early stages of failure. Still, no reason to use unplanned downtime to replace the bearing. The plan is to replace the bearing during the next scheduled shutdown. Please see the DIPF curve in Figure 3.

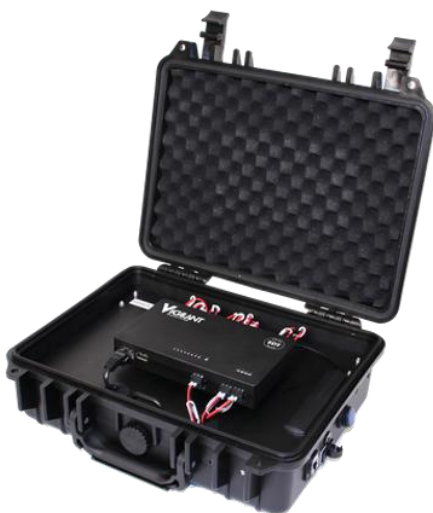
So, Jonathan did what any savvy reliability engineer would; used his Vigilant System (as per figure below) to establish permanent monitoring on this critical bearing, as operations and production continued. Jonathan used both ultrasound and vibration to monitor its condition.

For the next few months, the bearings condition continued to slowly deteriorate in the ultrasound spectra. It was eventually visible and well defined in the vibration spectra and demodulated spectrum, as seen in the data in Figure 4 & 5.

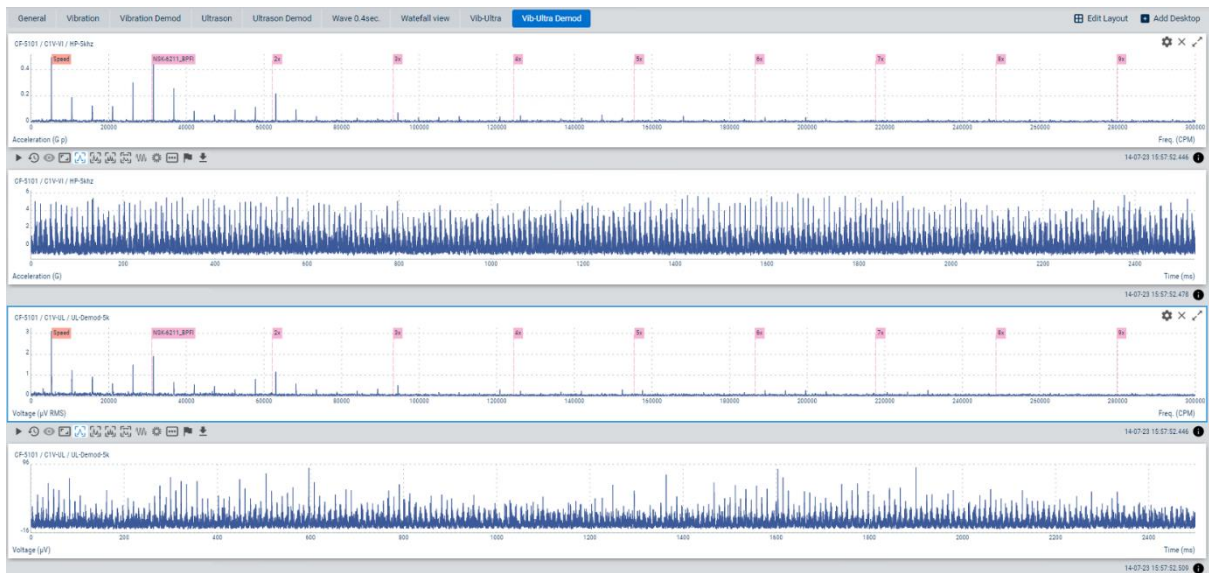
Figure 5 - Vigilant Dashboard - Ultrasound & Vibration Spectra Demodulated

The severity of the problem has clearly increased since it was first discovered with ultrasound. It is now visible in the vibration spectra, showing a ball pass frequency outer race defect with 1x rpm sidebands.
