# SUCCESS STORIES

# Identifying Condenser Tube Leaks with an SDT270 Ultrasound Detector

# Compressed air leaks and screw pumps inspection in a Cameroonian power plant

# Maintenance of hydraulic equipment and components: ultrasound, the winning solution

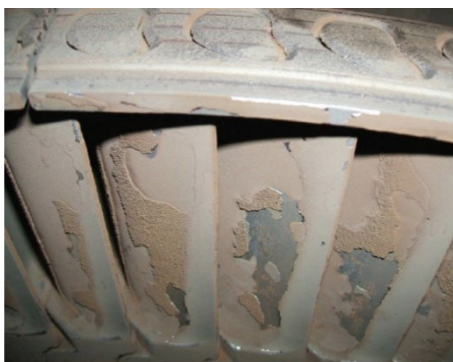
**Figure 2 - Scaling on turbine blades**

Formations on turbine blades, pump vanes and valves diminish their efficiency, creates imbalance, and forces drive components to work harder just to maintain output (Figure 2).

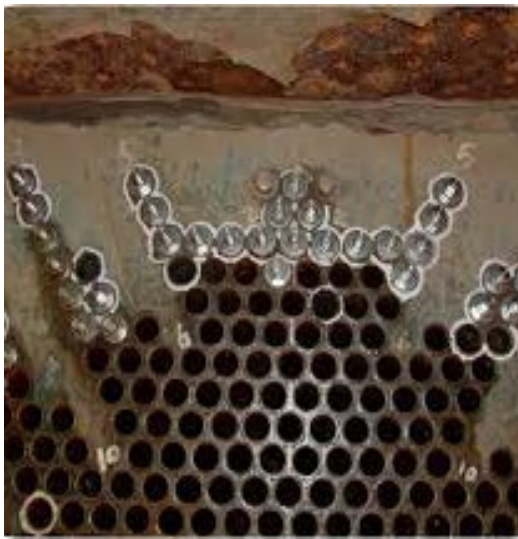
**Figure 3 - Leaking tubes are identified and plugged**

The other action choice is to identify the leaking tubes and plug them; effectively removing the leakers from service. This is the better solution because it treats the cause. But it too carries downside.

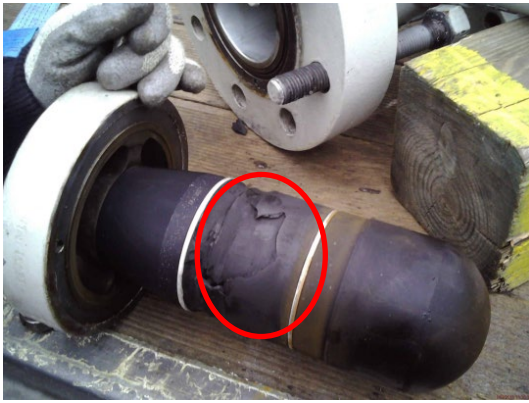
Upstream measurement: 21 dBμV

Seat measurement: 10dBμV, where turbulence and a slight whistling sound can be heard

The customer's assessment after dismantling the regulator

In this example, the customer is a natural gas supplier and distributor. The company's maintenance department only visually inspected its valves and regulators. When they dismantled this equipment, they could never be sure that they were dismantling a component that could be considered a leak. This on-site demonstration highlighted the effectiveness of ultrasound measurement in finding a defective component quickly and efficiently.
