# SUCCESS STORIES

# Time-Based greasing? Sure?

# On-Condition or Time-Based?

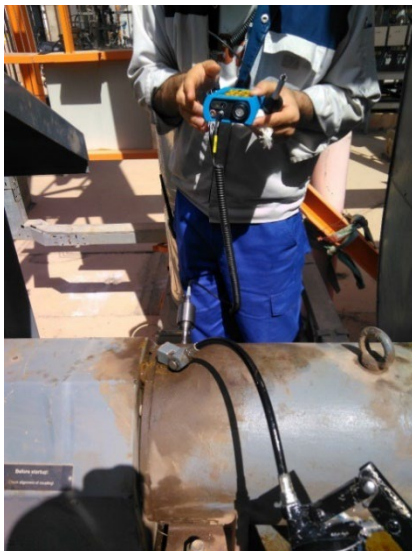
**Figure 1 - Collecting ultrasound data with SDT270 while replenishing lubricant.**

“During the training, we performed measurement practice on several machines (Figure 1). One of the machines was a fan, scheduled for re-lubrication in a few days” recalls Haris. “The customer’s standard greasing practice is to follow manufacturer’s recommendations for both interval and amount. In other words, they grease on a time-based schedule and trust the motor manufacturer to guide on quantity.”

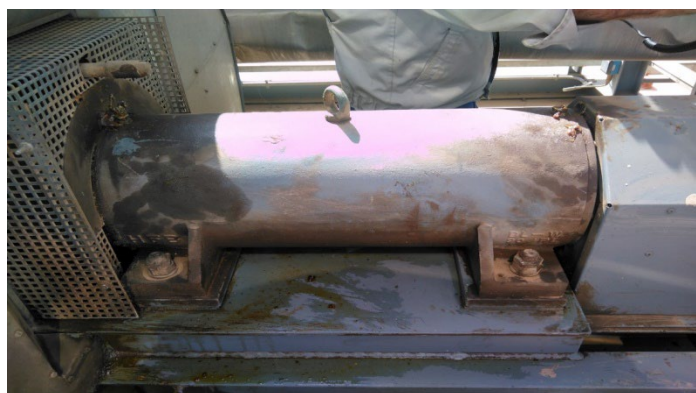
**Figure 2 - Two fan bearings with different load. Why do they share the same grease replenishment protocol?**

Following the facility's lubrication procedure raised several red flags. Figure 2 shows two bearings driving the fan. Why would two identical bearings, but with different loads, have the exact same grease replenishment protocols? Maybe it's purely out of convenience; since the lubricator is there to grease the drive end bearing, might just as well pump a few strokes into the non-drive end.
