# SUCCESS STORIES

Ultrasound Solutions

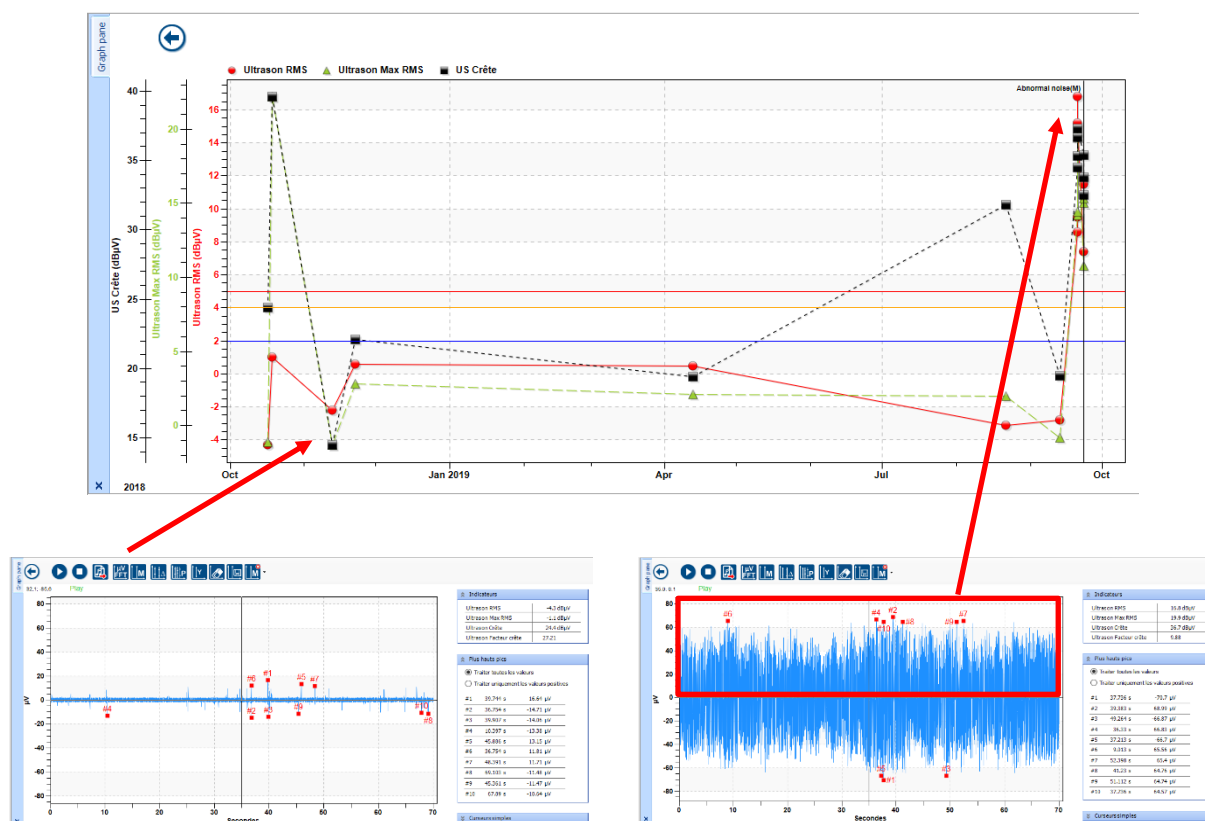
- Machine: **Decanter – High-speed input bearing of the reduction gear**

On the time spectra (same scale), we can observe the occurrence of shocks compared to the first measurement carried out in 2018. The trend curves show the evolution of the RMS static value: from **-4.3 dBµV in 2018 to +16.8 dBµV in 2019**.

Based on SDT criteria, this increase corresponds to the early failure of a mechanical part of the reduction gear (bearings and/or gears).

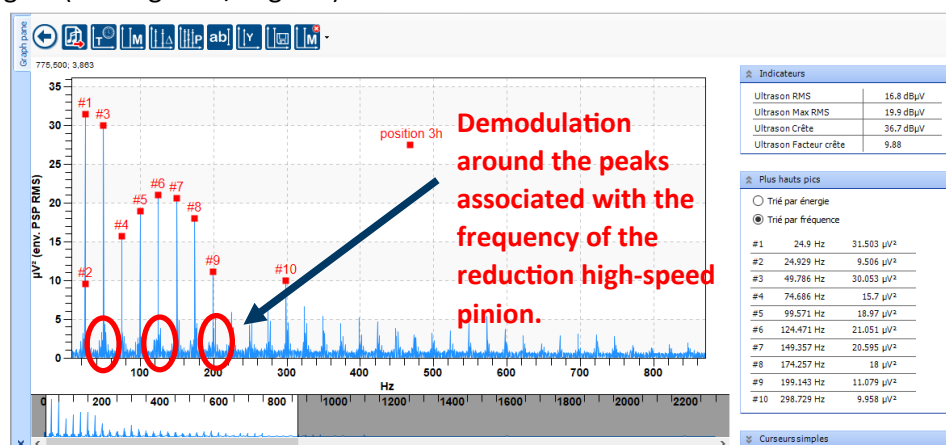
Listening to the bearing and analyzing the frequency spectra (see chart below) has allowed to confirm this diagnosis by observing the emergence of significant peaks associated with this gear damage.

We can observe repeated shocks associated with the frequency of the high-speed input drive pinion of the reduction gear (24.93 Hz and its harmonics) with demodulation at each peak. Broken tooth and teeth clearance. Replacement of the reduction gear during a scheduled production shutdown, which

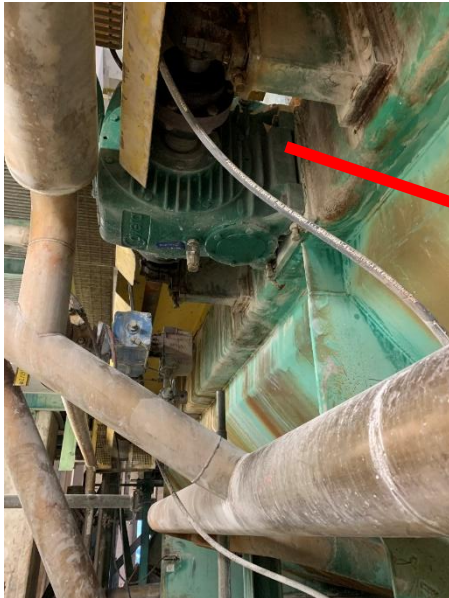
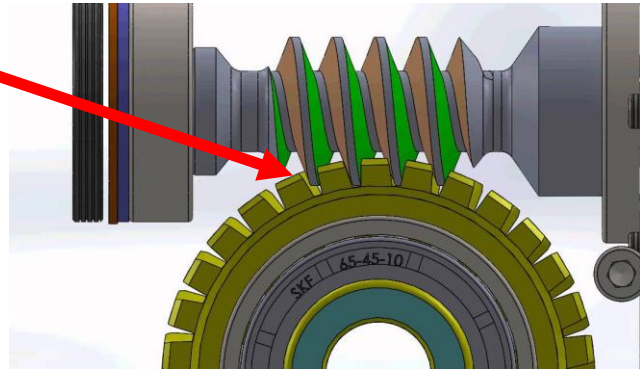
- Machine: **Lime mud filter agitator – High-speed input bearing of the reduction gear**

We can observe that between each revolution of the worm screw, there is a phenomenon occurring, which can be heard through the ultrasound detector as a sliding of the gear (worm screw/bronze wheel).

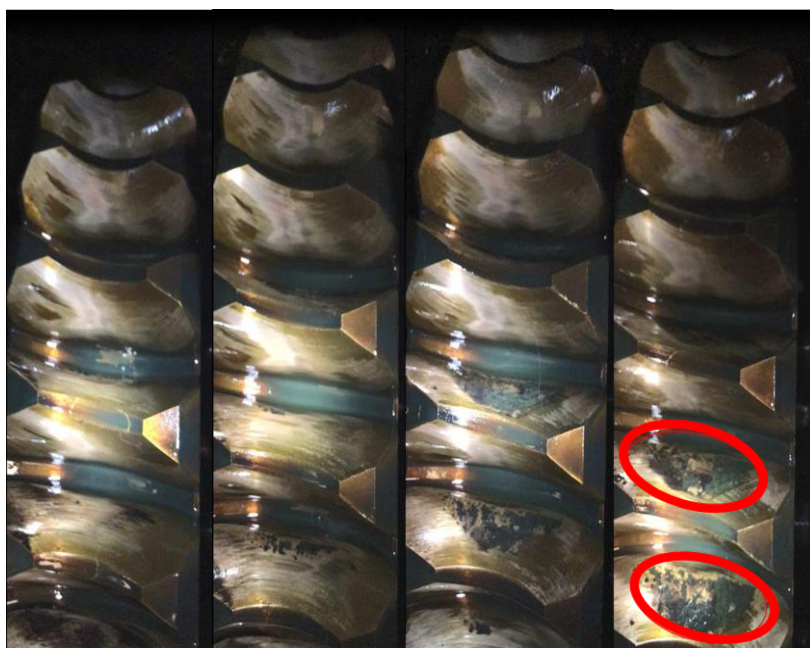
The endoscopic video inspection of the worm screw of the reduction gear confirmed the ultrasound diagnosis.

The customer took the reduction gear down during a production shutdown.

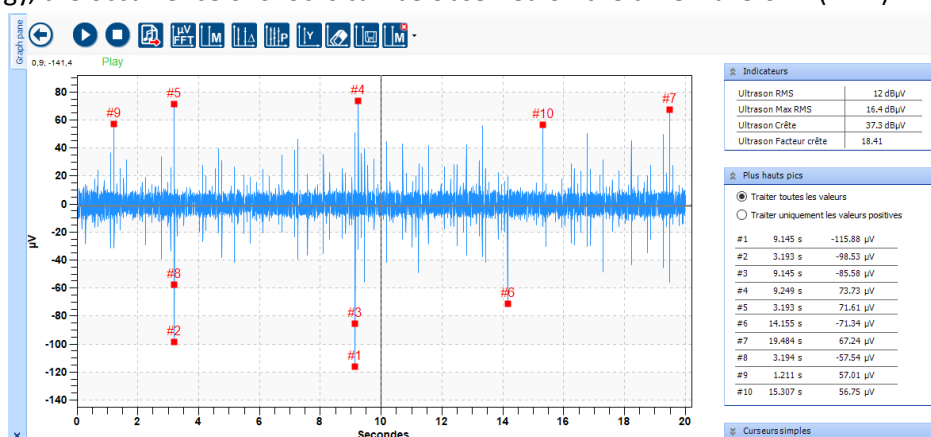
From the beginning of the monitoring of this reduction gear (August 2018) using ultrasound technology, the occurrence of shocks can be observed on the time waveform (TWF).

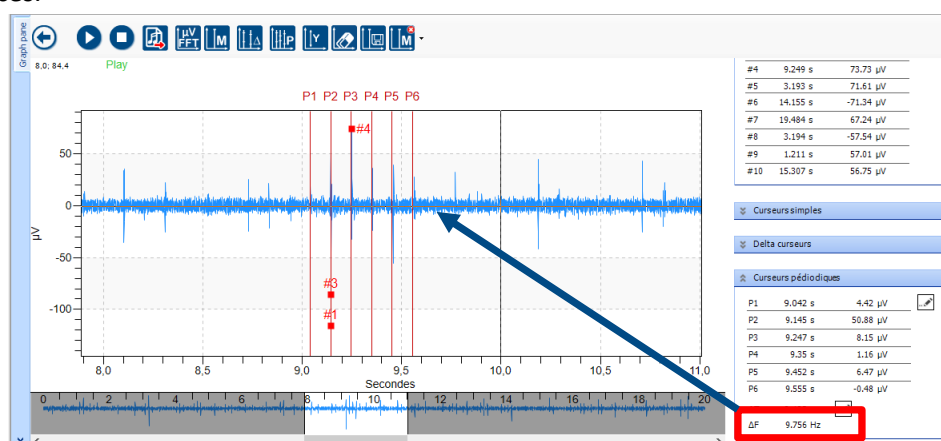
Below we focused on 3 seconds of the measurement, and we apply a periodic cursor to identify peak recurrences.

By looking at the envelope spectrum, one can observe repeated shocks at **9.756 Hz** (see the table of characteristic frequencies below) related to the frequency of the inner ring of the bearing of the low-speed reduction gear (opposite side of transmission).

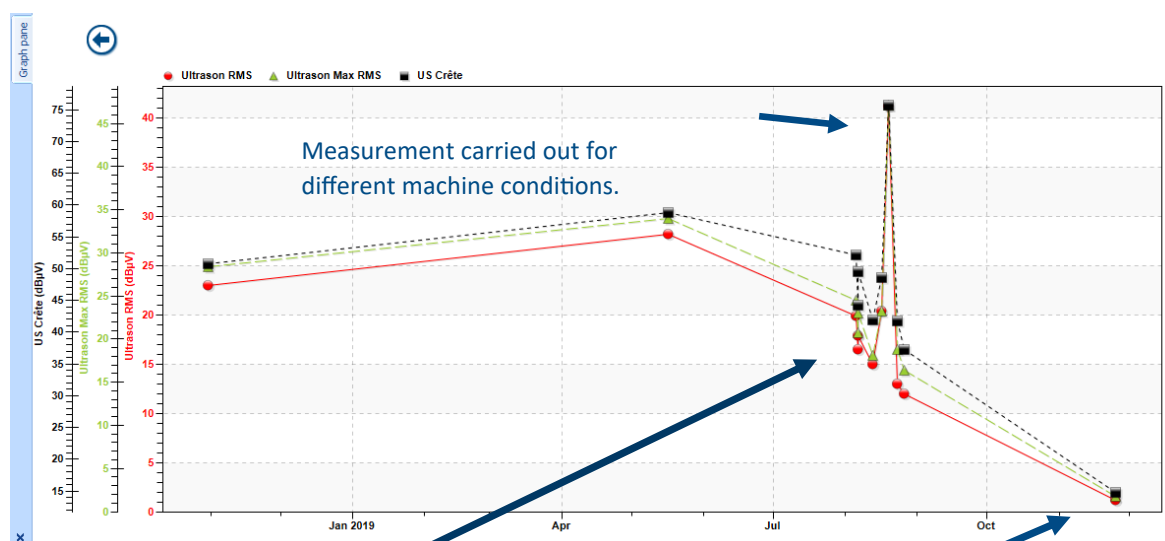
The trend curves show the decrease of the RMS value in red on the graph above, also confirmed by the other indicators, **from +12 dB $\mu$ V in 08/2019 to +1.2 dB $\mu$ V in 11/2019.**

Replacement of the reduction gear during a scheduled production shutdown, which avoided an untimely breakdown which could have generated significant expenses due to production losses.

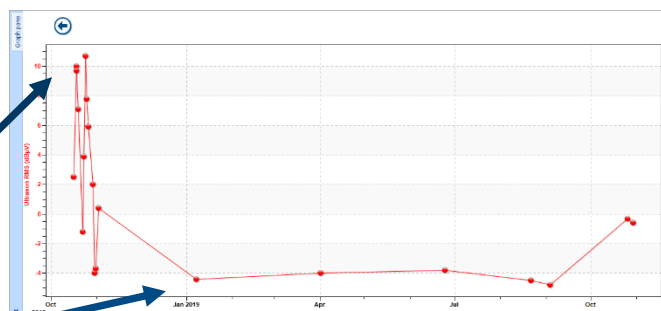
On the trend, one can observe the occurrence of high value in the RMS right from the beginning of the monitoring of this bearing. After replacement of the bearing, all shocks disappeared. The rolling elements were no longer held in their housings.

The trend curve shows the decrease of the RMS value after servicing (**from +10.7 dBμV in October 2018 to -4.4 dBμV in January 2019**).

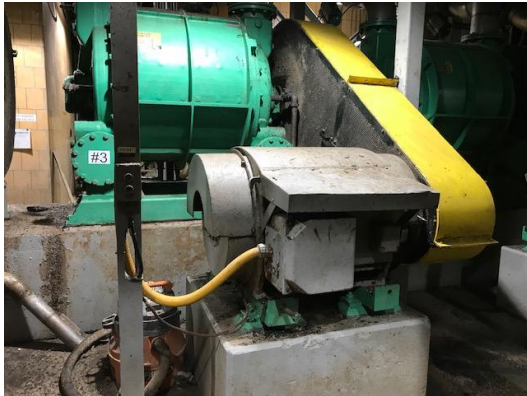
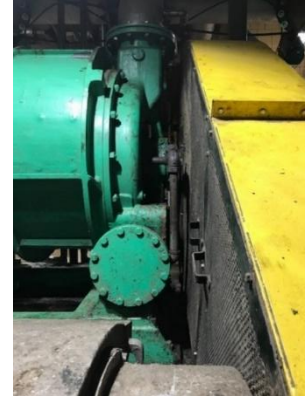
18-hour job to replace DE bearing on scheduled shutdown.  
Crest Factor Alarm

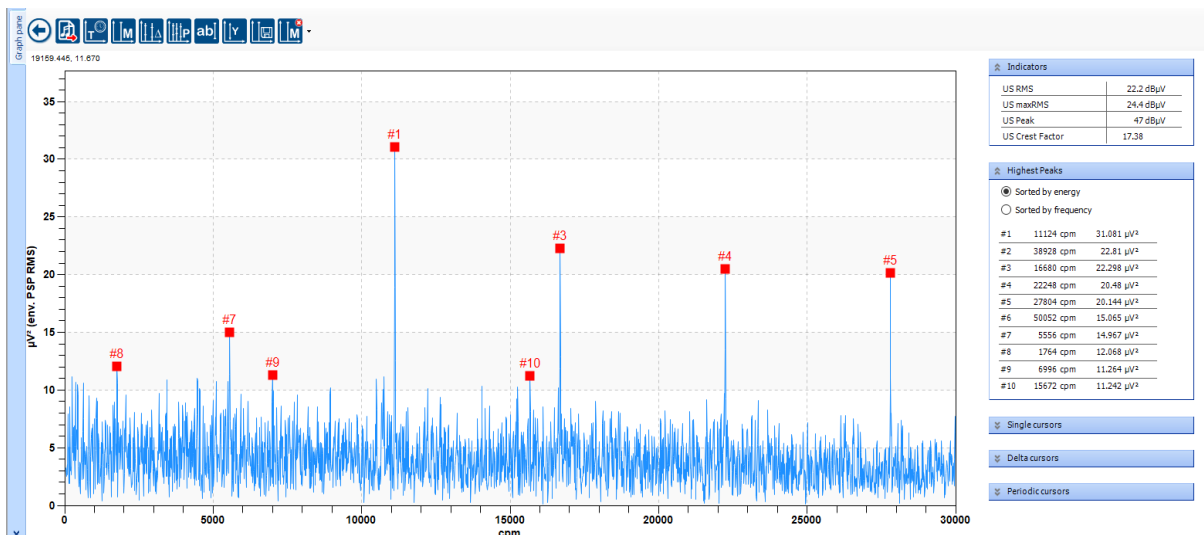
Recommended bearing replacement as soon as possible due to a signal containing high peaks indicating the lifetime span of the bearing.

Next available extended shutdown – April 15 – April 17. Bearing greased repeatedly until shutdown.

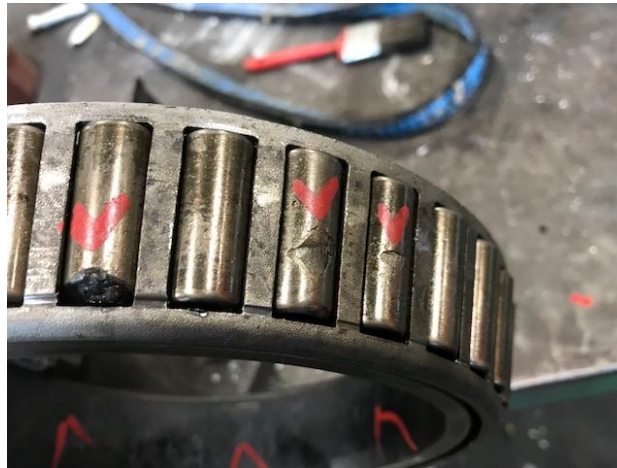
**Rolling elements**

Images of bad bearing – no secondary damage occurred:

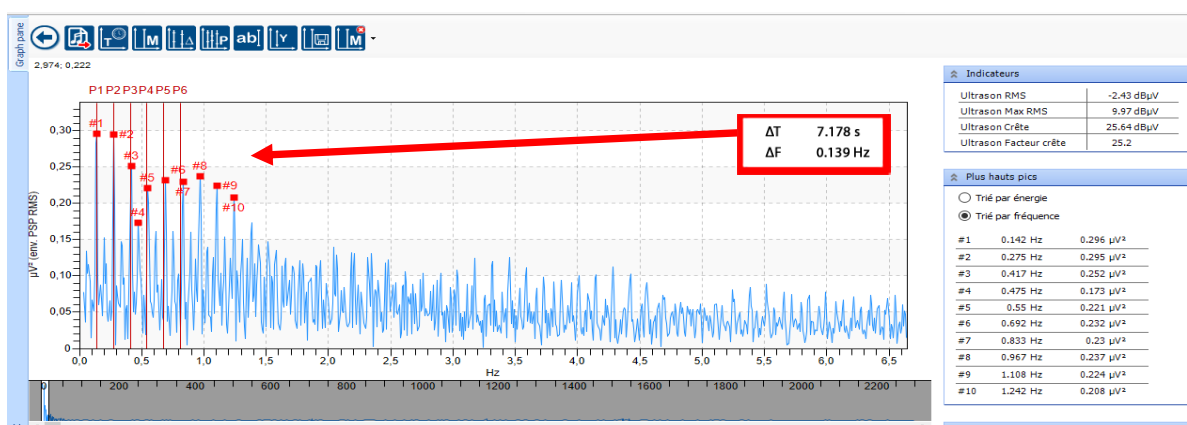
The spectrum shows an impact at the rotation speed (0.13 Hz) of the shafts of the rotating machine, along with its harmonics. Sub-harmonic frequencies can also be observed at 0.5 x the rotation speed, which is a characteristic spectrum for a rotational clearance due to friction or significant impacts. No impact due to bearing frequencies are observed. Our diagnosis is confirmed by the time waveform.

The encountered problem is due to the wear of the shafts and of the disks that are mounted onto these shafts and generate abnormal friction.

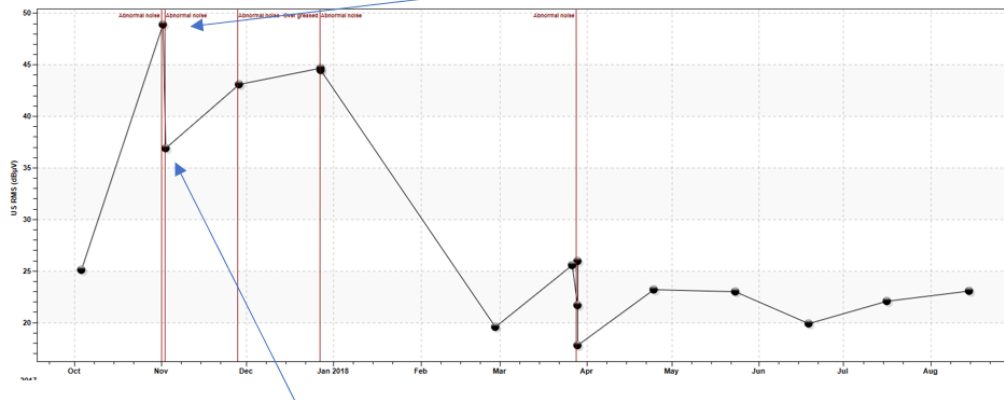
Problem identified by ultrasound on November 1<sup>st</sup>.

Ultrasound Trend - high RMS ultrasound values in early November

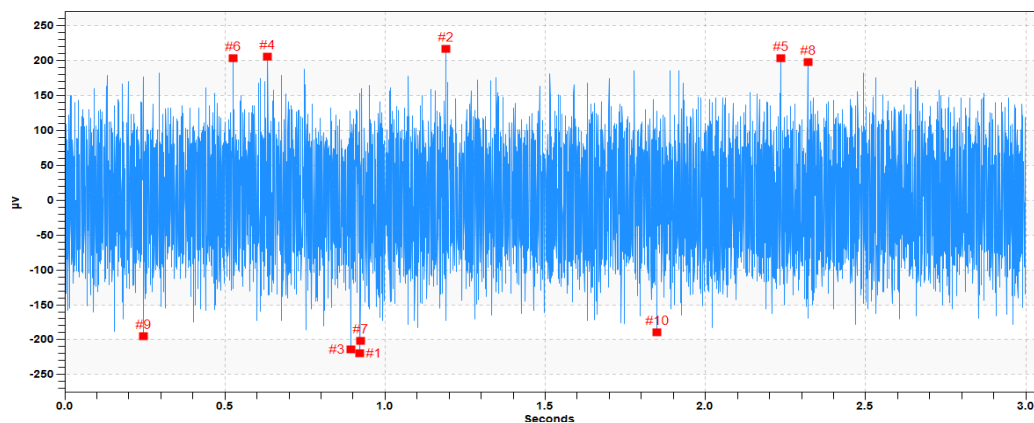
Ultrasound reading after greasing on November 2<sup>nd</sup>:

Ultrasound levels decrease as predicted.

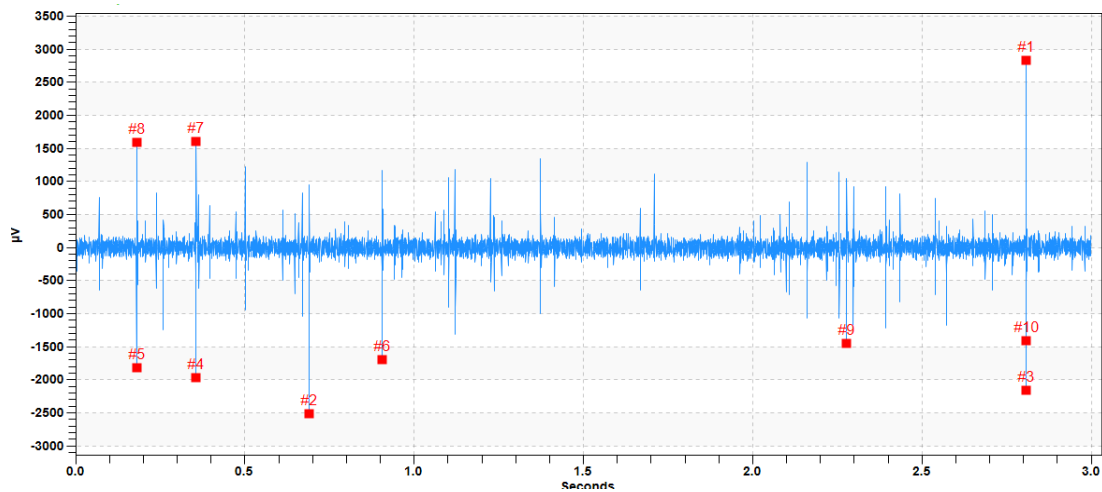
Ultrasound reading on November 28<sup>th</sup> (still containing high peaks as November 2nd):

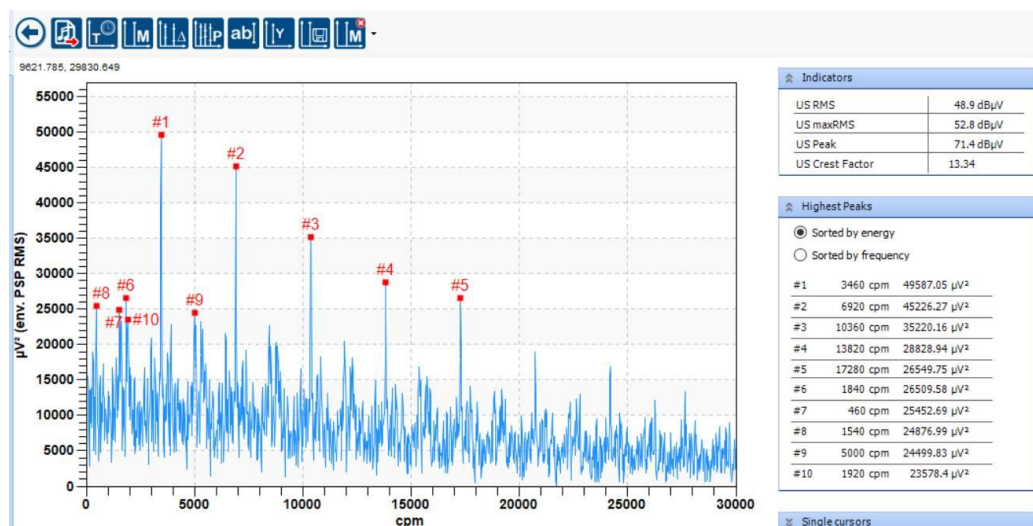
Levels rise back up. Bearing defect is very clear:

Defect clearly visible. The bearing is finished.

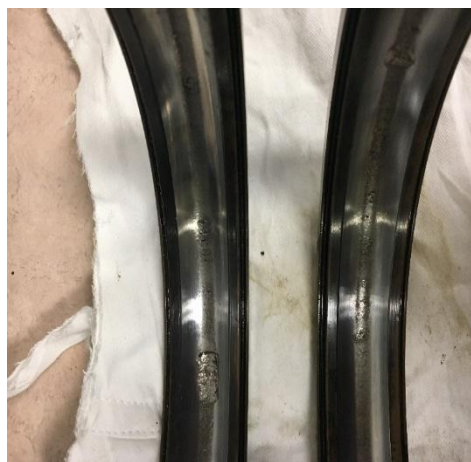
Figure 3 Outer race damage (BPFO)

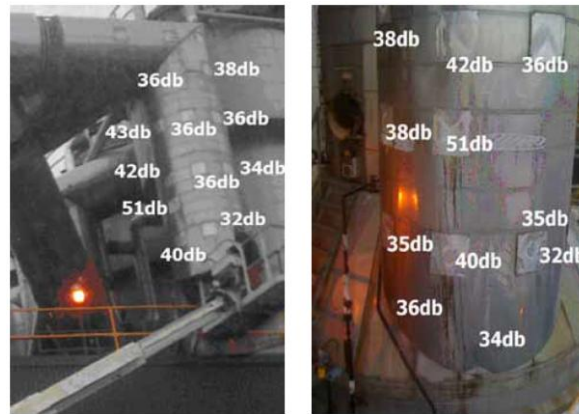
**Diagram shows dB levels mapped out using SDT RS1 Contact Probe. Vacuum leaks detected through 4" insulation and outer sheet steel. Loudest areas were cut away and patched with Gor-Tex™ patches.**

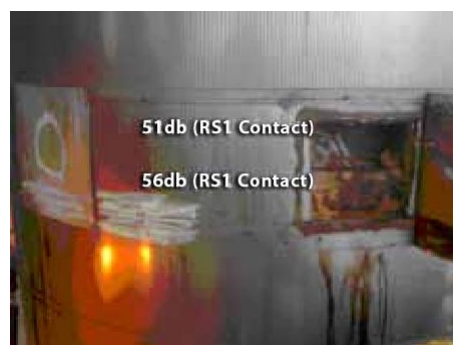
As the additional pictures below will show, there was a strong correlation between the locations of the leaks and the thinning of the wall of the stack. At the location of the highest ultrasound, 51 dB, the wall was found to be 0.091" thin. The thinnest area found on our initial survey.

**Wall thinning correlated to high dB values.**

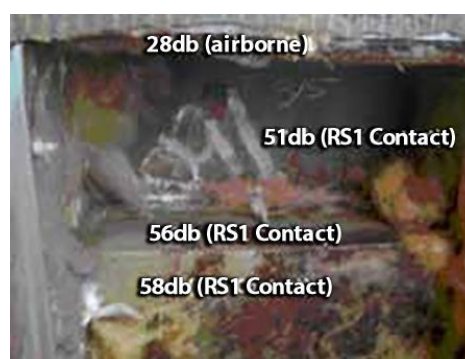
When I brought the airborne sensor near the 51 dB access door, the airborne sensor jumped to 32 dB – 33 dB and gave the telltale whooshing sound of rapidly moving air. When I used my hand to separate some of the insulation away from the metal flange, the airborne sensor levels rose to 38 dB.

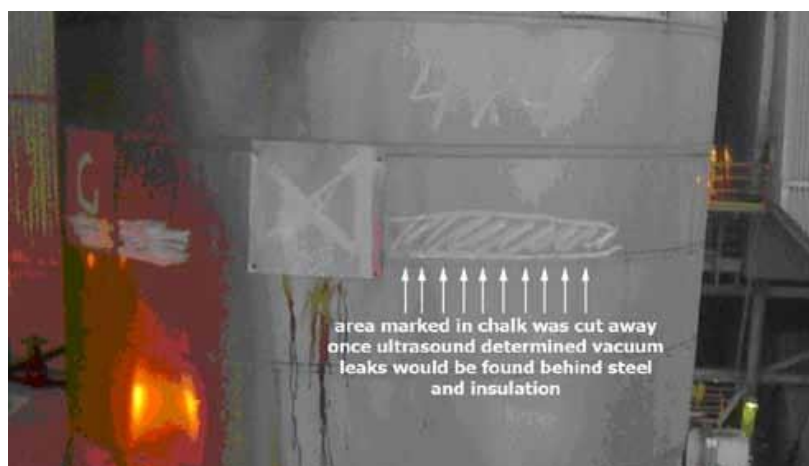
As soon as Mr. Rose removed the sheet steel we could see where the insulation had collapsed around the vacuum pull of the stack. As the insulation peeled away, the holes were immediately visible. We placed two rubber sheets over the large holes to prevent the loss of vacuum. The sheet on the left covered the largest area of corrosion, about 8" wide. The 2<sup>nd</sup> major area of damage was about 1½" wide.

The exact number of holes was too numerous to count. Also, many of the holes had blended together from the corrosion.

Mr. Rose recommended applying Gor-Tex™ sheets sealed with silicone to affect a strong, yet temporary repair. The decision was to strengthen and seal the holes so that the process could continue until a planned outage in March 2010. At that time a complete repair/replacement could be implemented.

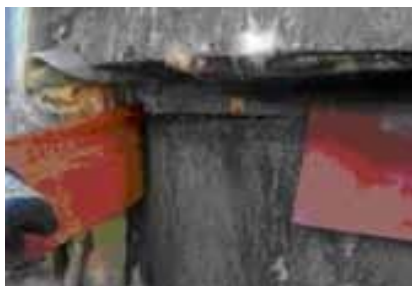
The areas below where the holes were discovered clearly show how the stack is wearing out. 0.077" was the thinnest area found without actually being a hole.

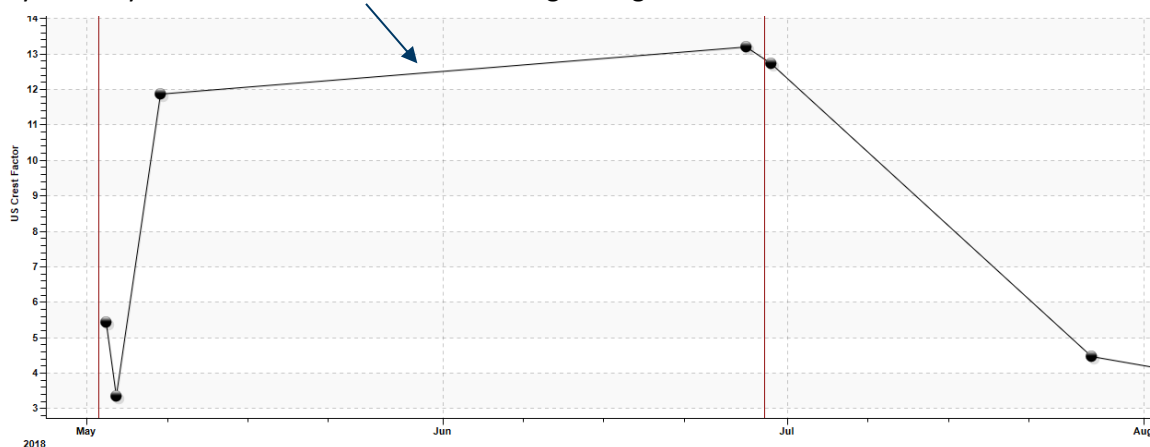
Greasing the bearing on May 3<sup>rd</sup> reduced the friction as seen by the drop in RMS over a few days and masked the impacting, but the impacting returned as seen by the Crest factor going back up to 11.88 by the May 7<sup>th</sup>. This is indicative of the bearing having a defect.

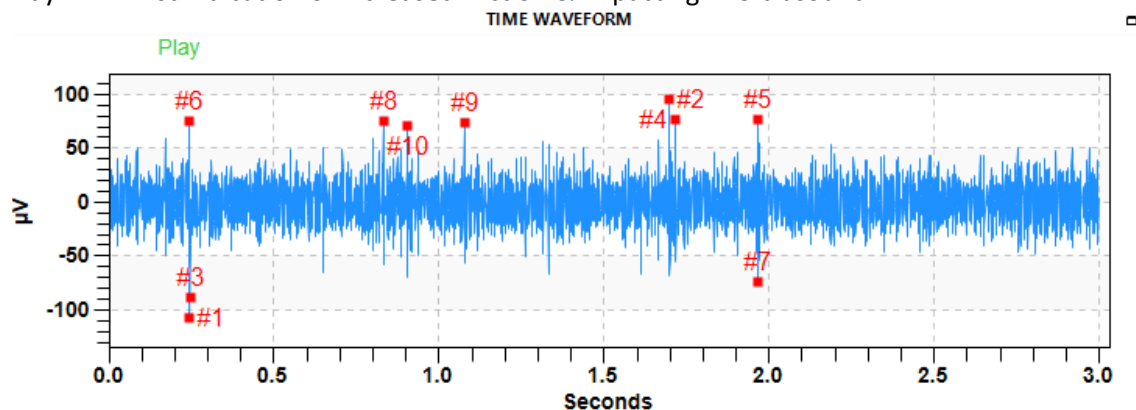
May 2<sup>nd</sup> – First Indication of increased friction & Impacting in Ultrasound.

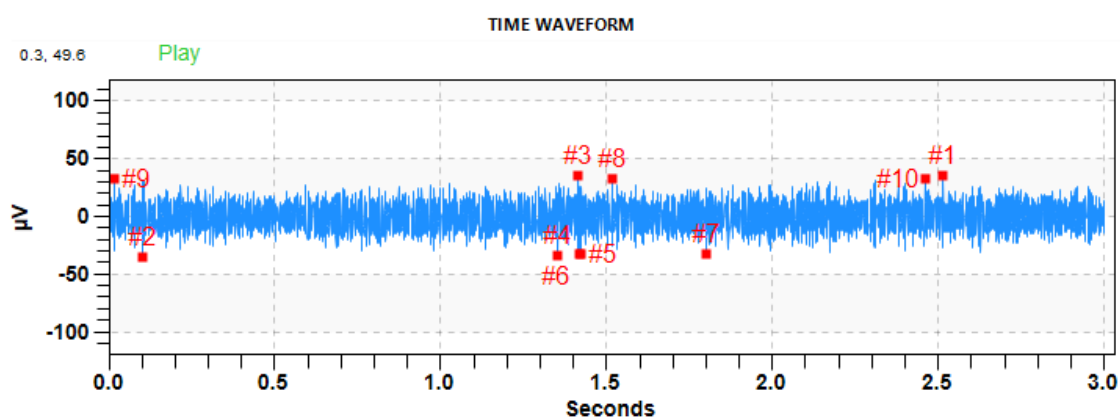
May 3<sup>rd</sup> – Greased Bearing. Reduced Friction.

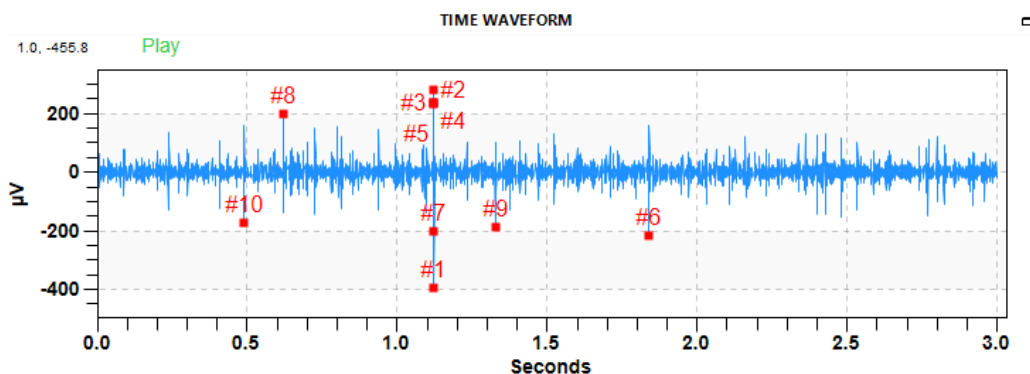
May 7<sup>th</sup> – Impacting back four days after greasing. Bearing has a defect.

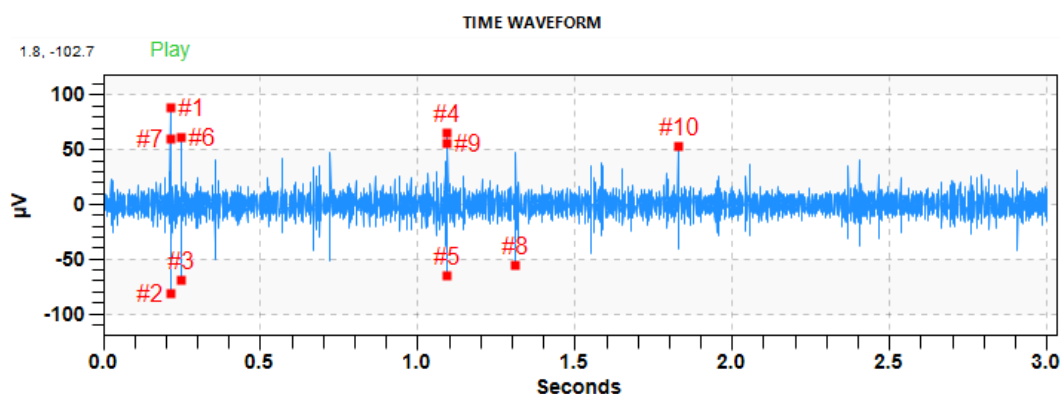
June 27<sup>th</sup> – Bearing being monitored and greased regularly but by end of June Impacting significantly worse. Scheduled for swap at next shutdown on July 24<sup>th</sup>.

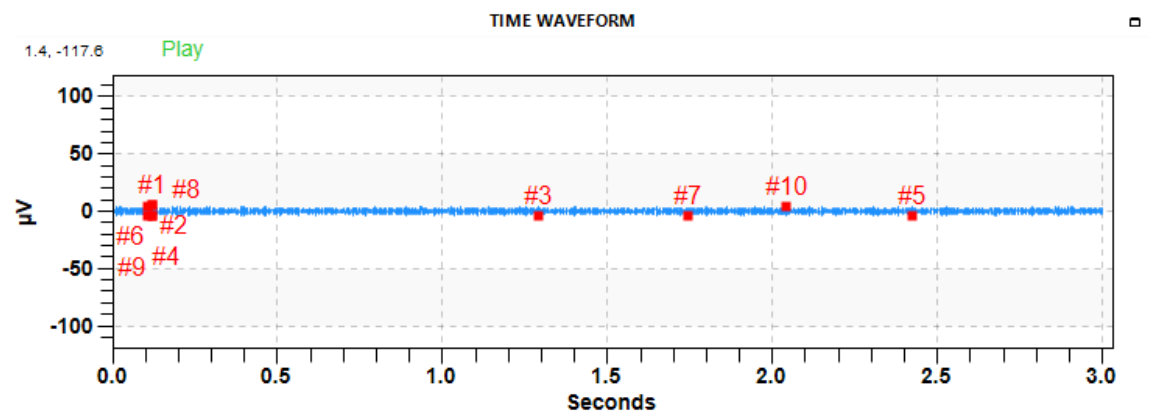
July 27<sup>th</sup> – New Ultrasound reading after bearing replaced.

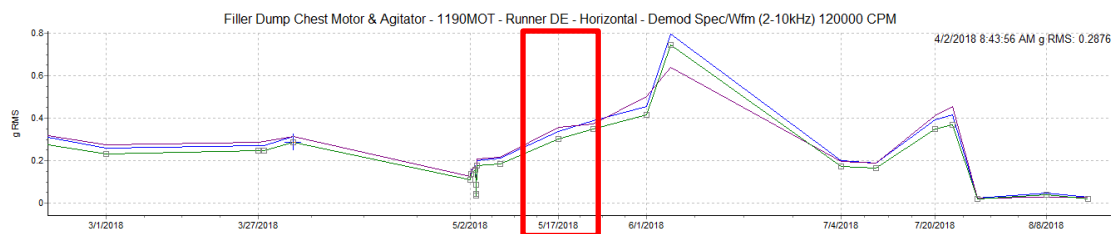
The g RMS trend from vibration shows increasing levels around middle of May confirming Ultrasound findings of a defective bearing.

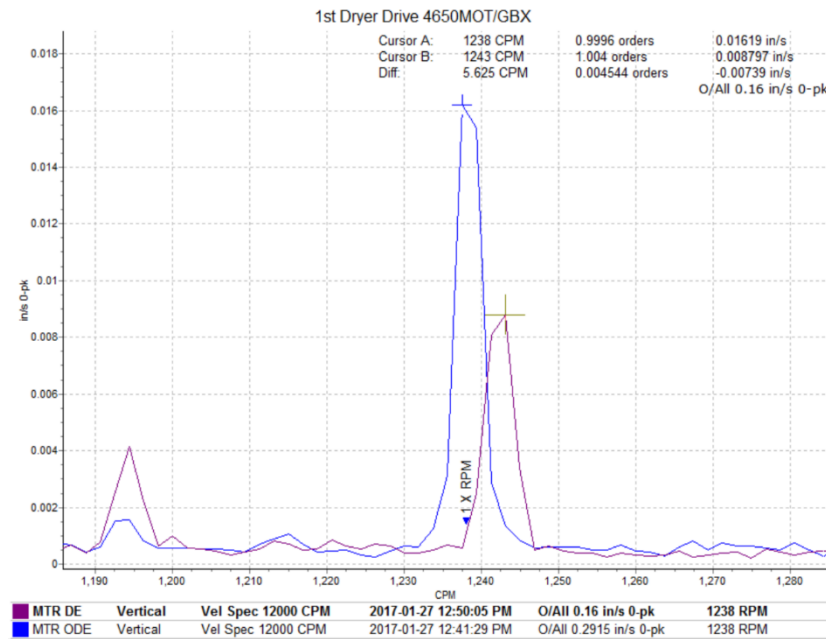
The two spectrums below illustrate the variation in speed on the motor. The first is on the DE and the second is on the ODE vertical.

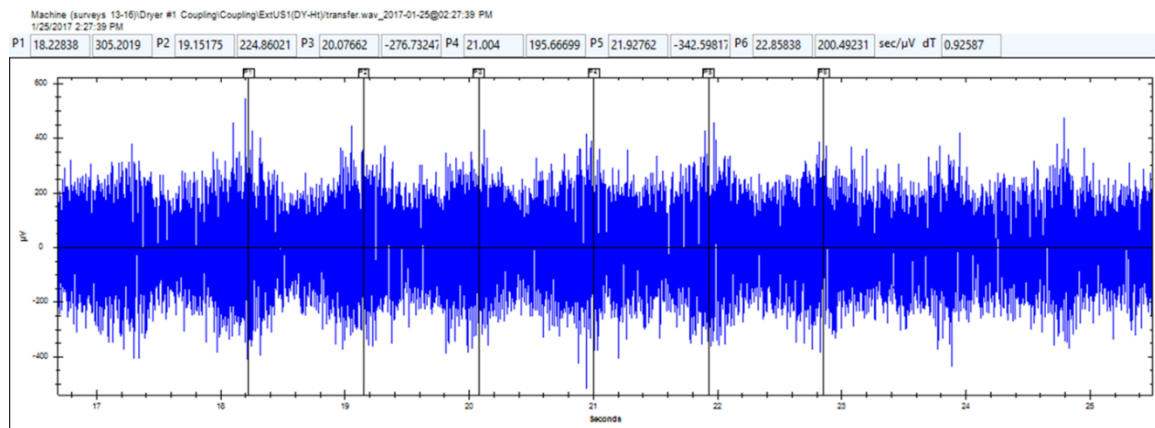
Ultrasound readings were also taken on the output coupling. It was generating a pulsating noise which was repeating every 90 CPM or at the output speed of the gearbox possibly due to the variation of the load on the coupling due to the variation in speed.

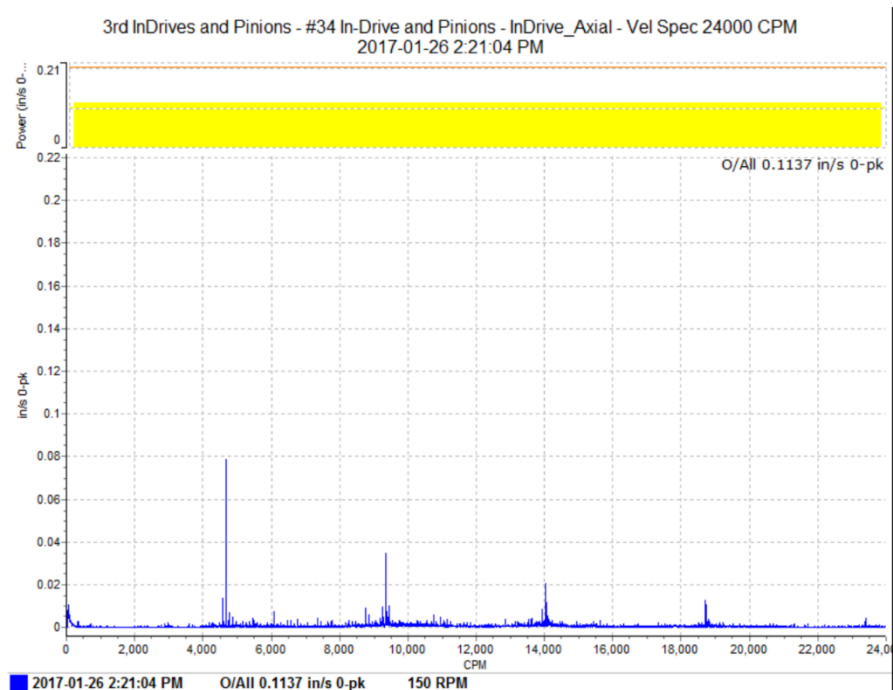
There is also evidence that there is a misalignment condition between the output of the gearbox and the In-Drive.

Gear Misalignment is probably the most prevalent cause of gear failure. Typically, this results from coupling misalignment between the input and/or output drive systems and the mating components. This produces Gear Mesh Frequencies (GMF) and sideband frequencies, spaced out at the rotating speed of the faulty gear. Gear misalignment can also occur internally if the gear shaft support bearings are not properly aligned with respect to one another. While not common, this problem will usually lead to premature bearing failure before gear problems are considered severe.

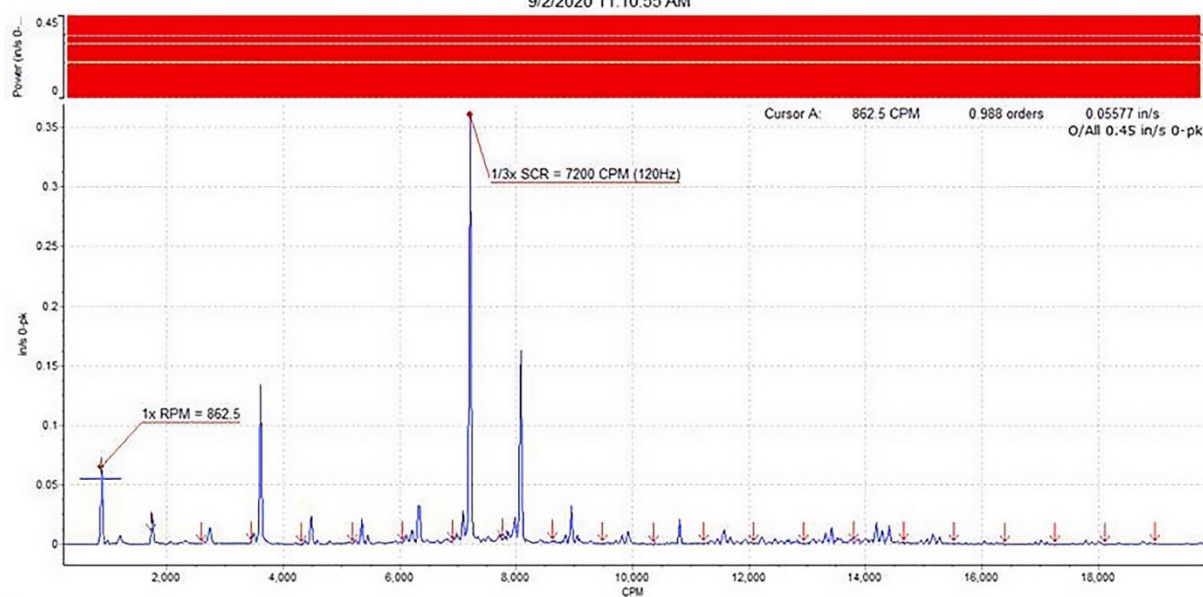
Fan Pump 52-31-08 A - MTR DE - Axial - Vel Spec/Wfm 120000 CPM  
9/2/2020 11:10:55 AM

When a firing card fails, then 1/3 of the power is lost, resulting in momentary speed changes in the motor's rotation. This can lead to high amplitudes at 1/3X and 2/3X SCR frequencies. As you can see on the vibration measurement this motor was firing at 1/3X SCR which is 7200 CPM meaning 2/3rds of the firing cards were faulty.

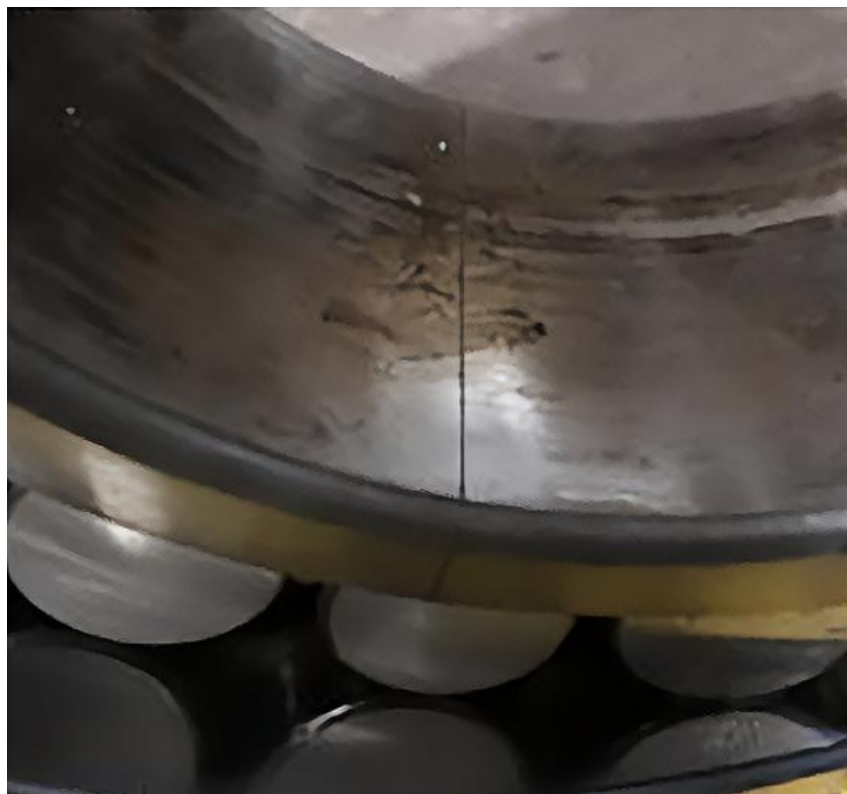
To prevent this, ensure that steam is reintroduced to the paper machine slowly, allowing for the temperature of the bearing to rise less rapidly, and therefore allowing its thermal expansion to not be so abrupt.

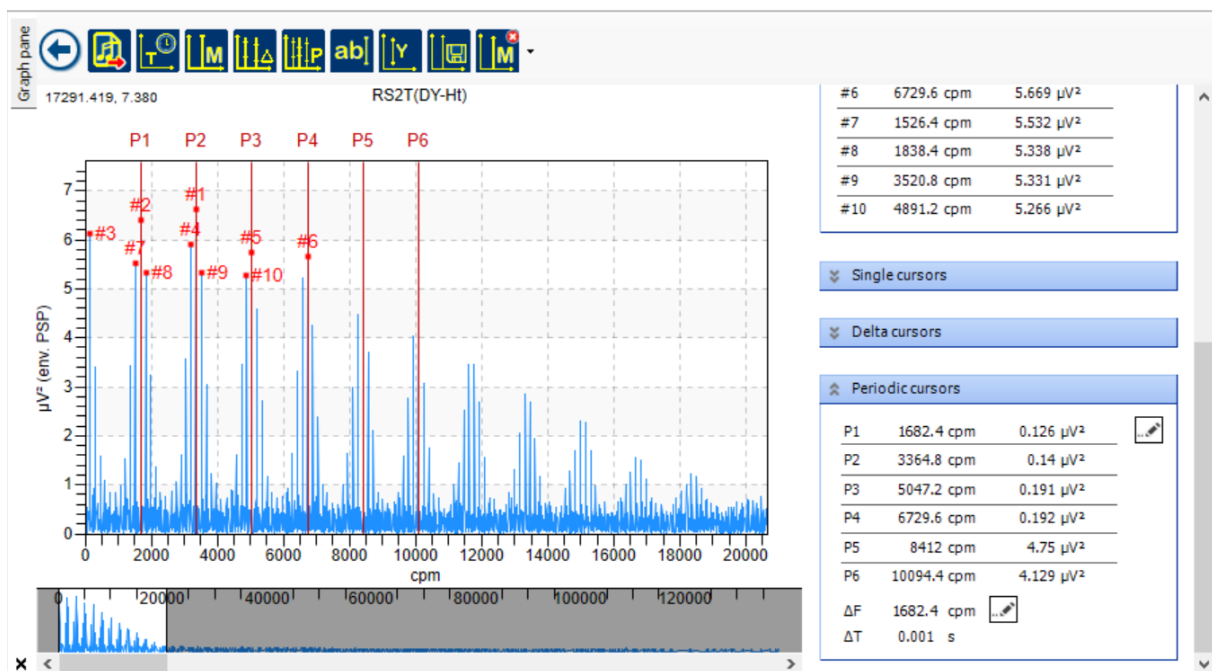
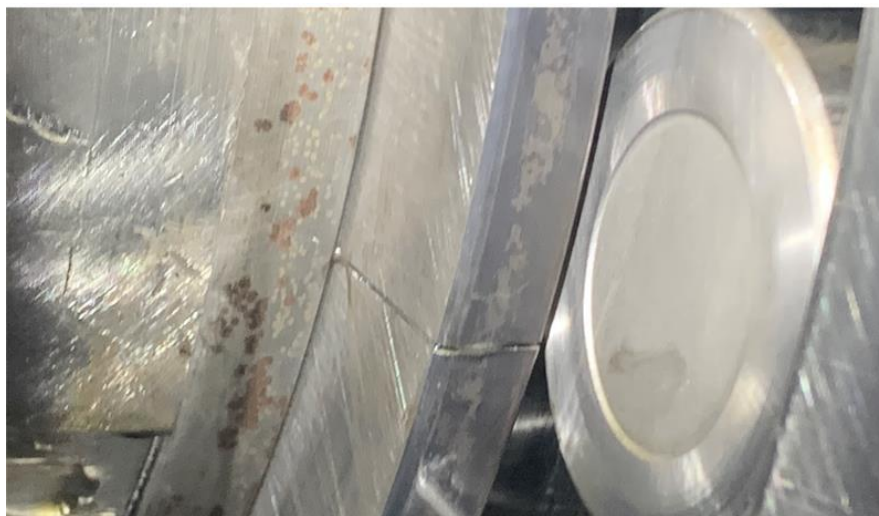
Paper roll with a defective inner race detected with ultrasound (UAS3 and SDT340).

The following is the spectrum of a slow-speed bearing (150 RPM), on a large roll (4-foot diameter), in a paper machine. Gilles Lanthier, our Partnered Ultrasound Senior Analyst found this defect using his SDT340 and performed analysis using UAS3 software. This find was then confirmed using vibration analysis.

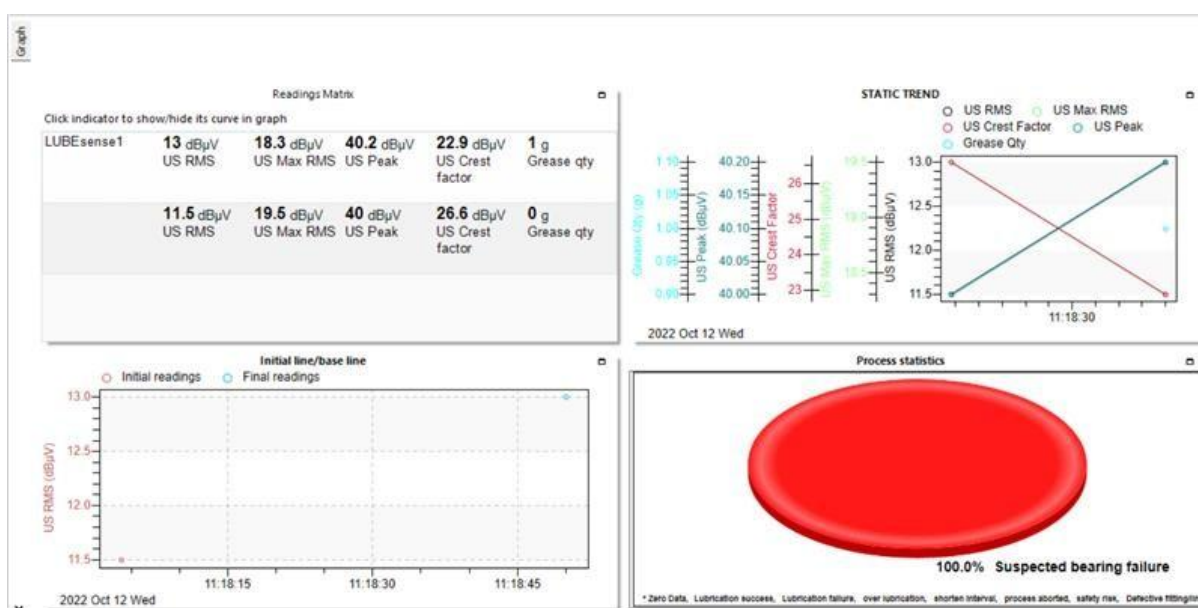
UAS3 LUBExpert Dashboard Configuration 1

SDT Field Services Technicians noticed the impact while listening to the lubrication task they were performing. And after greasing the bearing, its condition did not improve, indicating that the impact was not lubrication related.

After analyzing the dynamic ultrasound data in UAS3, it was confirmed that there was a suspected bearing failure.

A work order was promptly created to replace the bearing during the next planned shutdown.

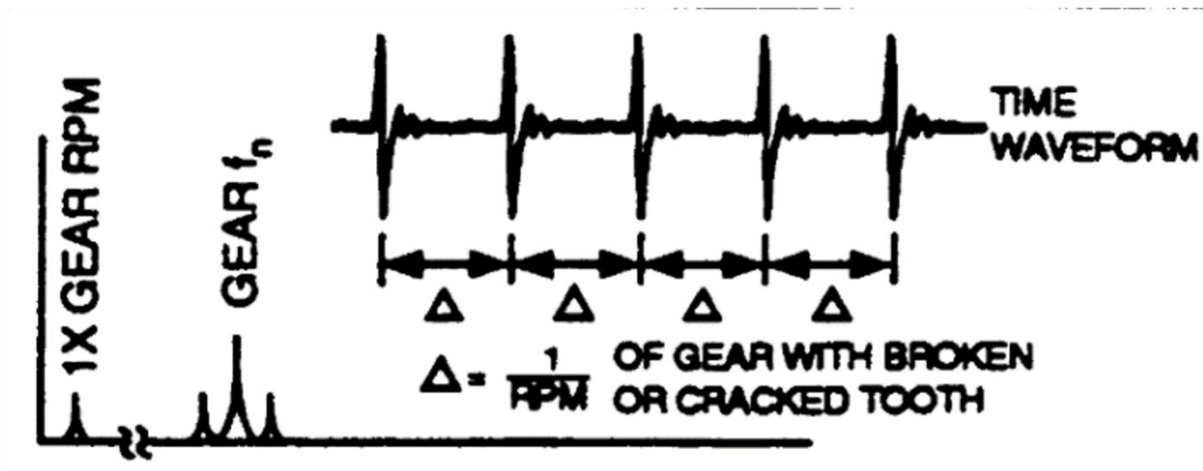
Figure 2 - Cracked or Broken Tooth

Cracked and broken teeth generate high levels of ultrasound at 1 x RPM in the time waveform. Figure 2 depicts what a typical time waveform looks like when dealing with a cracked or broken tooth.

Observed in Figure 1, we can see a similar pattern to that in Figure 2. There is a pronounced spike every time the problem tooth tries to mesh with the teeth of the bull gear. The time between impacts corresponds to 1/RPM of the gear with the tooth problem. This data analysis lead SDT's Reliability Technicians to believe there is a cracked/broken tooth on the pinion gear.

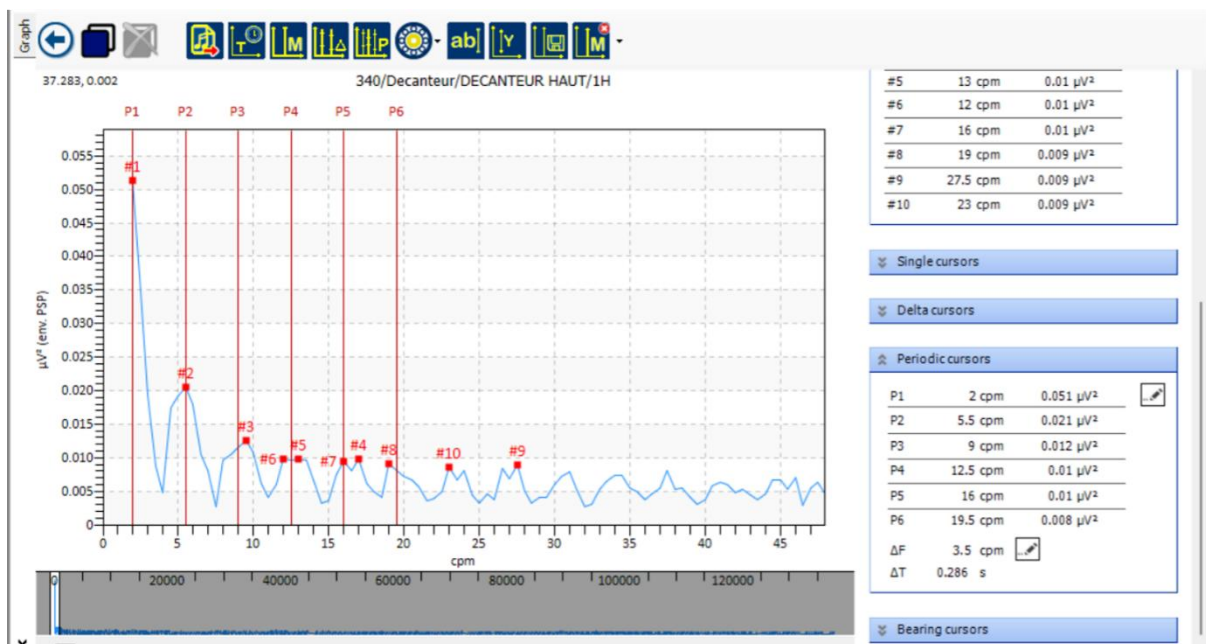
Figure 3 - FFT on the Pinion

As observed in the pinion's FFT, it can be seen that high levels of ultrasound above the sound floor are appearing at 1 X RPM.

With the use of the SDT340 ultrasound data collector, the Partnered Ultrasound Team was able to record data a full rotation of an asset turning once every 10 minutes. With this data, they were able to detect a broken tooth on the pinion, despite the slow speed, and low aptitude of the impacts.

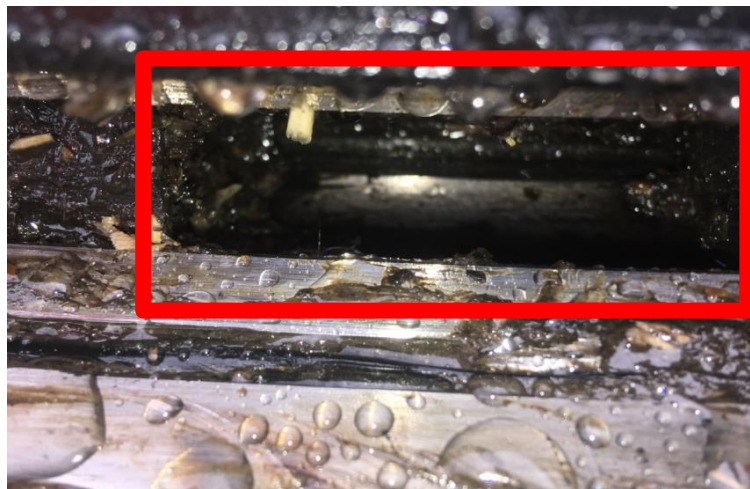
After extensive work, the team was able to determine that some equipment was missing a number of rolling elements essential to its proper functioning. The missing rolling elements were probably due to wear of the "spacers" between the balls acting as cages.

Thanks to this early discovery, the company was able to take corrective action to avoid a major malfunction that would have had serious consequences for the safety and efficiency of their

products. They undertook immediate repairs and reinforced their preventive maintenance procedures.

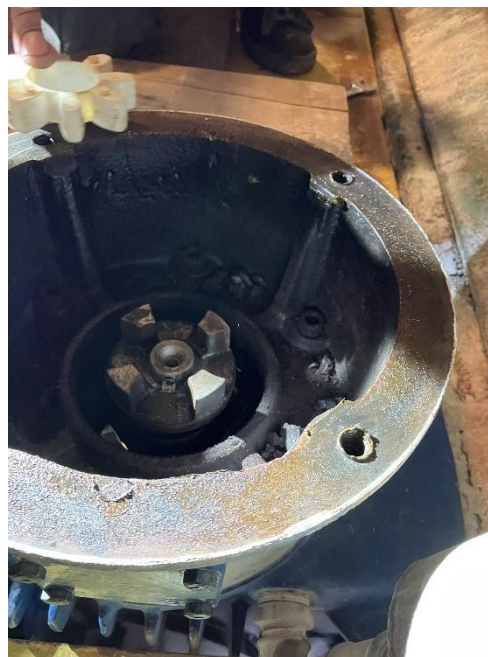
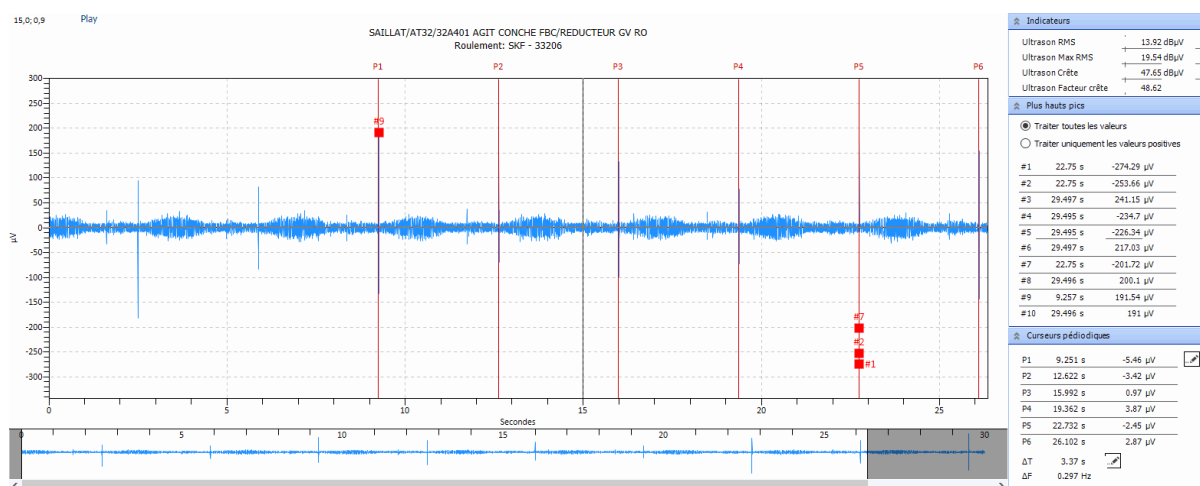
One day, the team in question decided to solve this noisy mystery using the SDT340, a state-of-the-art ultrasound measurement device. They positioned it strategically to investigate the sources of this annoying noise. After careful ultrasound listening, they discovered something interesting: shocks at a frequency of 0.3 Hz on the GV/PV points, visible in the UAS3 software in the image below.

The time waveform and frequency spectrum clearly showed a clear impact at 0.3 Hz on the GV and PV points. The maintenance team then focused their attention on the coupling location, as this was where the noise seemed to originate.
