# SUCCESS STORIES

Ultrasound Solutions

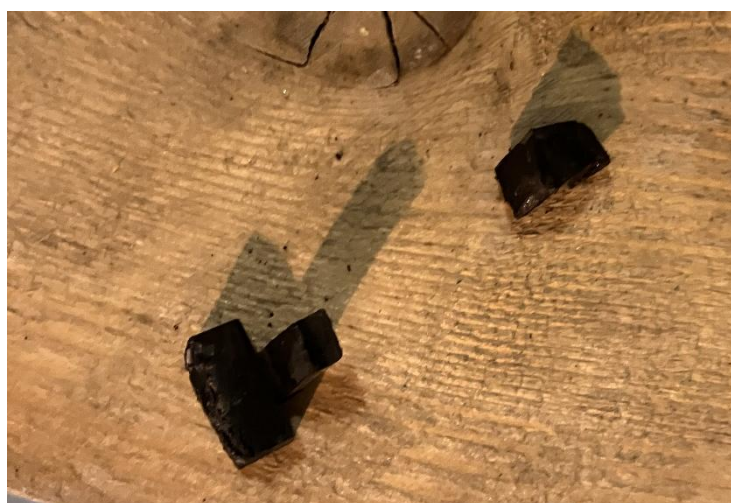
Initial diagnosis revealed that the problem affected both the PV and the GV. By moving the ultrasound sensor, they noticed that the noise was most intense at the coupling bell. On closer examination, they found that the flector was completely torn, as shown in the image below, which explained the shocks and noise. The shocks showed a coupling backlash, causing a modulation on the spectrum that even masked the GV rotation frequency.

The recommendation was clear: the flector was in such a state that it had to be replaced immediately to avoid further damage. Thanks to this innovative approach, which combined ultrasound technology with meticulous analysis, the company solved its lime sludge filter problem and was able to resume production without disruption or disturbing noise, marking a great success in their maintenance process.

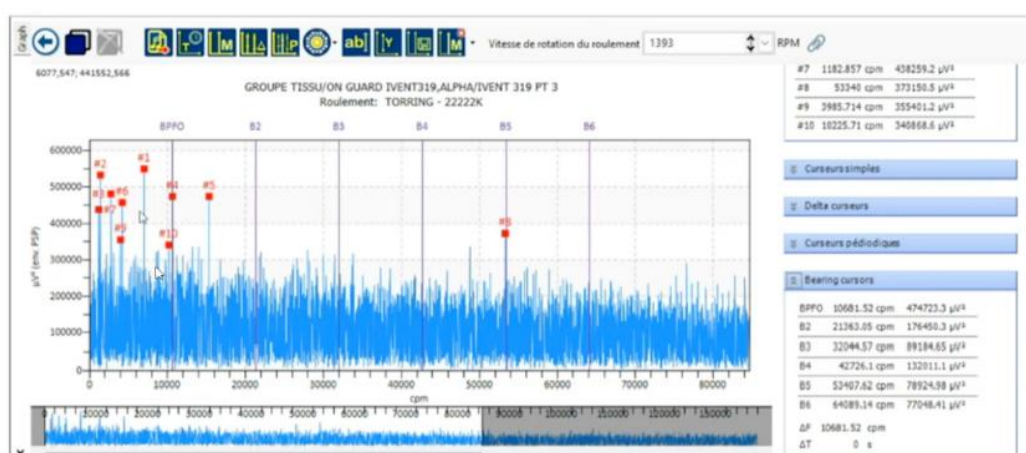
Figure 4: Dynamic Ultrasound Measurement Taken with the LUBExpert Handheld Data Collector & Analyzed in UAS3

In response to the Suspected Bearing Failure, additional follow-up dynamic measurements were recorded using a LUBExpert. We can observe this dynamic data in Figure 4 where we can see the suspected bearing failure was proven correct. The fault frequency cursors indicate this bearing had a BPFO.

By continuously monitoring RMS (overall friction) values of a rotating asset, the ON-GUARD determined that the bearing on the Pumps NDE had a suspected failure.

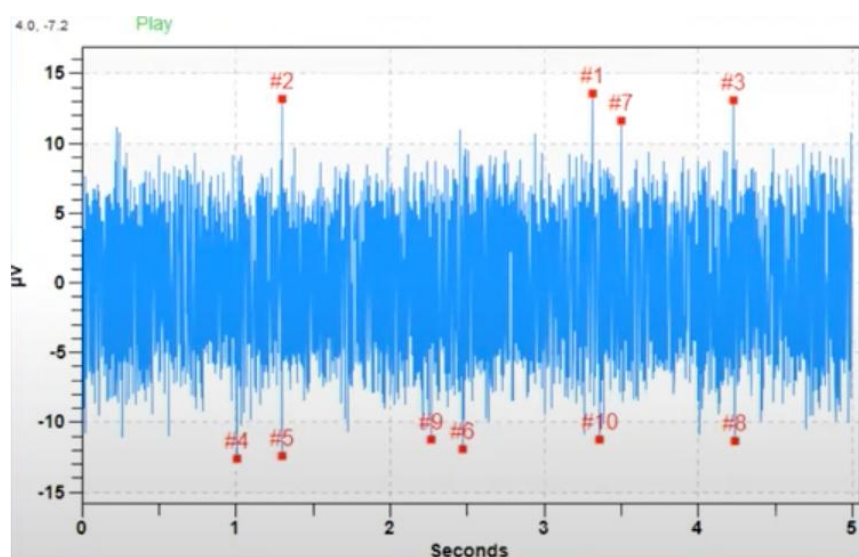
Figure 1 – Healthy Coupling Ultrasound Time Wave Form

Figure 1 is an airborne ultrasound signal captured of a healthy coupling. This coupling is emitting very low energy, and has a stable signal with no repeated impacting.

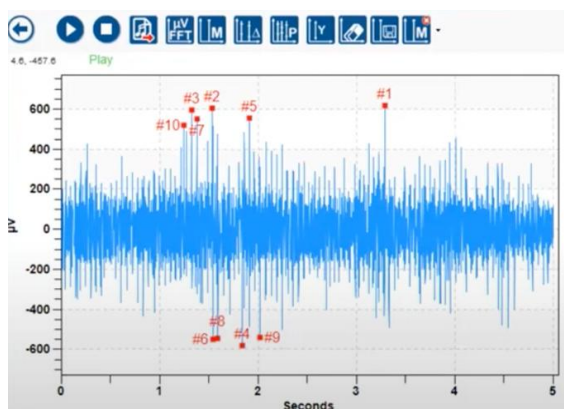
**Figure 3 – Coupling that Requires Lubrication & Follow-Up Measurements Time Wave Form**

In Figures 3 & 4, a coupling with an obvious lubrication error can be observed. But by examining the ultrasound spectrum of this coupling, there is an indication of repeated impacting at run speed. In this case, SDT's recommendation would be to lubricate the coupling and then perform follow up measurements to confirm if the repeated impacting signal is still strong enough to justify further inspection.

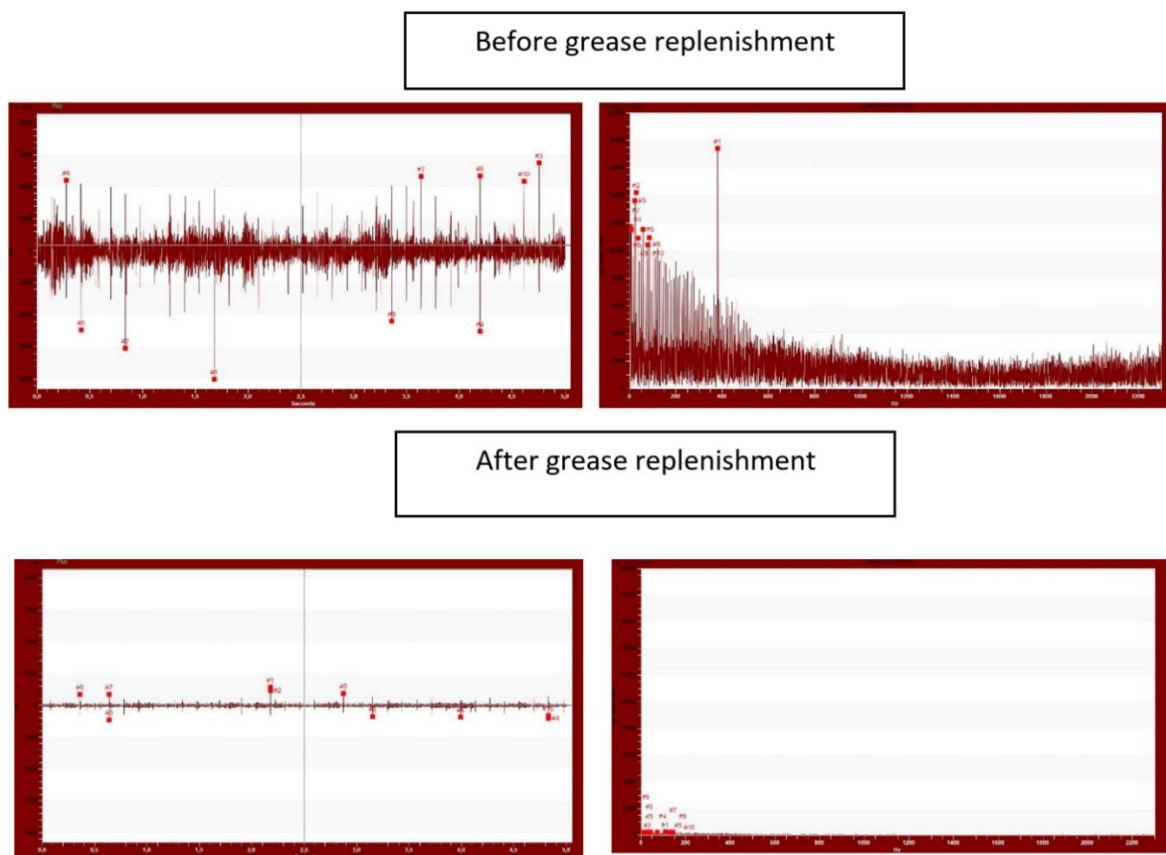
**Picture 3**

Here is what it looks like in the first week of implementation. Bearing successfully greased with declared condition as “Suspected bearing failure”, TWF and Spectra collected before and after grease replenishment (picture 3):

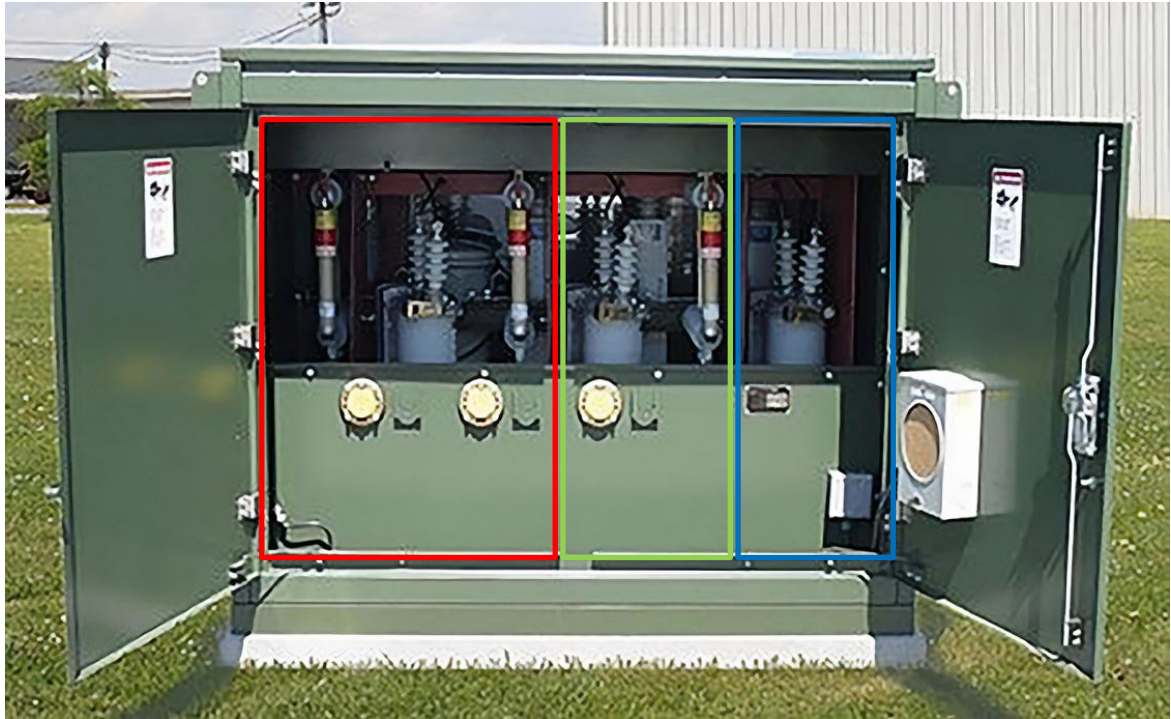
A hydro company in Ontario, Canada used a parabolic dish to check the insulators within an electrical distribution panel after complaints of a smell in the area.

Scanning across the insulators very quickly identified the problem.

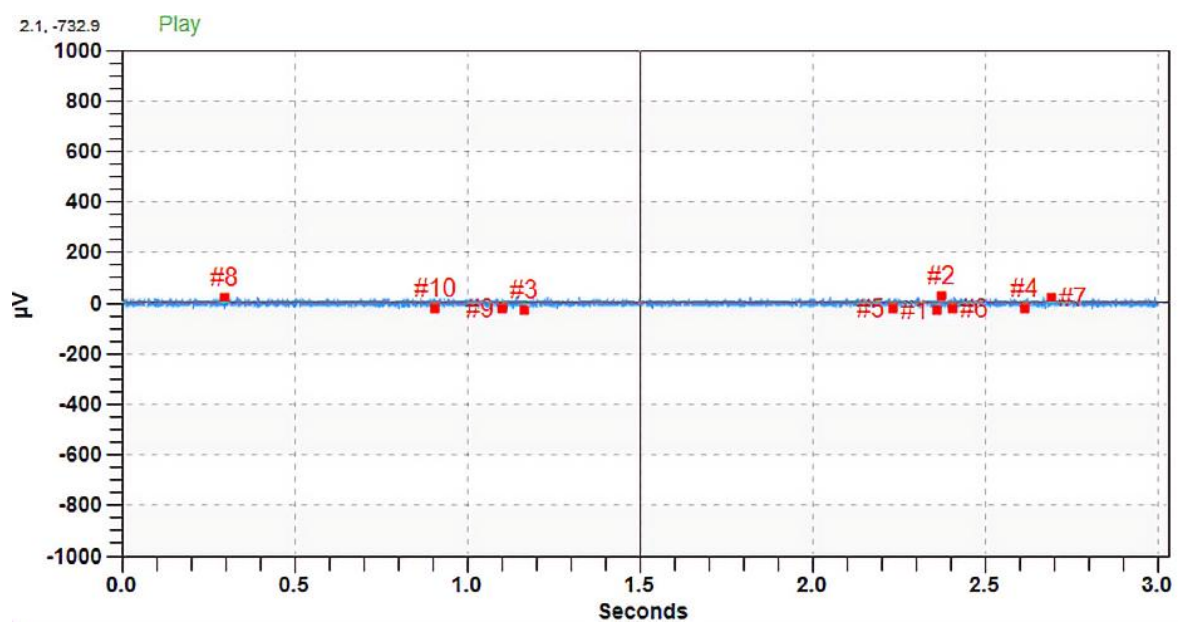
### Left Insulators: TWF

The time waveforms have been scaled identically. Ultrasound was present throughout the whole cabinet, but the source of the problem produced the loudest ultrasound. Corona was present.

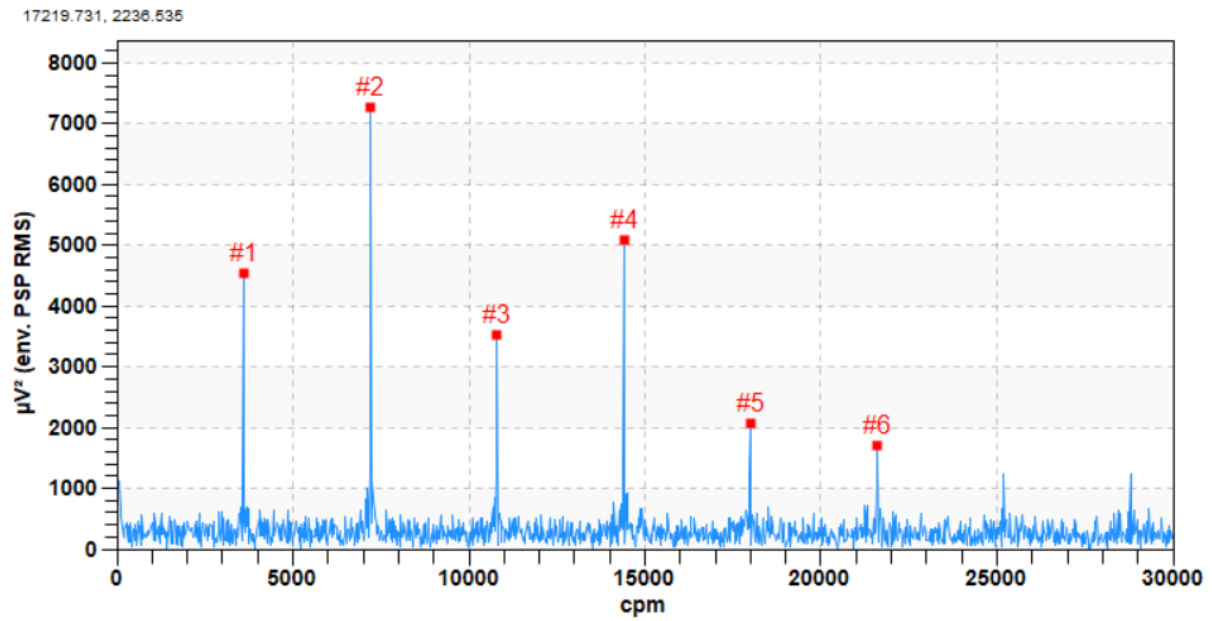
The FFT below clearly showed the signals being produced at harmonics of 3 600 CPM or 60 Hz which is the electrical frequency used in North America.

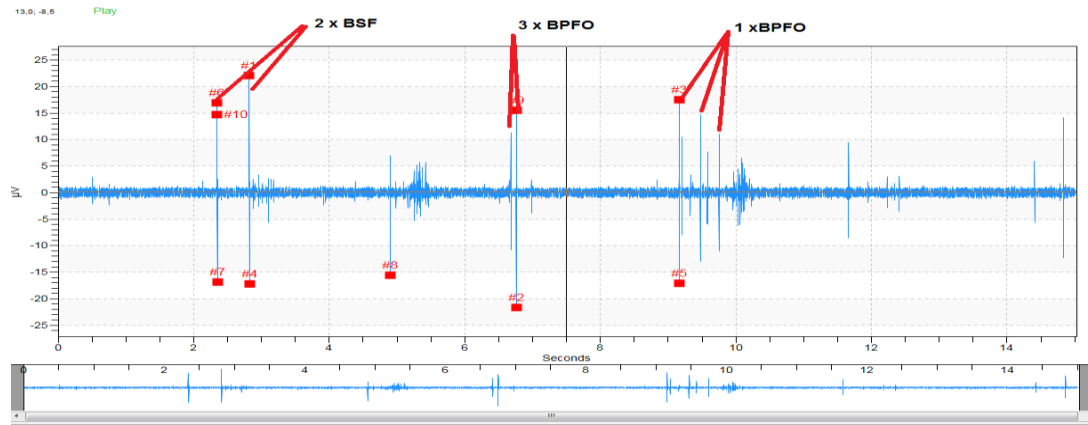
The ultrasound time waveform and spectra clearly showed impacts.

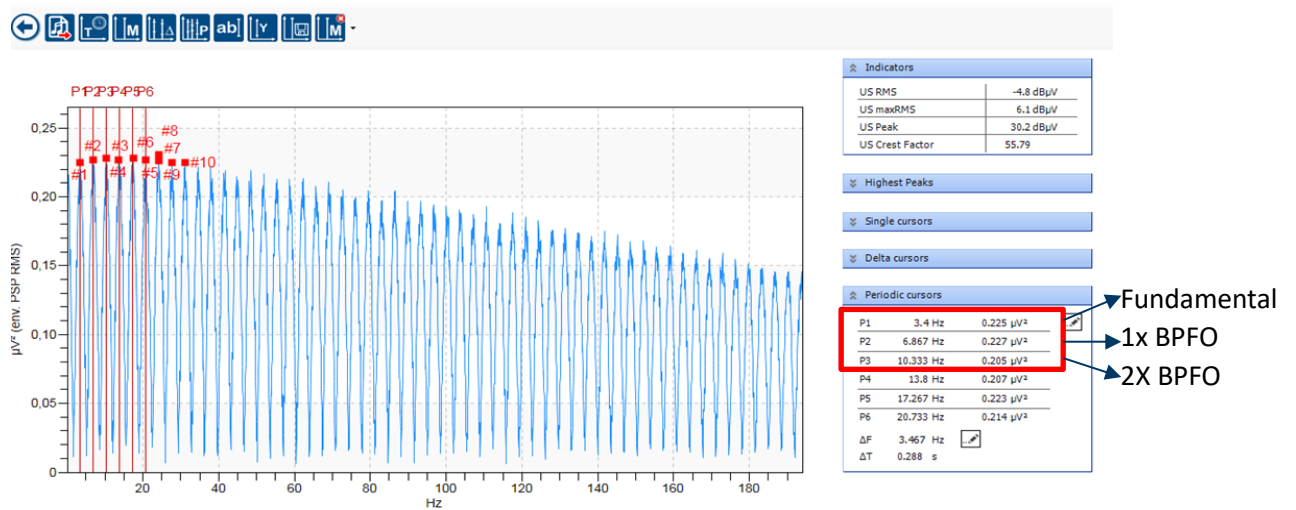
The ultrasound spectra showed the BPFO and many harmonics.

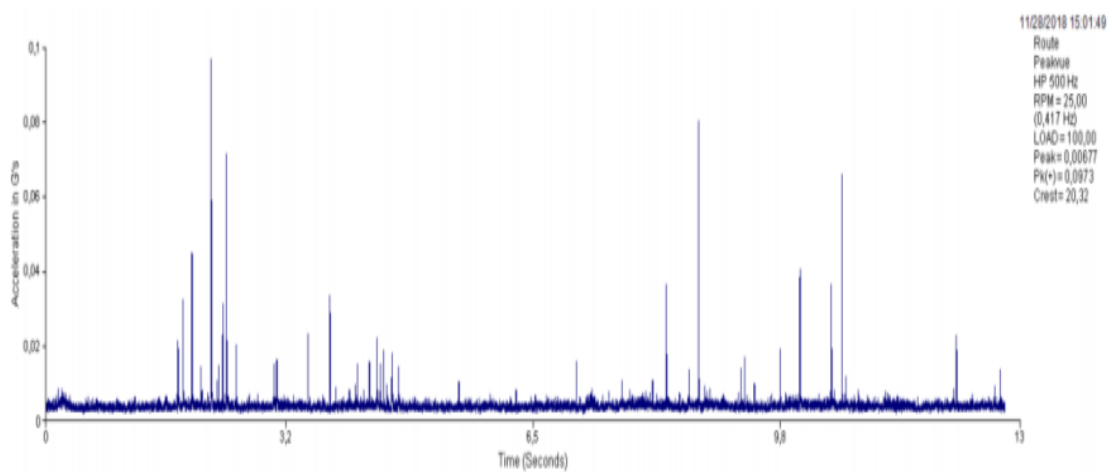
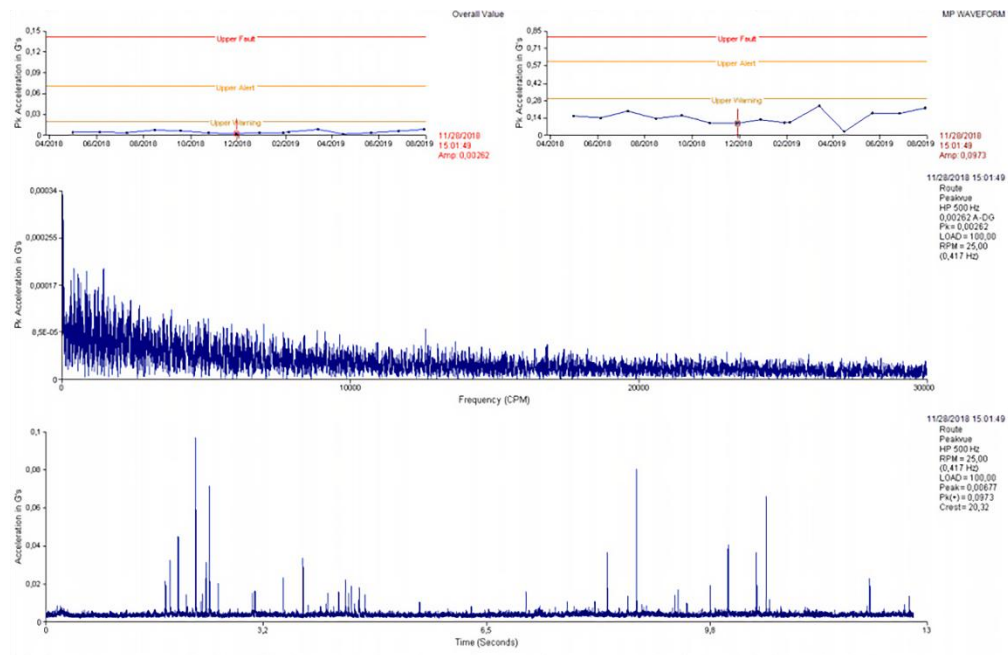
The vibration data did not reveal any noticeable problems because basically the accelerometer response is above 10 Hz.

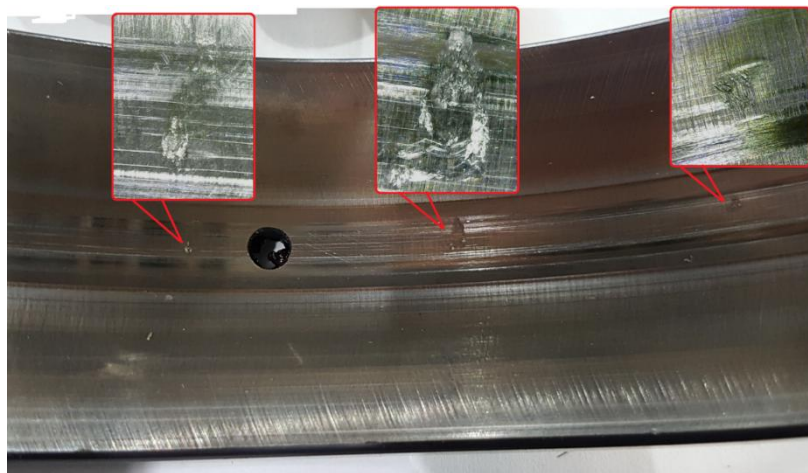
The bearing was inspected, and the outer race had cracks.

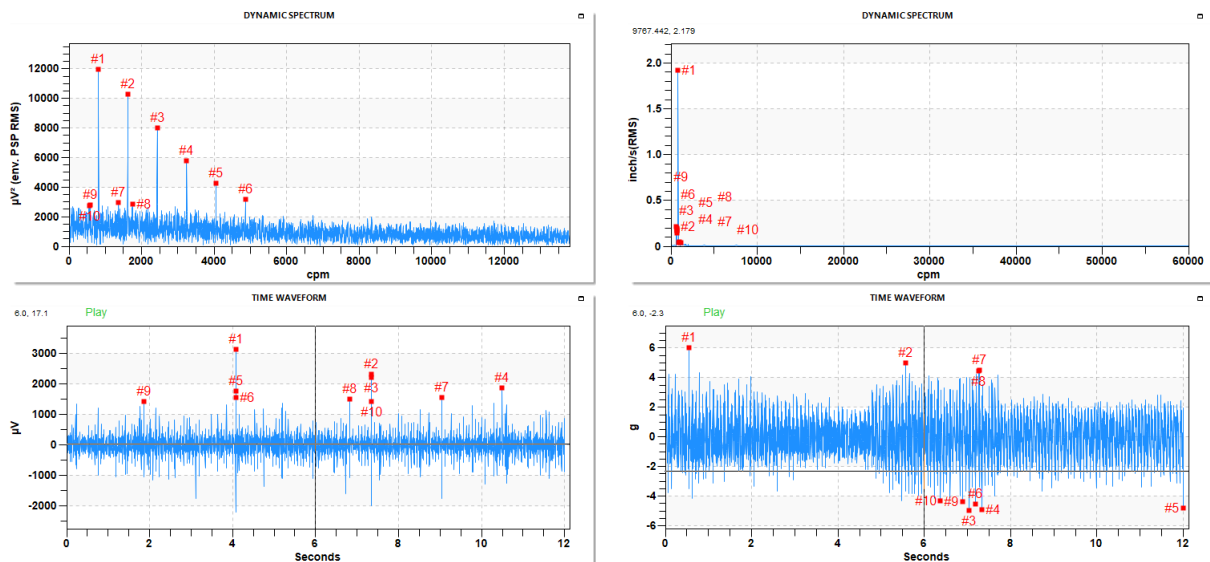
Bearing #1 drive side.

Amplitude 12 000

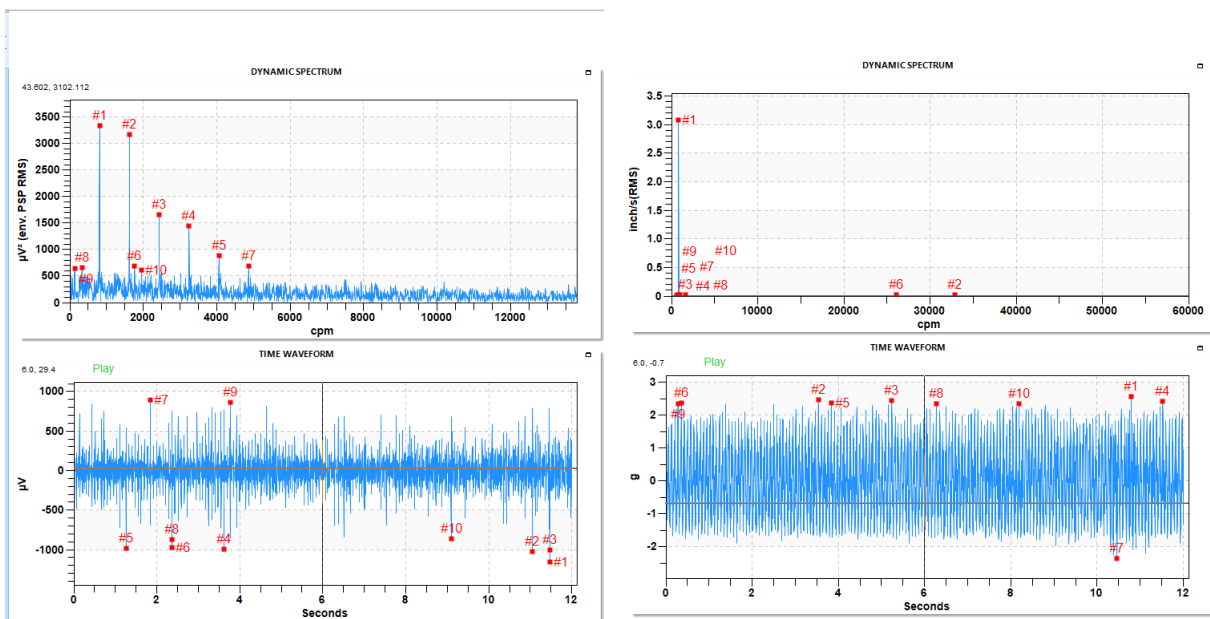
Bearing #2

Amplitude 3 500

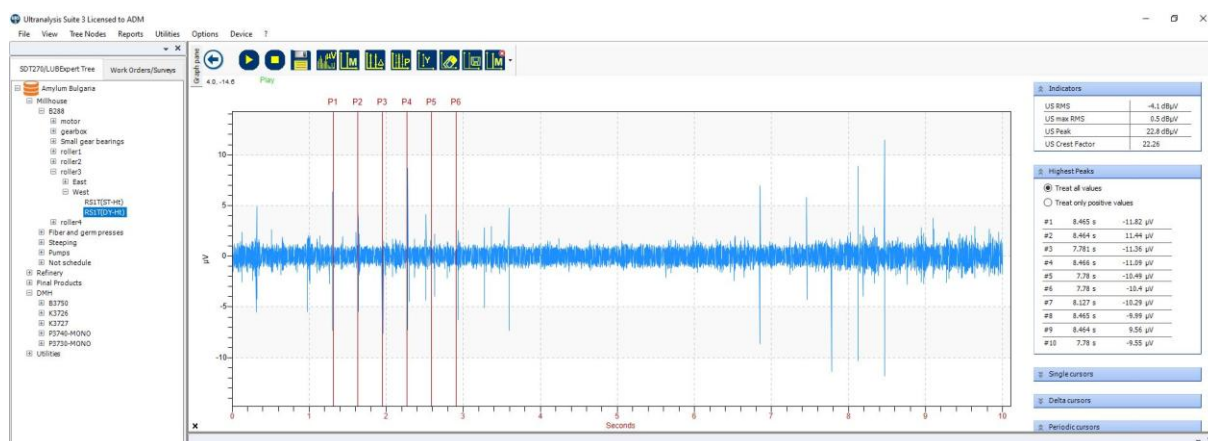
Building on their previous experience with vibration monitoring, they smoothly integrated the ultrasound condition monitoring program. This transition allowed them to capitalize on their existing knowledge while implementing the new technology. Early in the program, they detected damage in the support roller bearing of one of their dryers. Thanks to the early detection provided by ultrasound, they were able to continue monitoring the bearing and plan the necessary repair months in advance, preventing an unexpected shutdown.

Image showing the detected bearing problem.

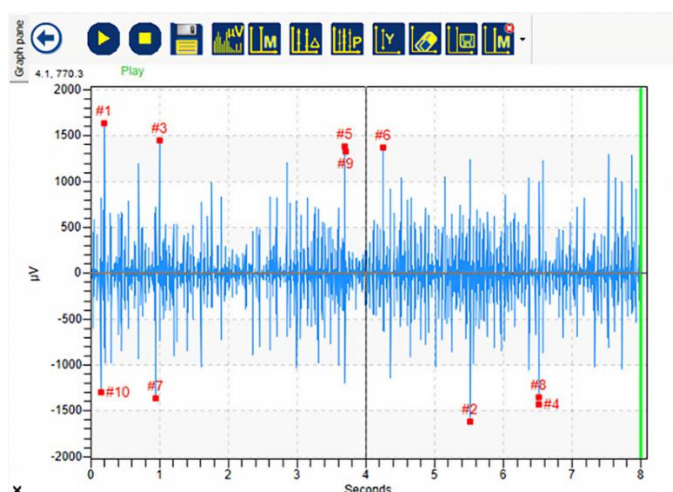
Upon arrival to the crane, he began listening to the bearings on the input shaft and the brake drum side of the gear box. Immediately, John recognized something didn't sound right. He made it known to the crane technicians and went to upload the data to UAS3 so he could perform an analysis. John immediately recognized very high peaks in the wave form as well as an audio signal full of impacts.

He immediately went back to the crane technicians to review with them the data he had found. John briefed them on the 4 condition indicators (41.7 dBµV rms, 43.9 dBµV max rms, 65.9 dBµV peak, and 16.2 crest factor).

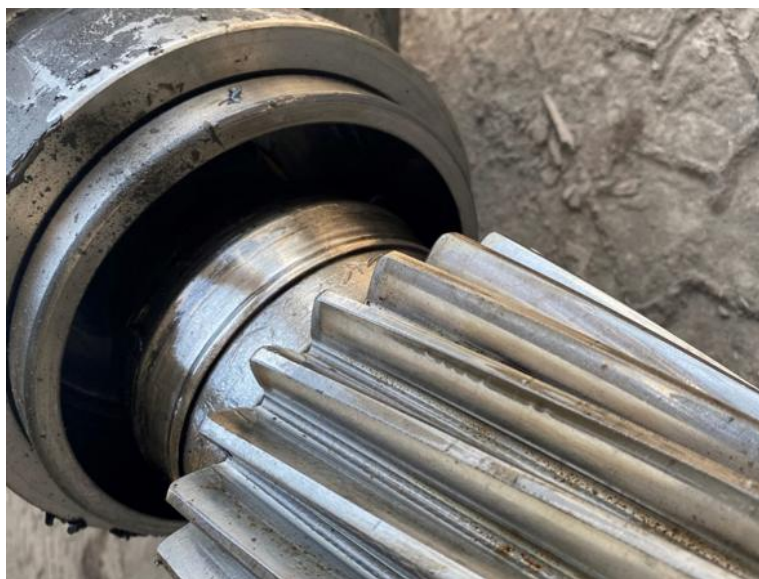
Unfortunately, it wasn't and two weeks later the bearing failed. The unplanned downtime to repair the damaged input shaft and replace the bearing took approximately 6 hours. The loss of production was expensive enough, not to mention the cost of parts and labor.

Below is the input shaft bearing right after being pulled out of the gearbox. As you can see all the rollers are gone and had to be fished out of the bottom of the gearbox. Fortunately, they didn't get caught in the gears causing further problems.

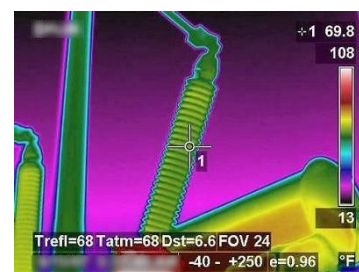
During an inspection, Skip Young detected the existence of a partial discharge on a phase of a transformer head using his SDT270 collector. By comparing the 4 condition indicators obtained after collecting static measurements, he was able to conclude that this was not a minor defect like nuisance corona. The thermogram showed no hot spot. Skip concluded that it was not a resistive defect of the arcing type.

Time signal analysis clearly shows the presence of tracking.

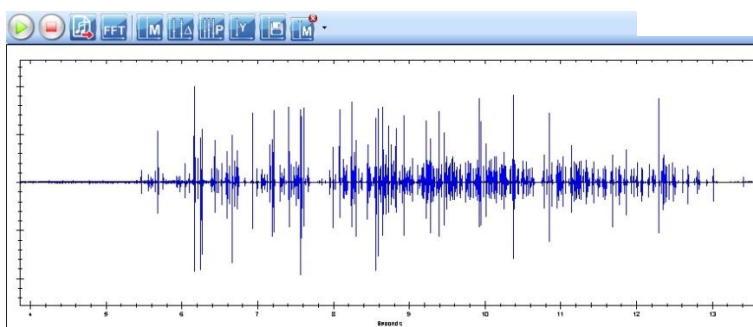
The thermogram showed no hot spot.

The time signal shows the presence of short-lived successive flashovers that are not repetitive and are typical of tracking.

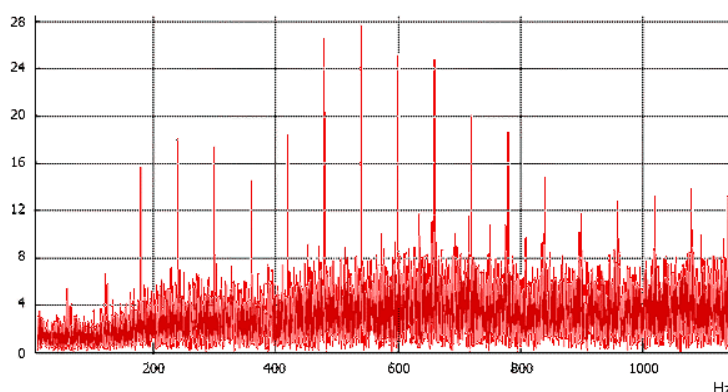
Tracking was confirmed by analyzing the spectrogram. However, it also revealed the presence of a destructive corona.

The frequency signal shows peaks at the fundamental frequency (60 Hz) and at its harmonics, which is typical of a destructive corona. It also shows noise between the peaks, which is typical of tracking.

After analyzing the data originating from the static measurements and time and frequency representations, the company decided upon scheduling a maintenance operation during the next shutdown planned for the transformer. It simply consisted in cleaning the transformer head.

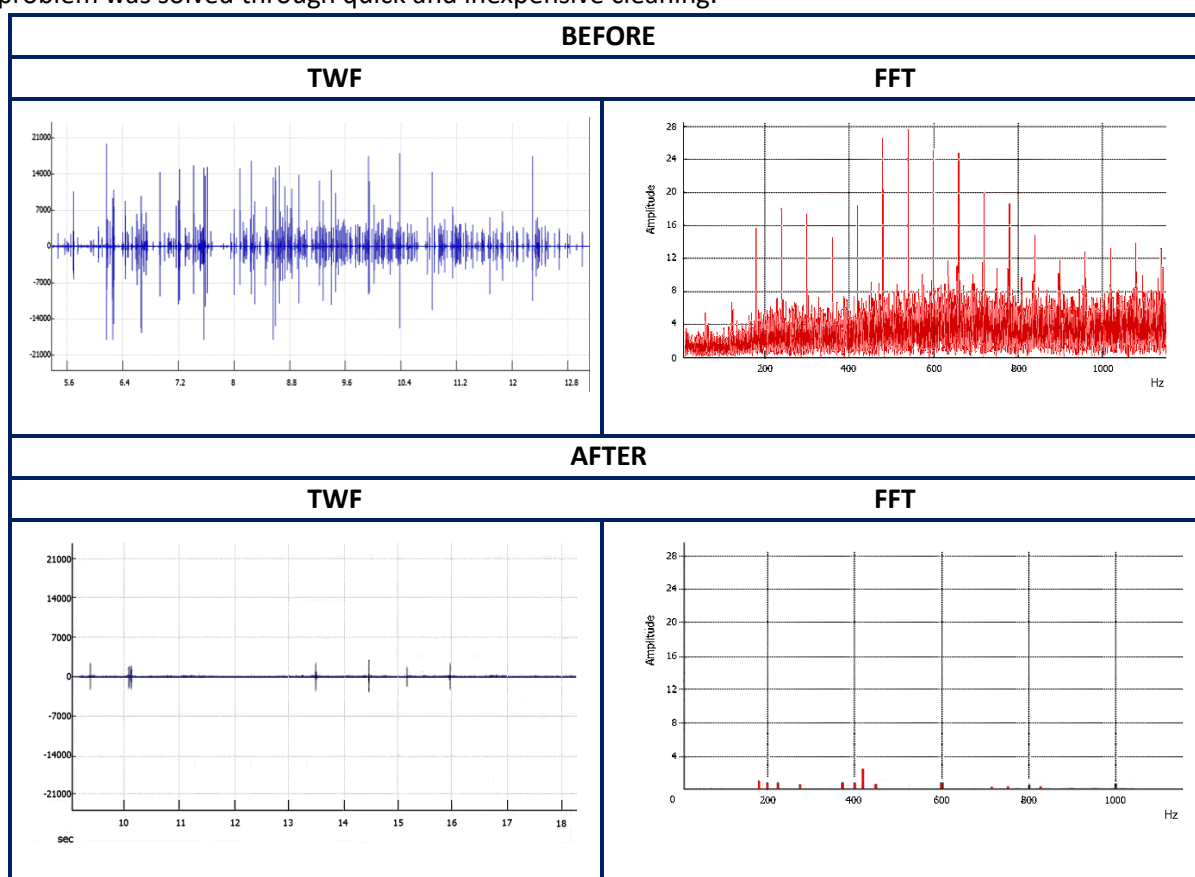
Finally, a new data collection was carried out after restarting the system. The curves below show the results obtained before and after the maintenance operation. They clearly demonstrate that the problem was solved through quick and inexpensive cleaning.

Top: measurements prior to maintenance. Bottom: after maintenance. Please note that time and frequency representations are on the same scale.

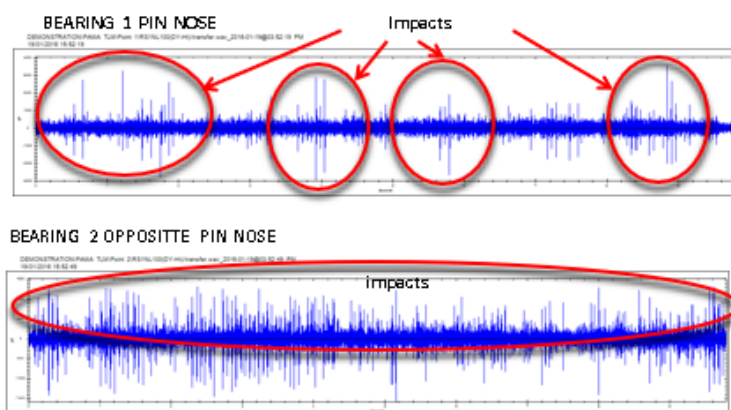
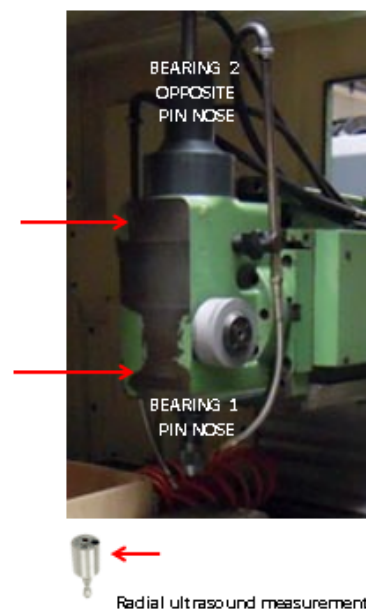
1 X RPM harmonics in ultrasound spectrum from bearing shows looseness. Bearing fit tolerances are out.

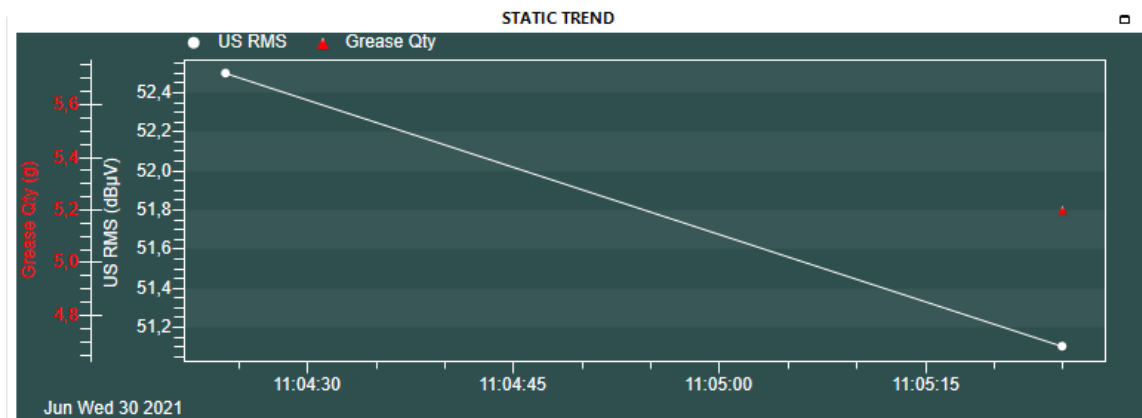
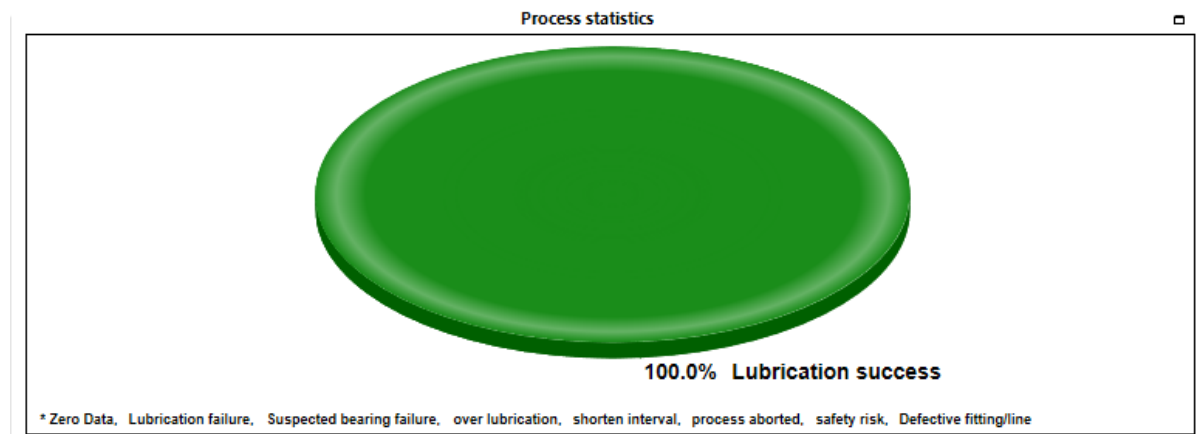
Applied: 5.2 grams

Outcome: Lubrication success

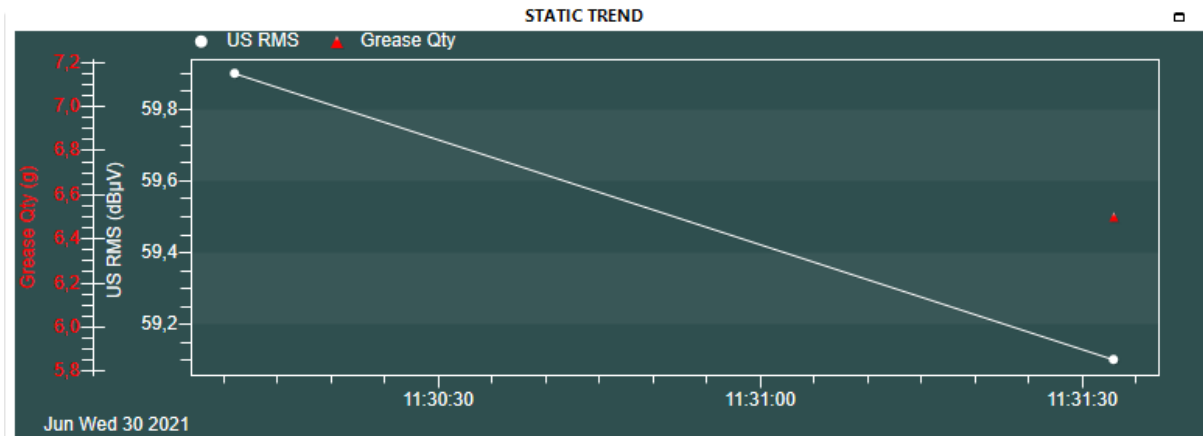
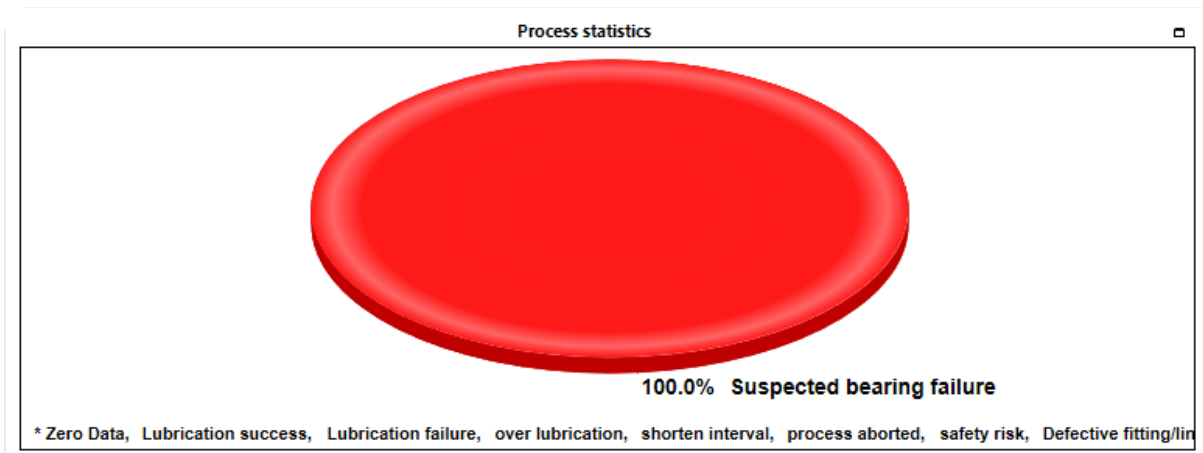
Applied: 6.5 grams

Outcome: Suspected bearing failure – Data reported to CM team

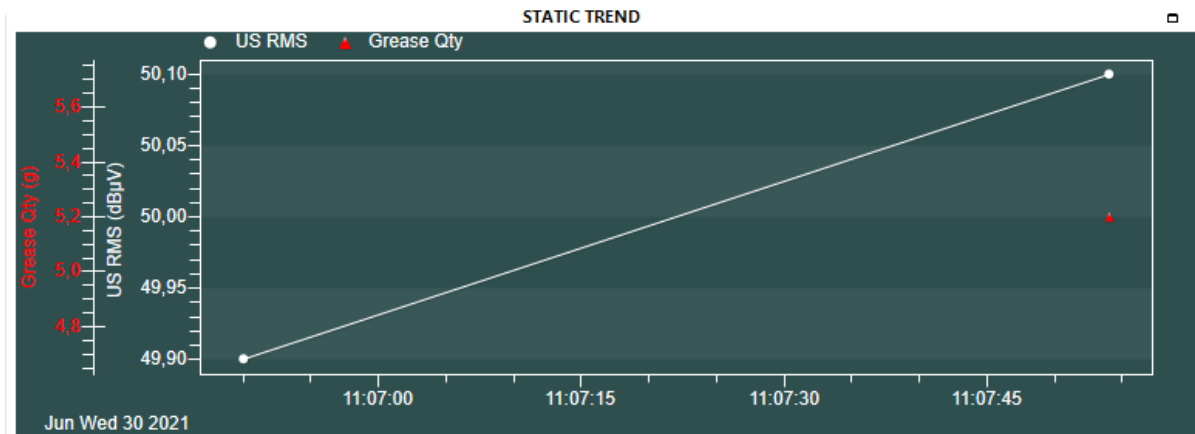
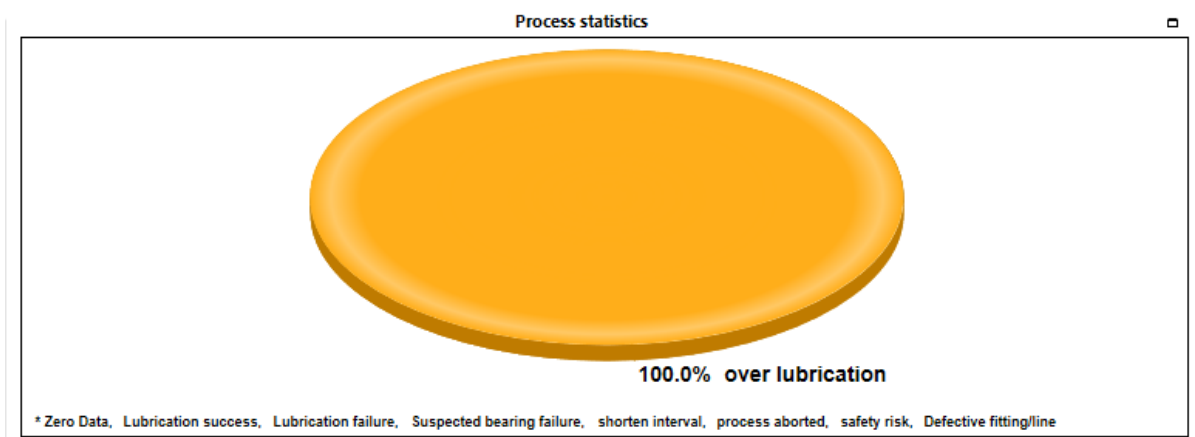
Applied: 5.2 grams

Outcome: Over Lubrication – Bearing didn't need any grease

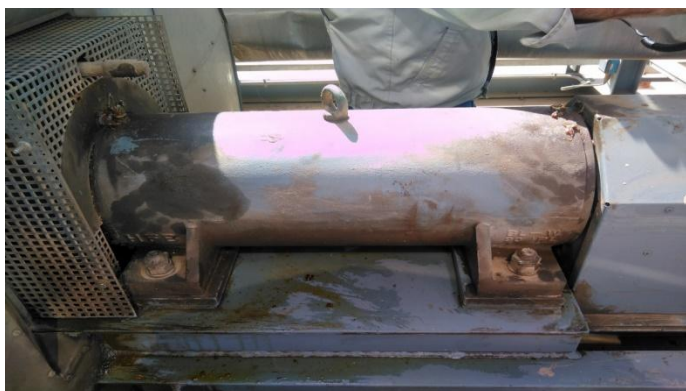
**Figure 2 - Two fan bearings with different load. Why do they share the same grease replenishment protocol?**

Following the facility’s lubrication procedure raised several red flags. Figure 2 shows two bearings driving the fan. Why would two identical bearings, but with different loads, have the exact same grease replenishment protocols? Maybe it’s purely out of convenience; since the lubricator is there to grease the drive end bearing, might just as well pump a few strokes into the non-drive end.

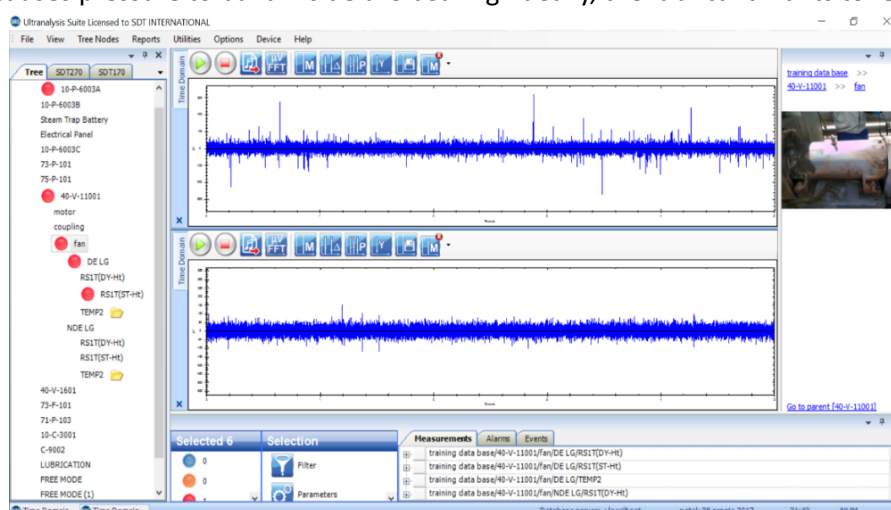
To drive home the point, Haris also captured DYNAMIC signals from the drive end bearing. As seen in Figure 6 the time signal before (bottom) and after (top) reveals new peaks and impacts forming. Over lubrication causes pressure to build inside the bearing. Ideally, the lubricant wants to feed from the

**Figure 6 - Dynamic data from drive end shows the emergence of defects (top) after bearing was over-greased following OEM recommendations.**

thickener to form a thin film between the rolling elements and the race. It can't do this if there's too much grease and pressure. The result is increased friction and impacting, two phenomena easily detected with ultrasound specialty tools like SDT's LUBExpert.

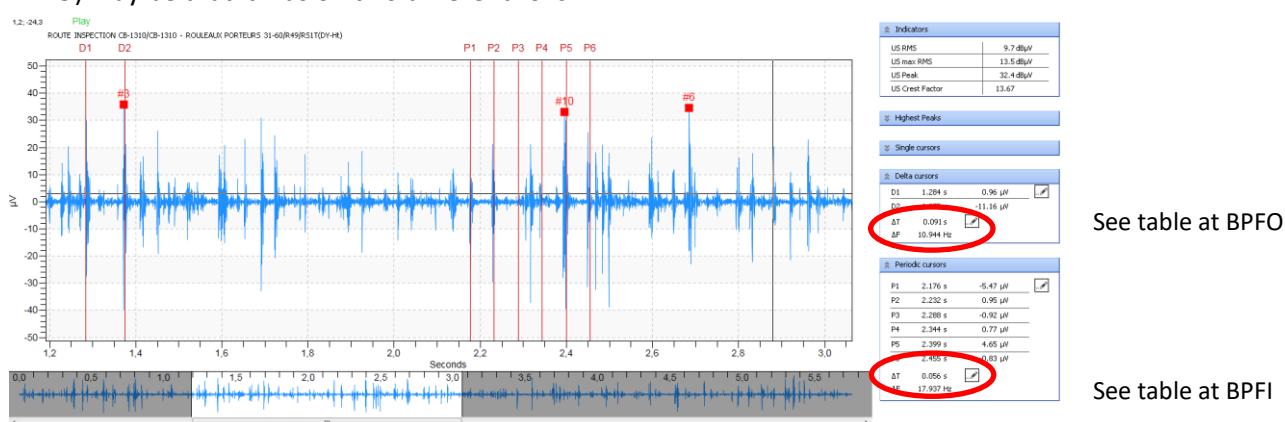
January 25, 2017: Roller bearing R49 presence of internal and external bearing failure (BPFI and BPFO) may be that it was on two different rolls.

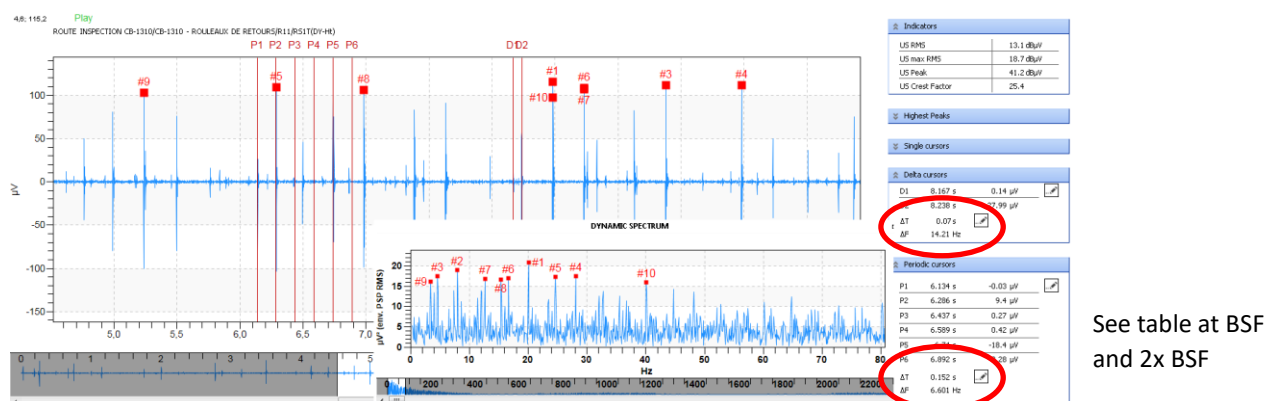
August 20, 2018: Roller back R11 bearing ball bearing frequency (BSF)

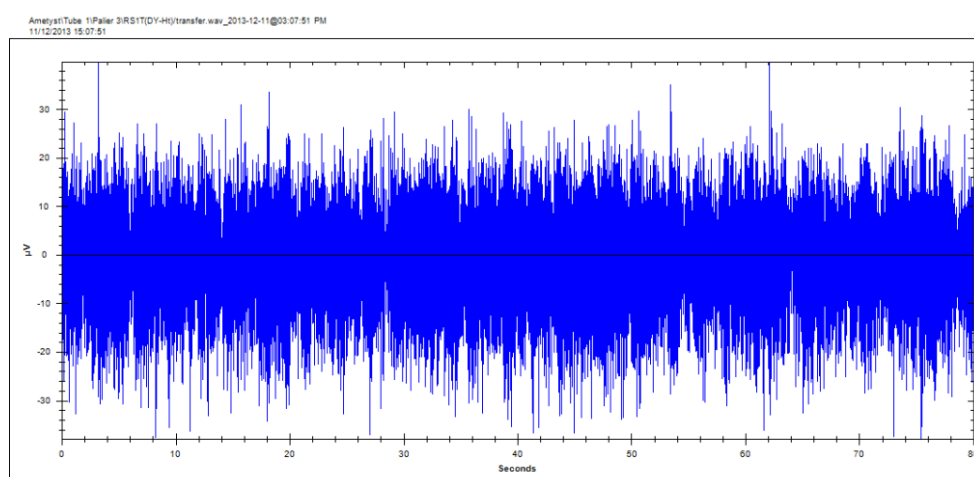
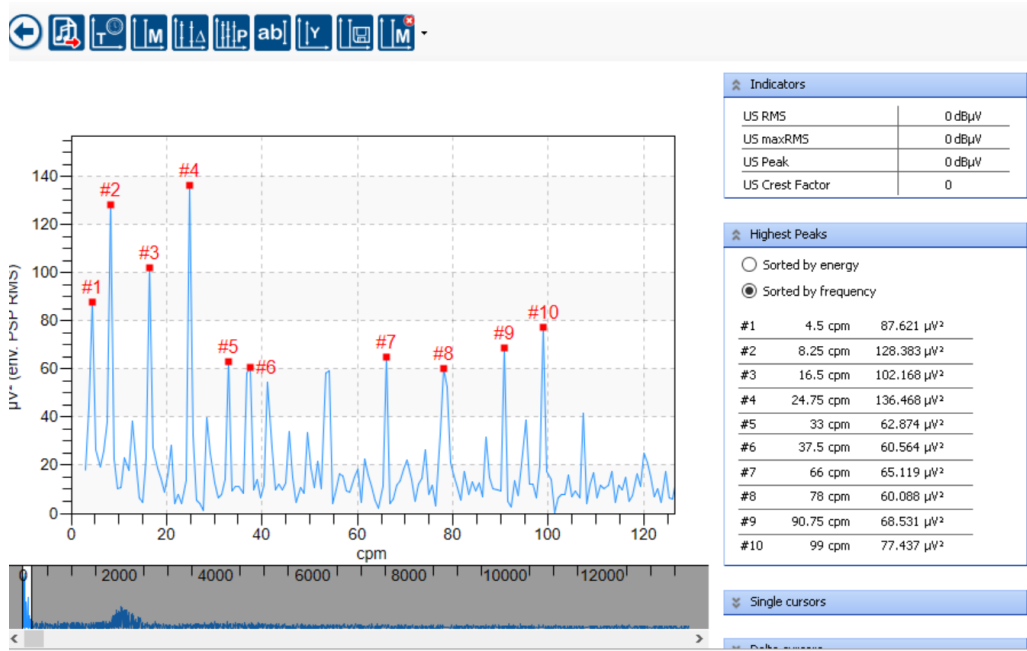
## Bearing #3

Emergence of peaks on the bearing 3 spectrum, which is not the case on the bearing 2. The RMS value is 12,8 dBµV concerning the spherical roller bearing 3 and -9,7 dBµV for the spherical roller bearing 2. Replace the spherical roller bearing 3.

The conclusion was to replace both #3 and #4 bearings. Bearings 5 through 8 on the Product Exit side of the oven returned low dB RMS values and no impulses were detected in the time trace. All four bearings were given a pass.

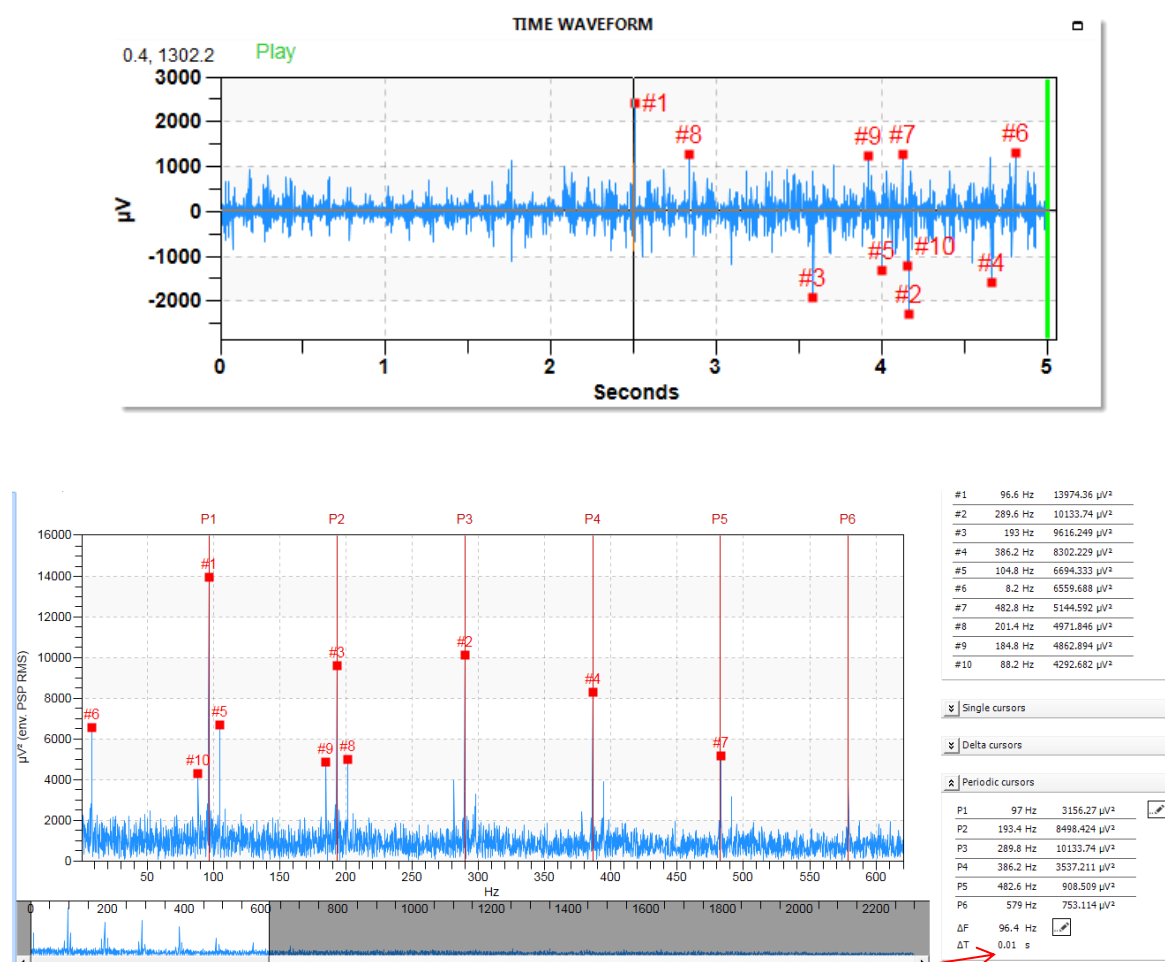
On July 18, 2019, during Cody's SDT routes he recorded a repeating ticking in the drive side bearing on the intermittent shaft for the horizontal mixer.

The ticks were found to repeat at 96.4 Hz.

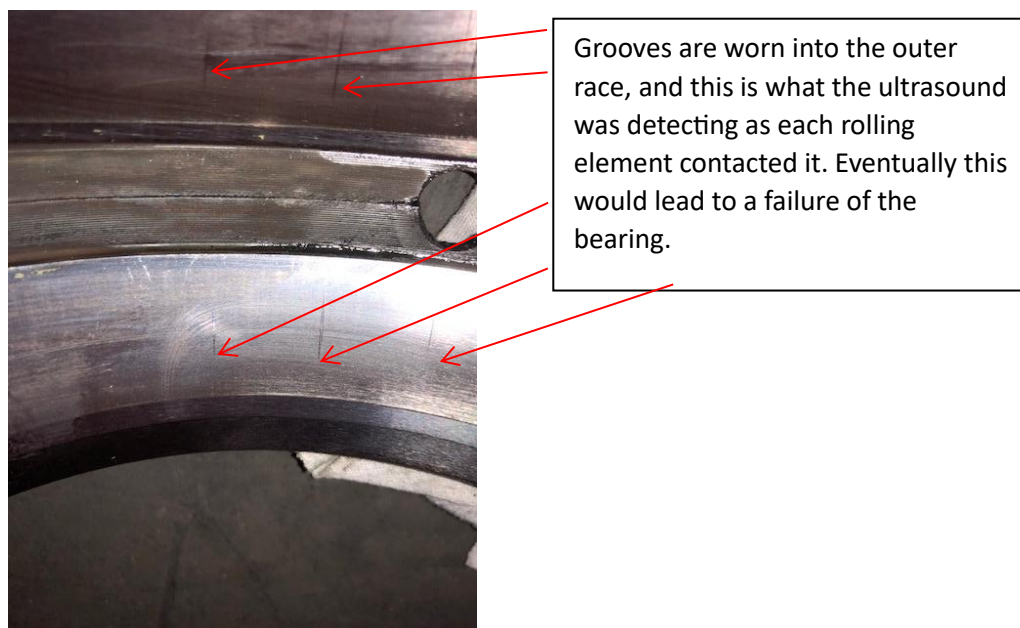
Due to uncertainty in the tac, it was determined there was an issue within the out race of the bearing.

Below is a picture of the outer race of the bearing when taken out and inspected.
