# SUCCESS STORIES

Ultrasound Solutions

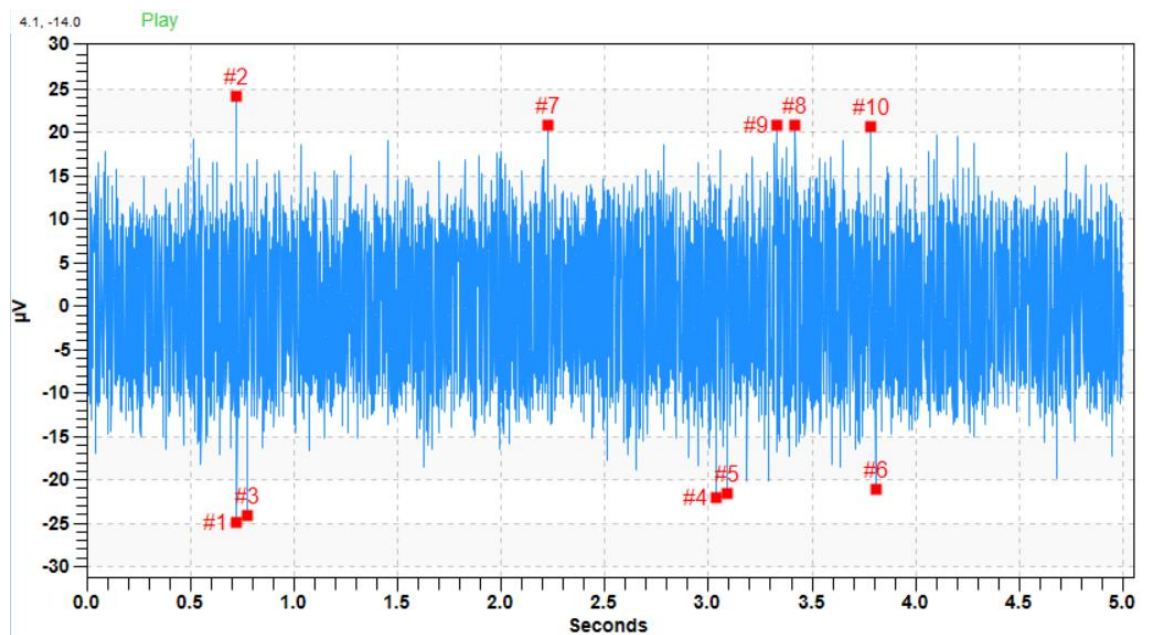
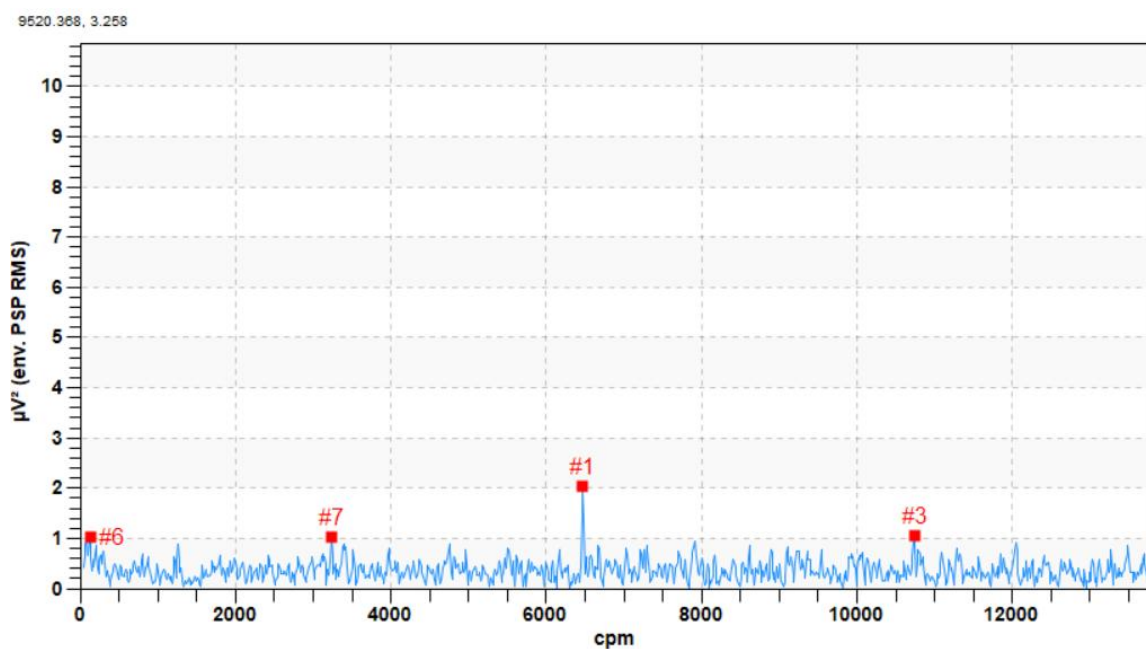
### Grid coupling with no problems

No real impacting – very low energy being generated.

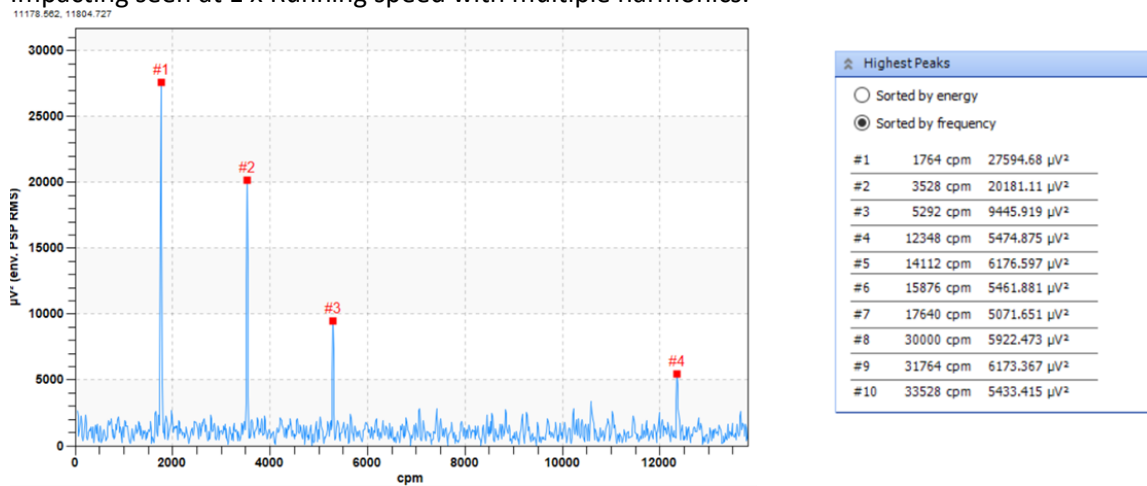
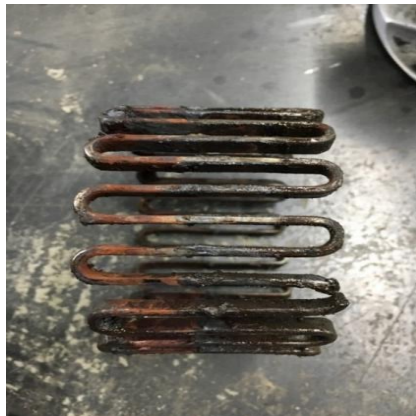
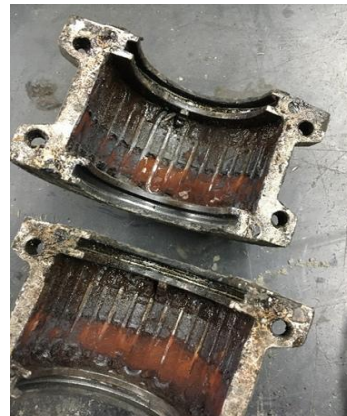
Impacting seen at 1 x Running speed with multiple harmonics.

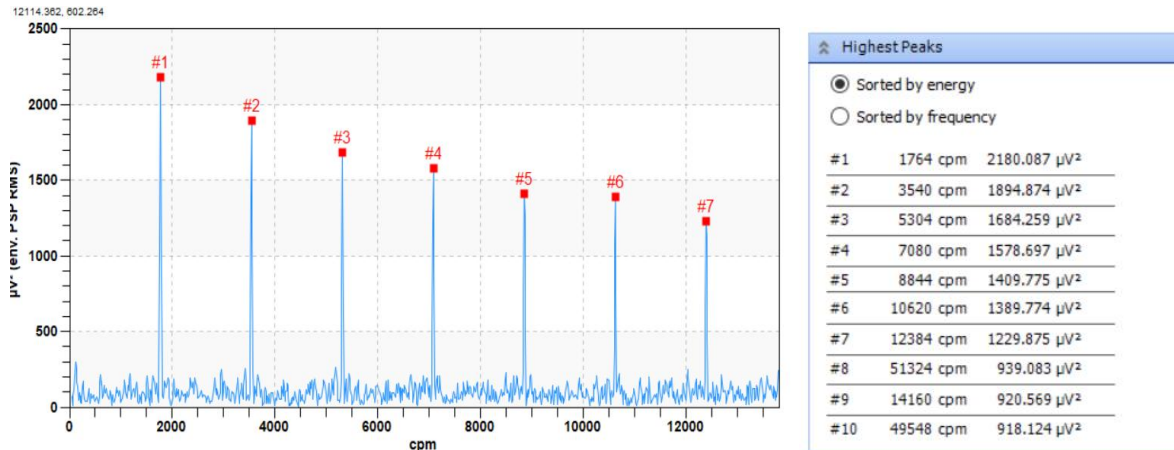
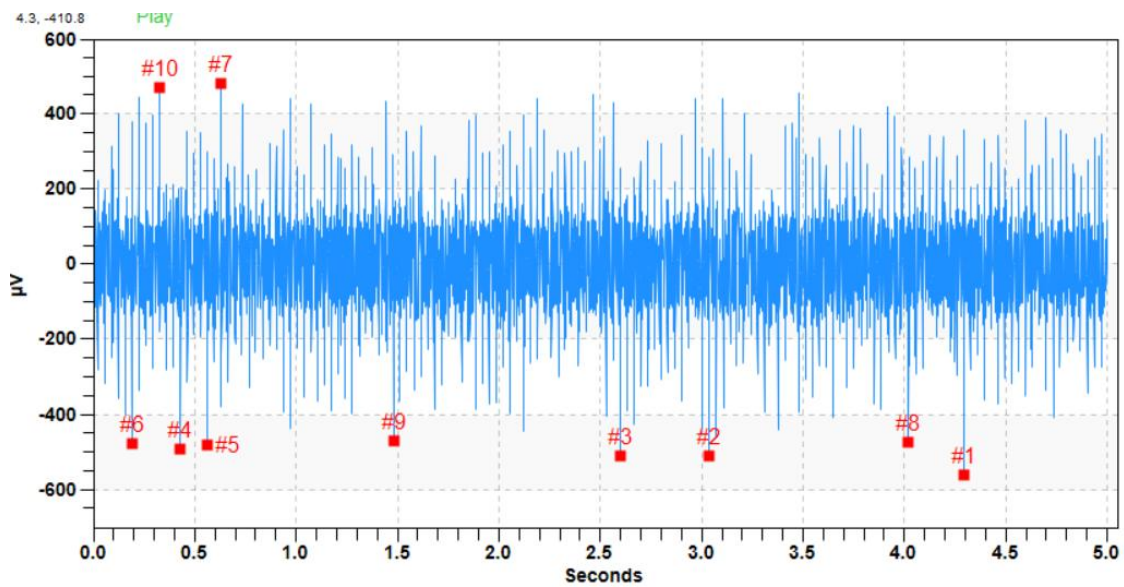
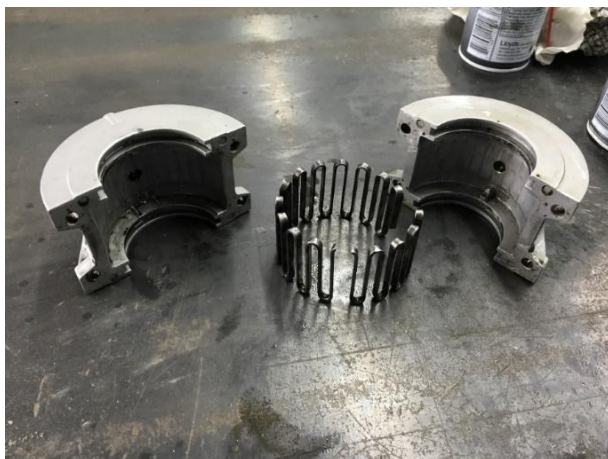
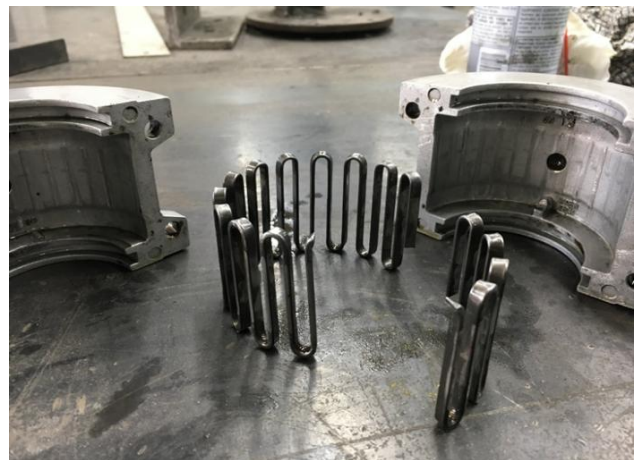
## Grid coupling (broken grid)

Impacting seen at 1 x Running speed with multiple harmonics

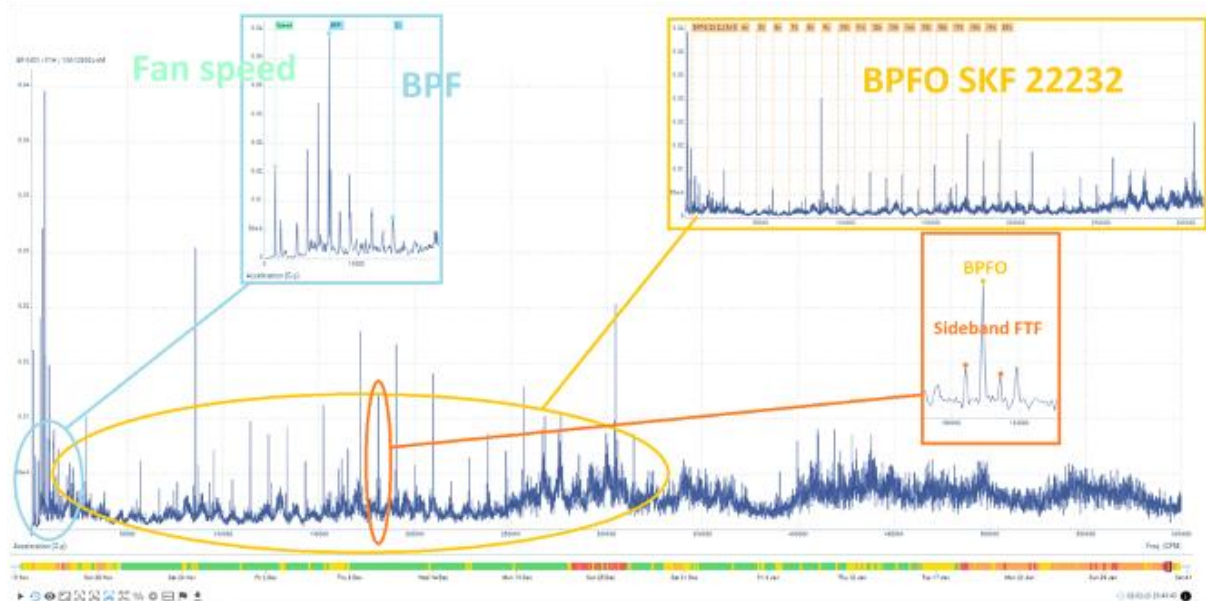
Lead Vibration Analyst, Jonathan Dion takes routine vibration measurements on this plant's critical equipment. Back in 2018, a defect was detected on the pulley side of the fan (SKF 22232). It has since been evolving. Using the acceleration envelope filter in Peakvue, it can be seen clearly.

Window 1 - Max. Frequency 10000hz, Lines 12800, Averages 6 – February 2, 2023

With no plan to replace the bearings until the large-scale planned shutdown in September 2023, the best course of action decided by the reliability team was to install a Vigilant System to continuously monitor the condition of the fans bearings, and hopefully see the assets life extended until the planned shutdown.

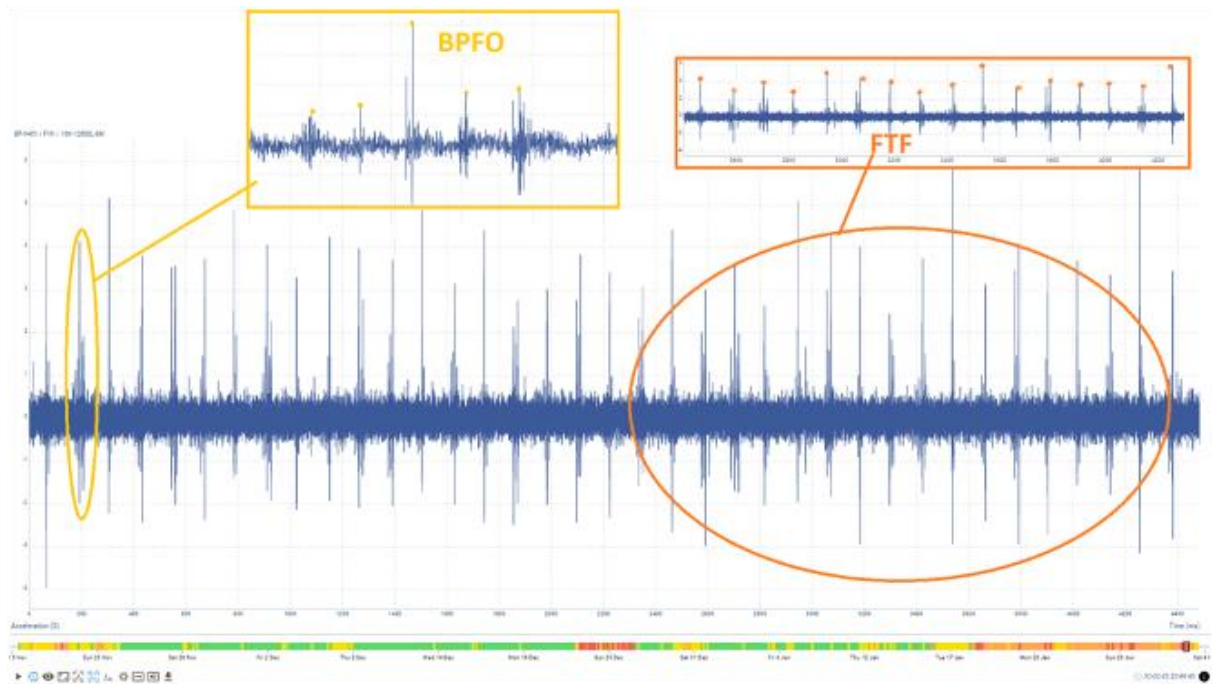
**Window 2 – Time Waveform – Duration: 4.485 seconds – Points: 114817 – February 2, 2023**

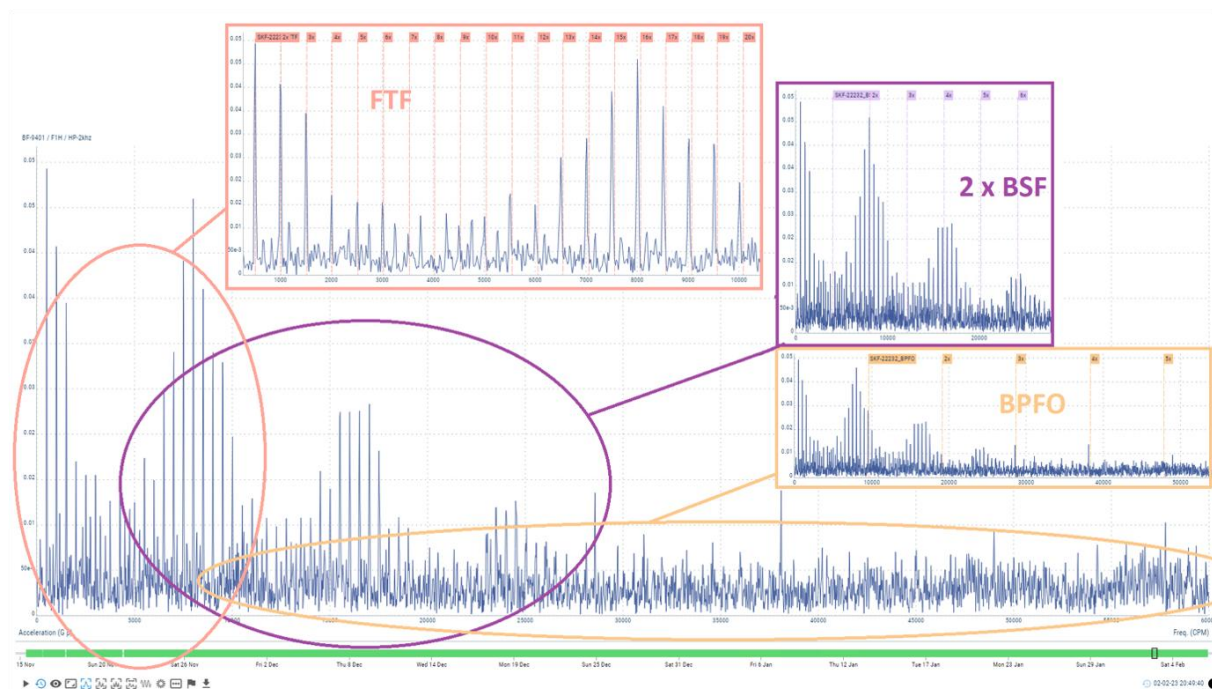
**Window 3 – Envelope Spectrum – High-Pass Freq. 2000hz, Max. Freq. 1000hz, Lines 3200, 1 Average – February 2, 2023**

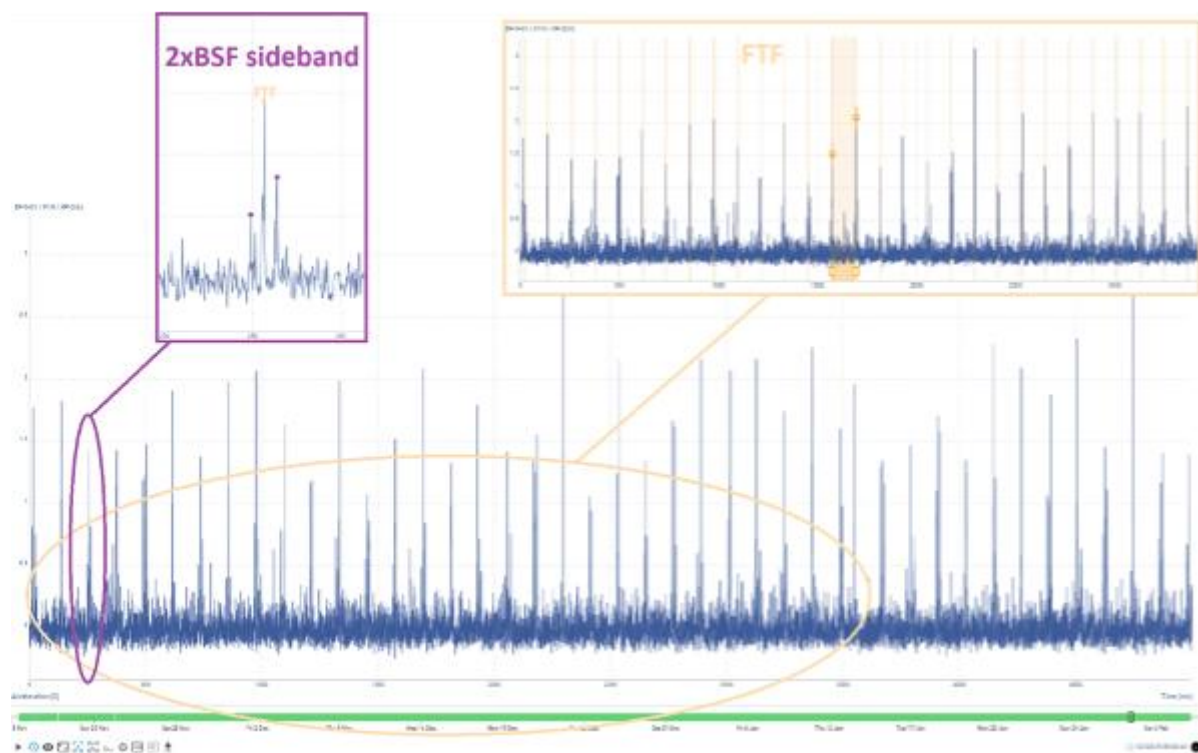
**Window 4 – Envelope Time Waveform – High-Pass Freq. 2000hz, Duration: 5.05 seconds – Points: 12800 – February 2, 2023**

With the Vigilant system in place, constantly monitoring the condition of the fans faulty bearing, the maintenance and reliability team at Greenfield Ethanol can safely extend the life of this fan, possibly even until the next scheduled shutdown in September 2023.

But just in case, alarm management was set up with the plants DCS to trigger email alerts if the condition of the fans bearings decreases to dangerous levels.

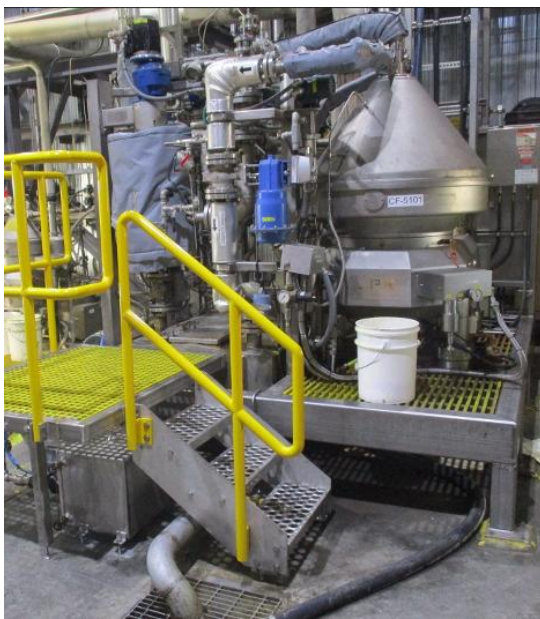
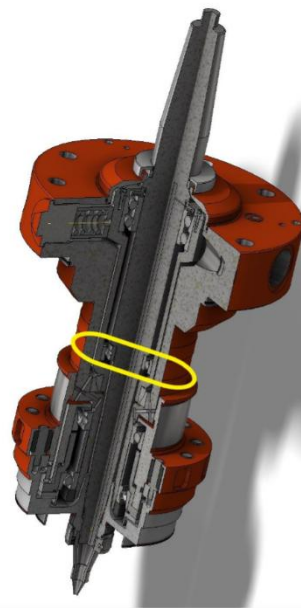
This centrifuge in question rotates at 5250RPM, and it has a suspected bad bearing. The following Figure 1 & 2 depicts the bearing & the asset.

**Figure 1 - Centrifuge - Greenfield Ethanol**

**Figure 2 - Centrifuge Diagram - Bad Bearing in Question**

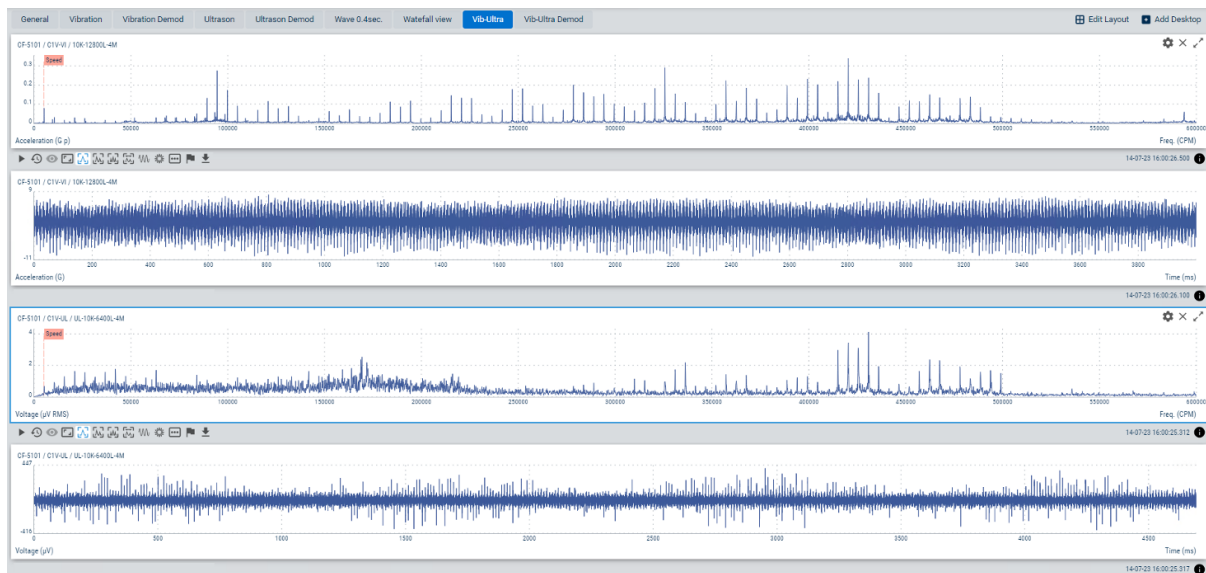
For the next few months, the bearings condition continued to slowly deteriorate in the ultrasound spectra. It was eventually visible and well defined in the vibration spectra and demodulated spectrum, as seen in the data in Figure 4 & 5.

Figure 4 - Vigilant Dashboard - Ultrasound & Vibration Spectra

The severity of the problem has clearly increased since it was first discovered with ultrasound. It is now visible in the vibration spectra, showing a ball pass frequency outer race defect with 1x rpm sidebands.

A similar situation arose at his plant. He discovered a bad bearing on a centrifuge using his SDT Ultrasound Data Collector. The fault was not yet visible with his vibration analysis tools. No cause for concern yet, the bearing had a lot of life left, but it was in the early stages of failure. Still, no reason to use unplanned downtime to replace the bearing. The plan is to replace the bearing during the next scheduled shutdown. Please see the DIPF curve in Figure 3.

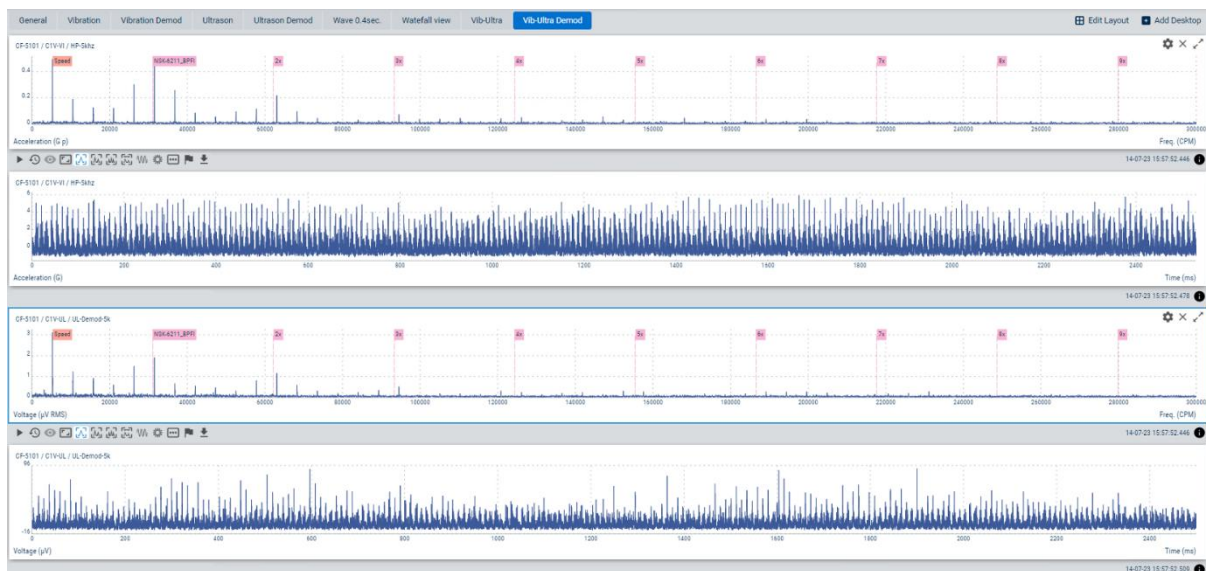
Figure 5 - Vigilant Dashboard - Ultrasound & Vibration Spectra Demodulated

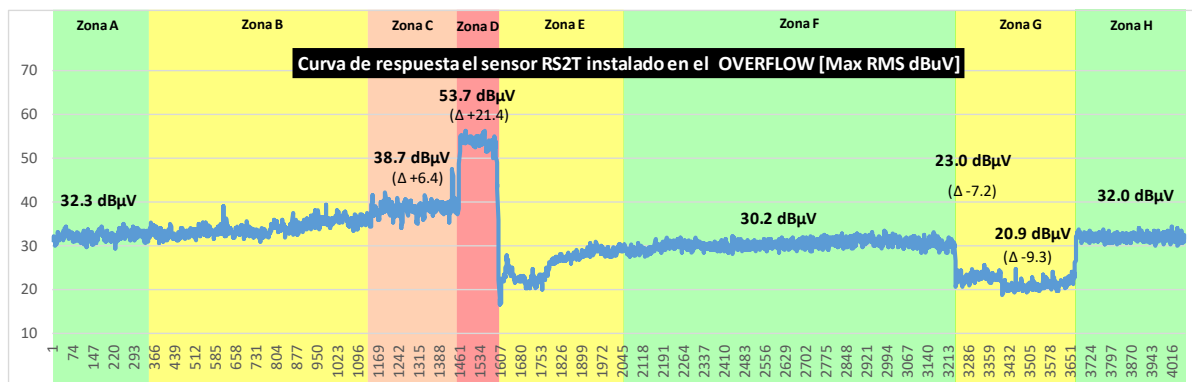
Figure 3: Preliminary Test Data

- Zone A indicates normal condition
- Zone B, C, D indicates sanding as it is intentionally induced gradually
- Between Zone D & E – Clogging occurred, the Emergency Stop was triggered
- Zone E – Process was restarted after the clog was removed
- Zone F – Normalized operation was achieved again
- Zone G – Flow was intentionally decreased
- Zone H – Normalized Operation was achieved again

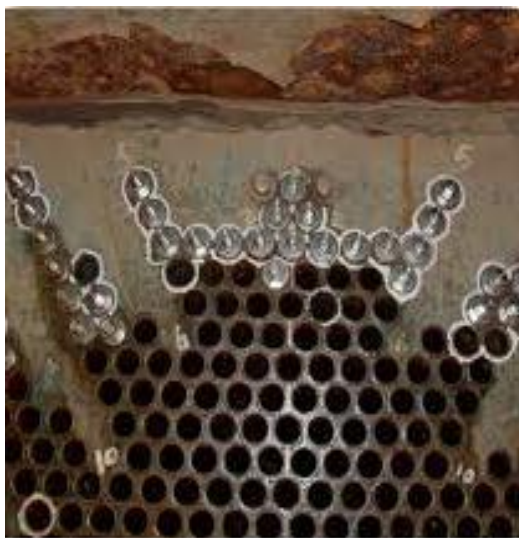
**Figure 3 - Leaking tubes are identified and plugged**

The other action choice is to identify the leaking tubes and plug them; effectively removing the leakers from service. This is the better solution because it treats the cause. But it too carries downside.

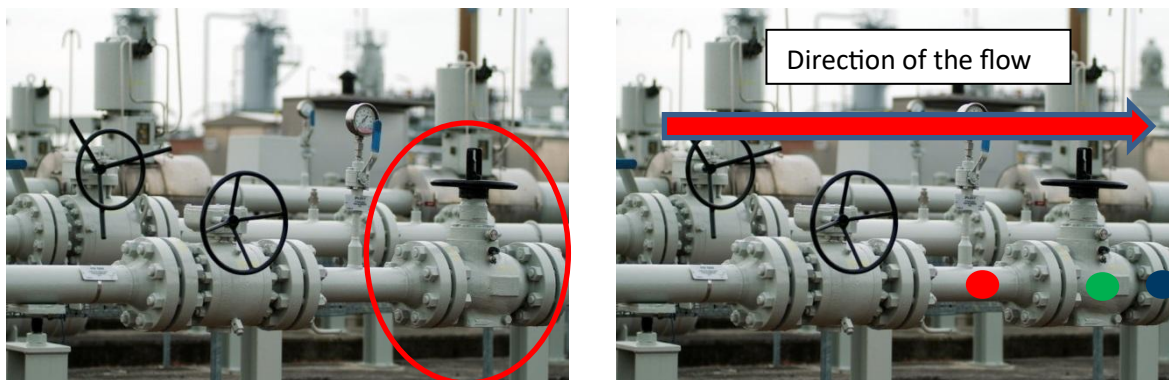
With an SDT detector, valve testing involves placing a contact sensor at three points: upstream, on the seat and downstream of the valve. Diagnosis is quick and immediate, based on a comparison of the 3 measurements. A rise in pressure on the valve seat indicates that the valve is leaking. This is confirmed by listening: the operator actually hears the leak.

Inspection of a pressure reducer on a natural gas installation. measurement

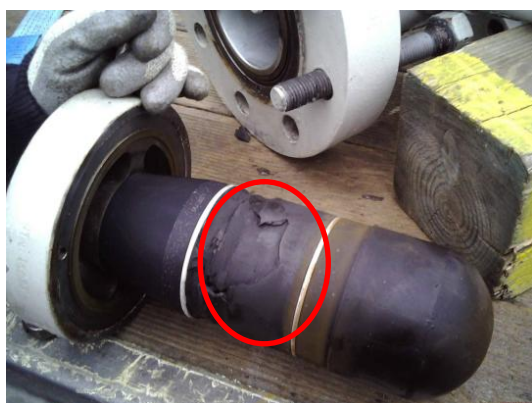
The customer's assessment after dismantling the regulator

In this example, the customer is a natural gas supplier and distributor. The company's maintenance department only visually inspected its valves and regulators. When they dismantled this equipment, they could never be sure that they were dismantling a component that could be considered a leak. This on-site demonstration highlighted the effectiveness of ultrasound measurement in finding a defective component quickly and efficiently.

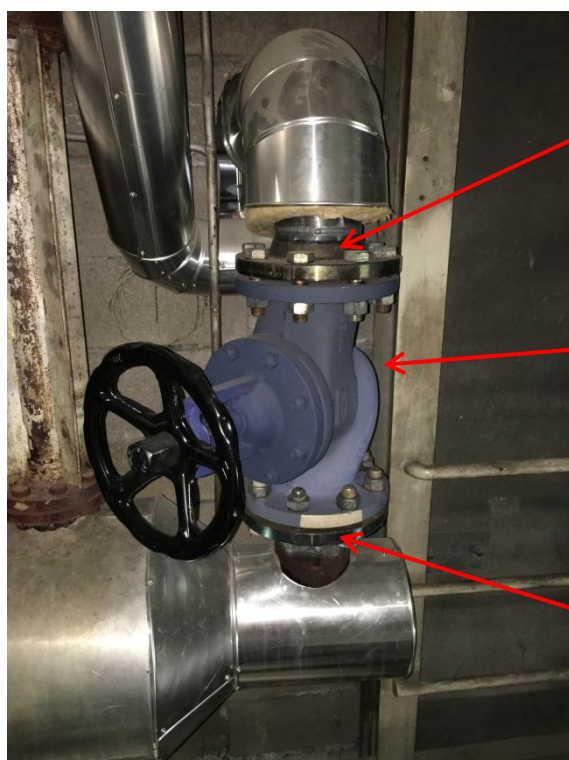
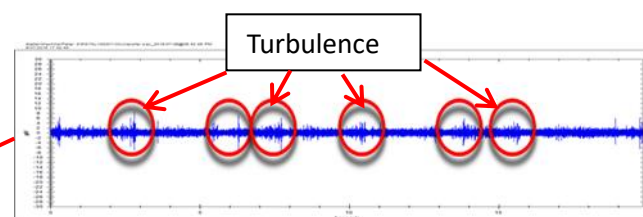
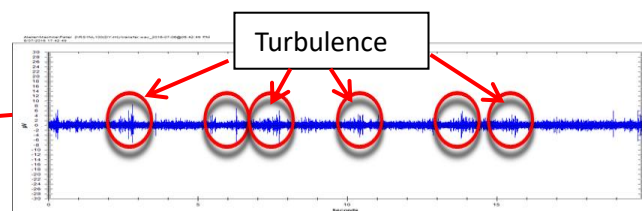
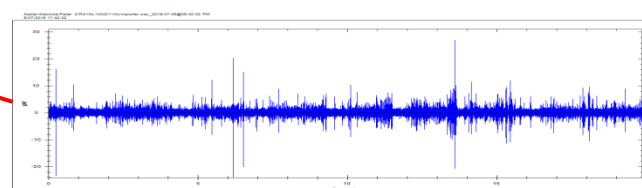
Below is a second example of a leak test on a steam valve in a boiler room at a cardboard plant.

Turbulence on the steam valve seat and downstream of the piping (highlighted on the spectra above), demonstrates that this component is leaking. This enabled the Maintenance Manager to confirm the failure of this component, which could cause a problem in the boiler room process.

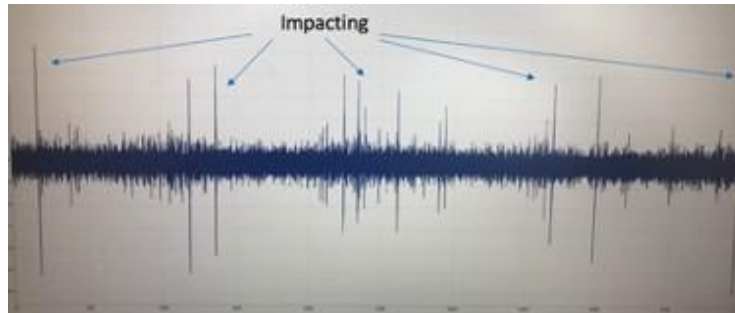
Planetary Bearing - As expected from the initial vibration data, ultrasound reading confirmed the presence of impacting.

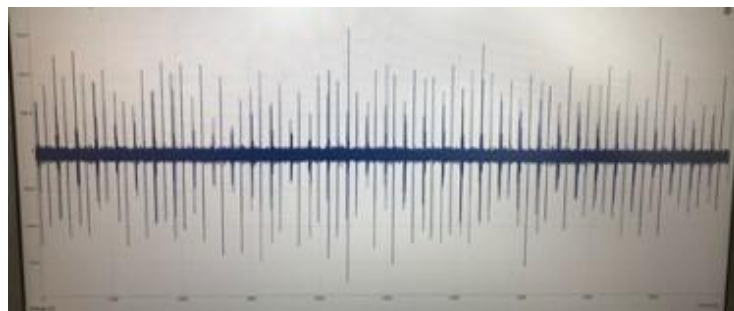
Slow-Speed Main Bearing - The initial ultrasound reading on the main bearing came back higher than expected with lots of impacting. SDT's recommendation was to lubricate the bearing. Ultrasound decibel levels dropped afterwards, indicating a reduction in both friction and impacting as seen in the figure below.

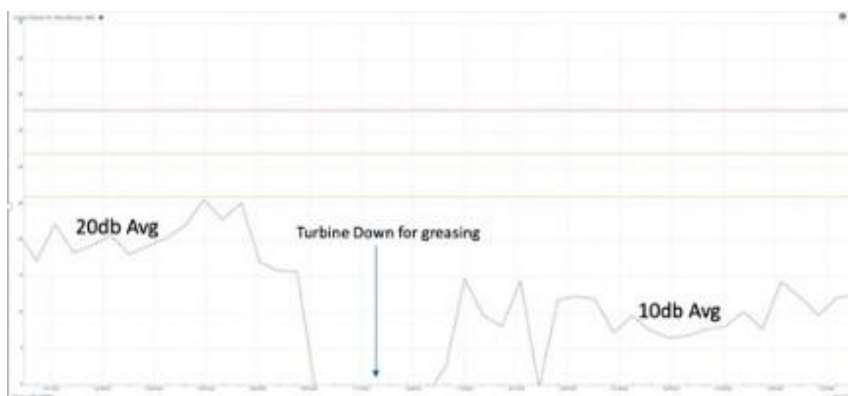
Slow-Speed Main Bearing, Before and After Greasing

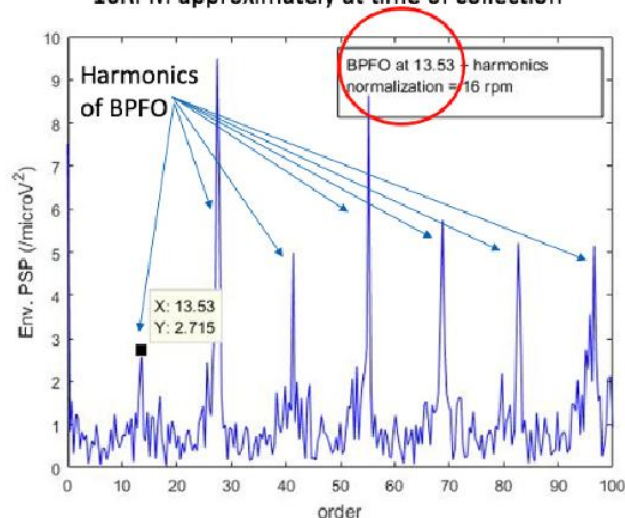
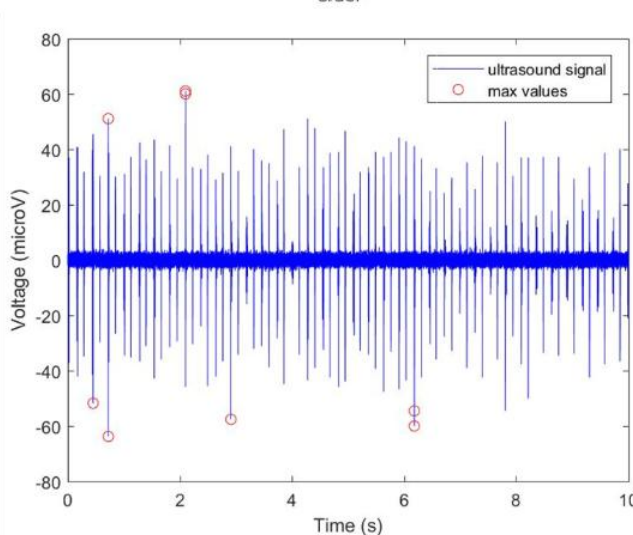
Additional analysis was conducted on the main bearing. Repetitive impacts were discovered at a BPFO of approximately 13.5x running speed, consistent with an outer race defect. SDT's recommendation was to closely monitor the condition of the main bearing. The defect will eventually result in the main bearing needing to be replaced.

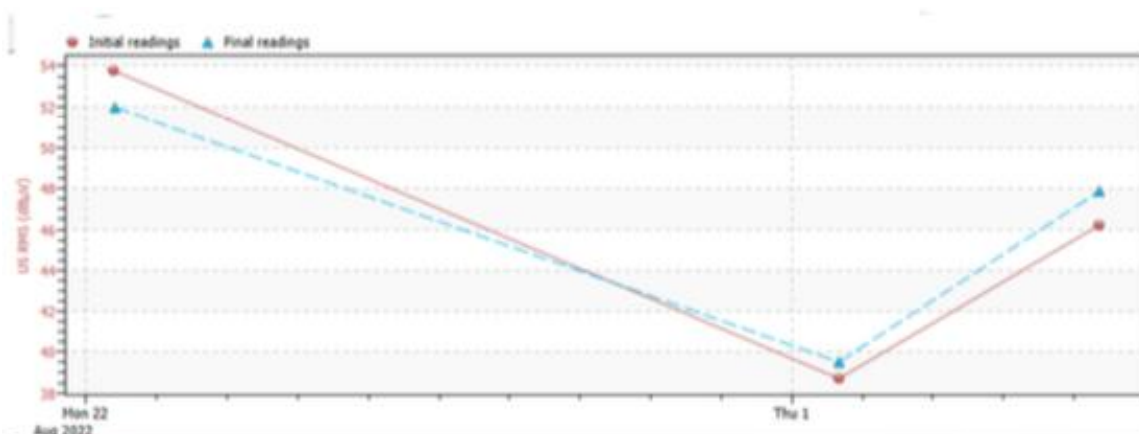
Drive End – September 5

As seen above, lubricating the drive-end bearing increased friction, indicating over-lubrication or a suspected bearing failure. Lubricating the non-drive-end bearing drastically reduced friction indicates a lubrication success. However, the LUBExpert still issued a suspected bearing failure warning on the non-drive-end bearing. This additional analysis from the LUBExpert was backed up by the vibration analysis performed by Khaled, which indicated mechanical looseness, as seen in the harmonics of the impacts in the vibration spectra below.

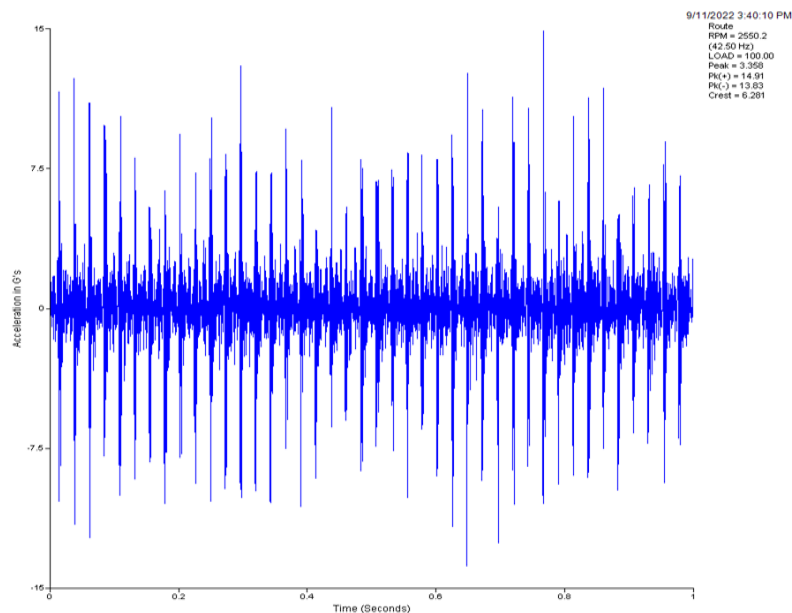
### Waveform – September 11

As seen in the vibration data, the bearings were in a failed state due to mechanical looseness and required replacement. They were replaced during the next shutdown, and new vibration measurements were taken on the machine. As seen below, the overall RMS went from 8.2 to 2.7 after the bearings were replaced.

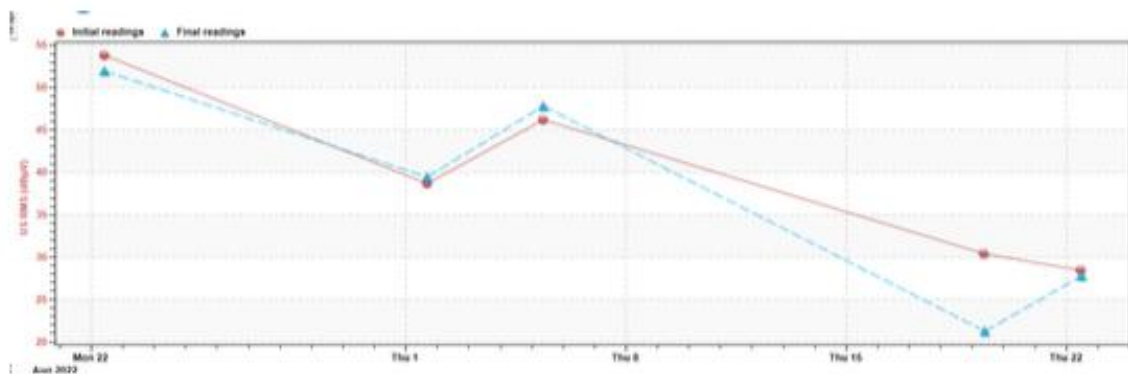
**Drive-End – September 22**

After the bearings were installed on September 18, they were lubricated successfully 4 days later on September 22 using the LUBExpert Static. The data can be seen below!

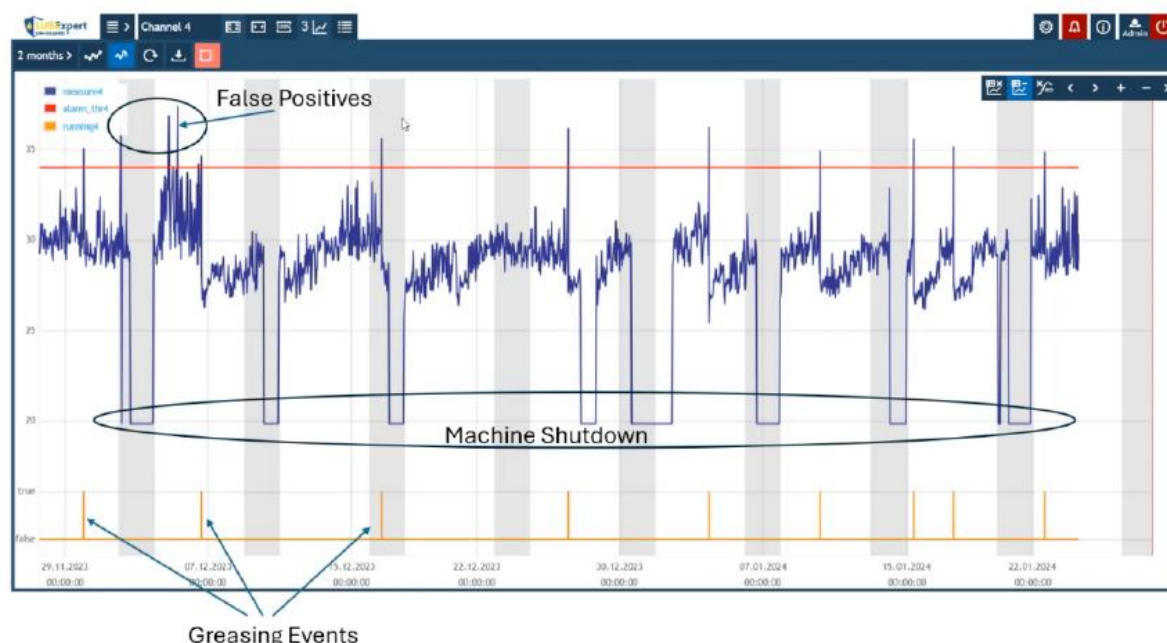
**Figure 2 – ON-GUARD Dashboard – Asset 2 Month Snapshot**

The ON-GUARD was installed on these assets roughly six months ago. This case focusses on a two-month snapshot of these assets. In Figure 2 we can observe the two-month trend of one of these fan

bearings. In the two months, the ON-GUARD triggered nine greasing events when the asset surpassed its designated alarm threshold.

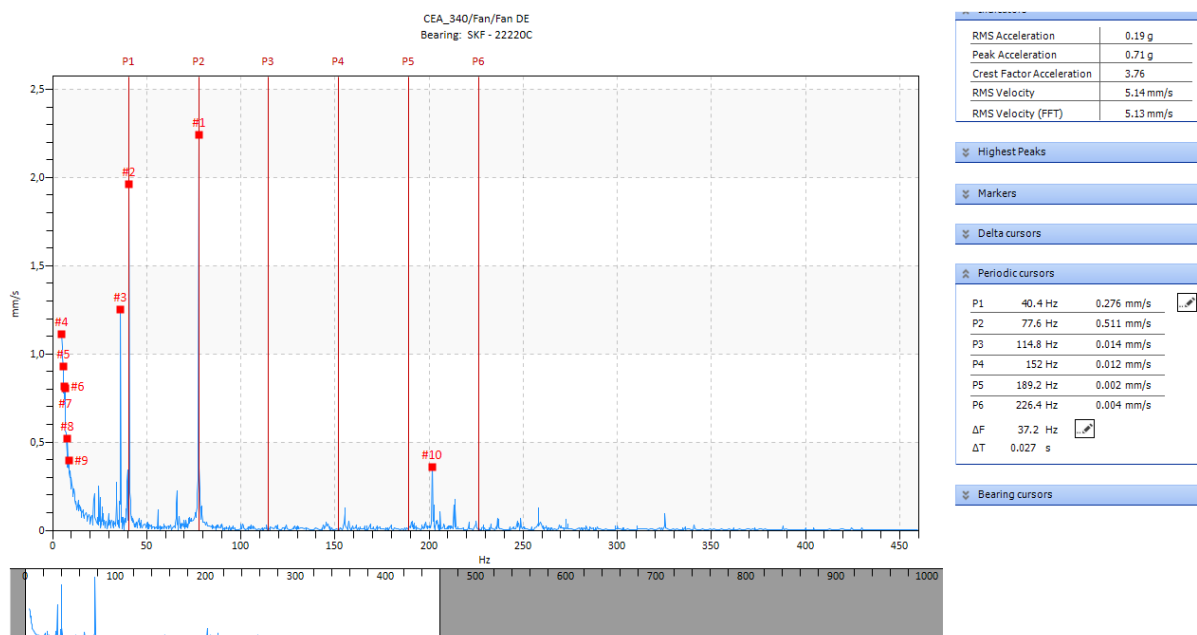
- Interpretation:** No significant concern was observed in the measurements taken from the motor bearings, but the spectrum of the bearing at the fan pulley side, measured at 78 degrees, shows dominant 1x and 2x signals, indicating a possible misalignment issue. Checking the belt tension, alignment, and bearing axes would be beneficial.

- **For Motor 1:** After checking the belt tension, alignment, and bearing axes for the potential misalignment issue, if the peaks increase as the frequency increases, bearing damage may be progressing. It is recommended to re-lubricate the motor and repeat the measurements.
- **For Motor 2:** If the frequencies are very high and the peaks are large, bearing replacement should be scheduled. The operation of this motor should be monitored and reassessed after further measurements.

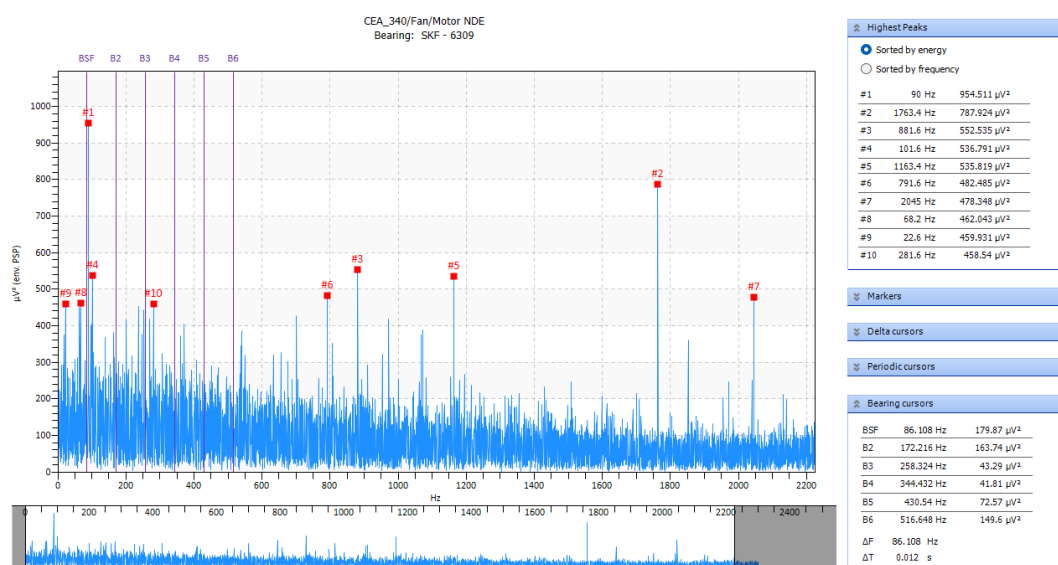
Motor NDE

- Interpretation:** The motor body temperature was measured around 75 degrees, and while the vibration values are within acceptable ranges (around 2.5mm/s to 5mm/s), the ultrasound values measured for bearing condition are at warning levels, with dominant signals in the spectrum matching the bearing ball and outer race fault frequencies. In addition, the measurements taken from the fan's rear bearing suggest an early stage of bearing damage. General motor maintenance and bearing replacement are recommended, while the fan bearing should be monitored with interim measurements.
