# SUCCESS STORIES

## Paper Mill

# Implementation of an ultrasound-based preventive maintenance program on rotating machinery

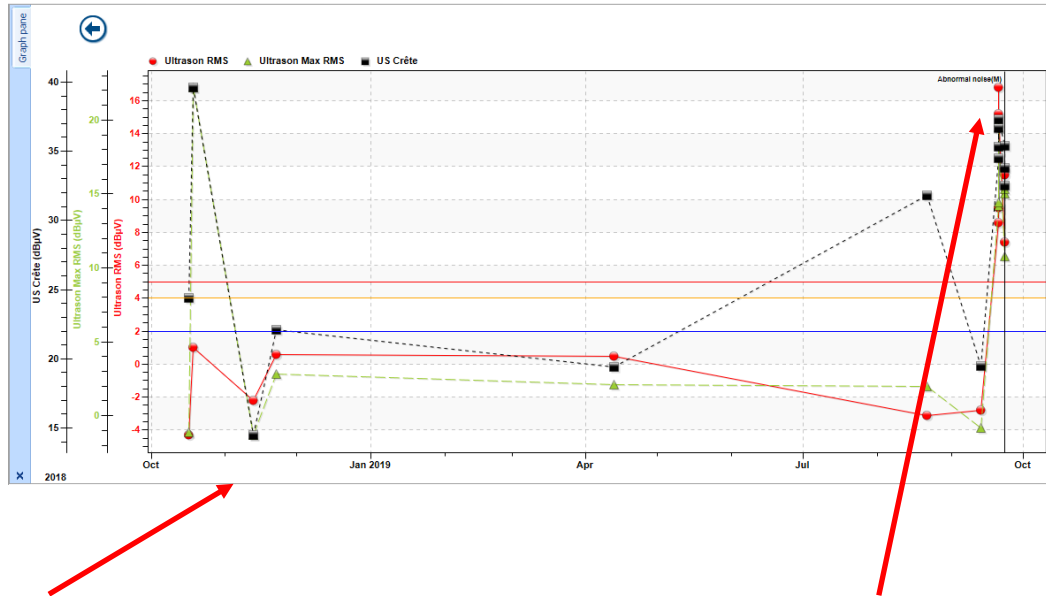
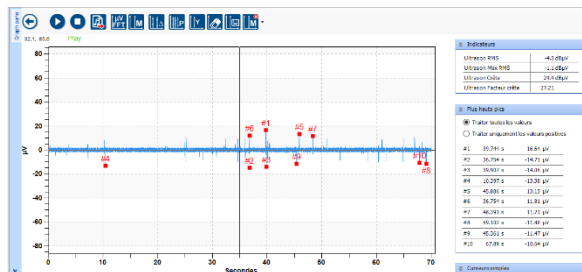
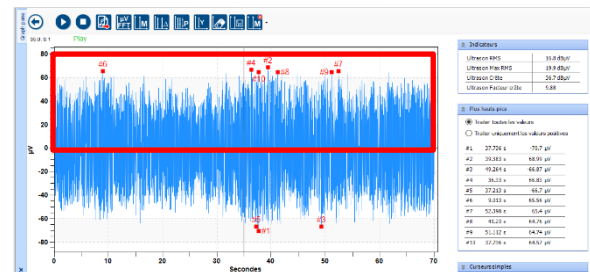
- Machine: **Decanter – High-speed input bearing of the reduction gear**

Measurement carried out on October 16, 2018

Measurement carried out on September 20, 2019

Based on SDT criteria, this increase corresponds to the early failure of a mechanical part of the reduction gear (bearings and/or gears).

Listening to the bearing and analyzing the frequency spectra (see chart below) has allowed to confirm this diagnosis by observing the emergence of significant peaks associated with this gear damage.

We can observe repeated shocks associated with the frequency of the high-speed input drive pinion of the reduction gear (24.93 Hz and its harmonics) with demodulation at each peak. Broken tooth and teeth clearance. Replacement of the reduction gear during a scheduled production shutdown, which avoided an untimely breakdown which could have generated significant expenses due to production losses.

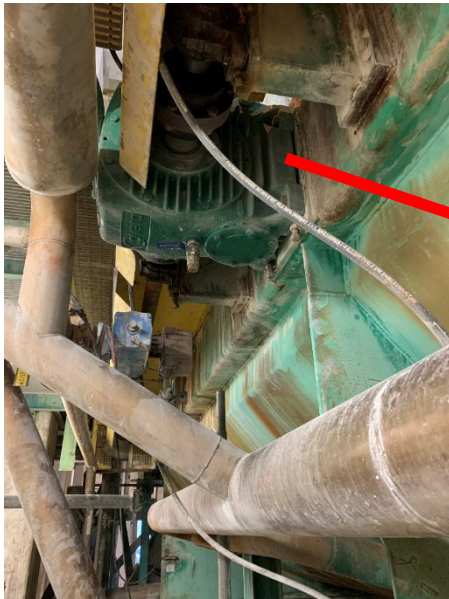
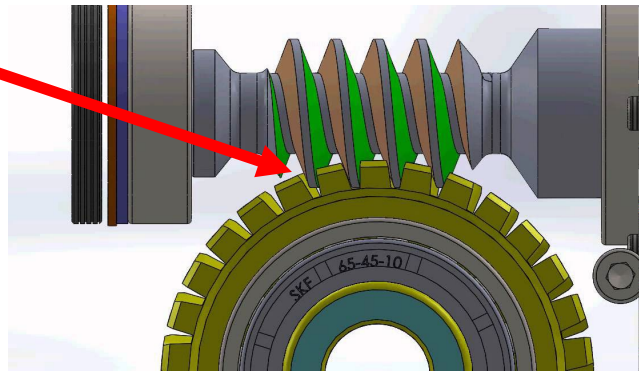
- Machine: **Lime mud filter agitator – High-speed input bearing of the reduction gear**

Wear detected on the tooth of the worm screw of a reduction gear, wheel, and screw:

We can observe that between each revolution of the worm screw, there is a phenomenon occurring, which can be heard through the ultrasound detector as a sliding of the gear (worm screw/bronze wheel).

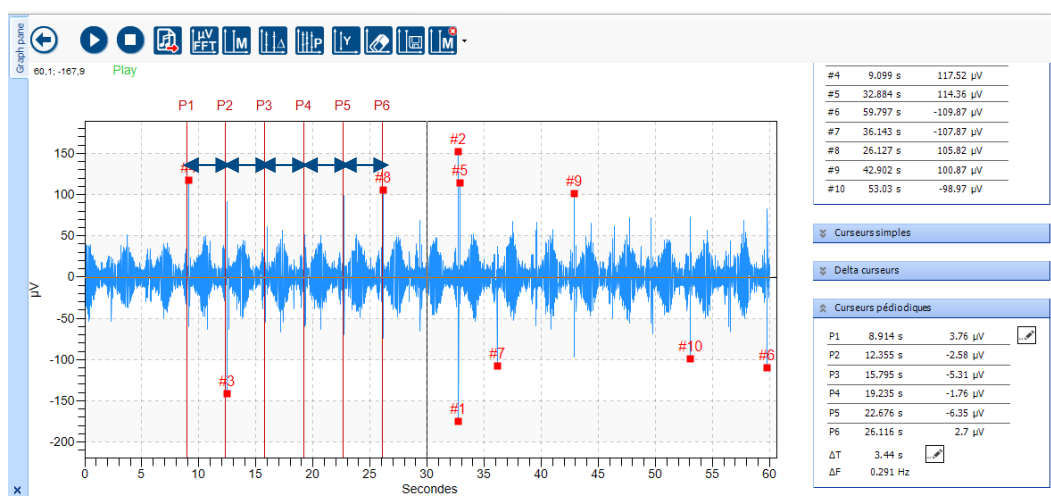
Measurement carried out on December 11, 2016

Zooming in on the envelope spectrum highlights the dissymmetry of the modulation around the meshing frequency, which is characteristic of a damaged gear mesh.

The endoscopic video inspection of the worm screw of the reduction gear confirmed the ultrasound diagnosis.

The customer took the reduction gear down during a production shutdown.

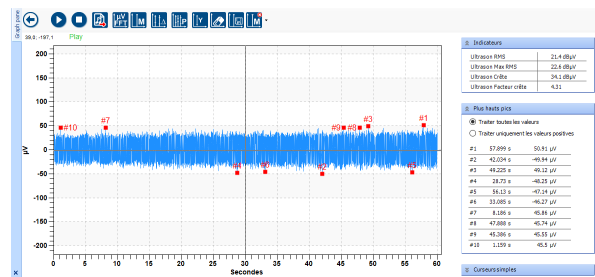
Measurement carried out on October 29, 2019  
After replacement of the reduction gear

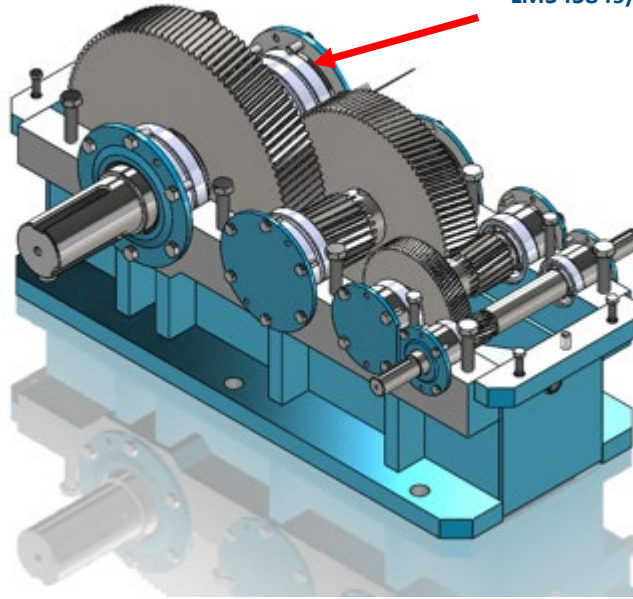
LM545849/545810

From the beginning of the monitoring of this reduction gear (August 2018) using ultrasound technology, the occurrence of shocks can be observed on the time waveform (TWF).

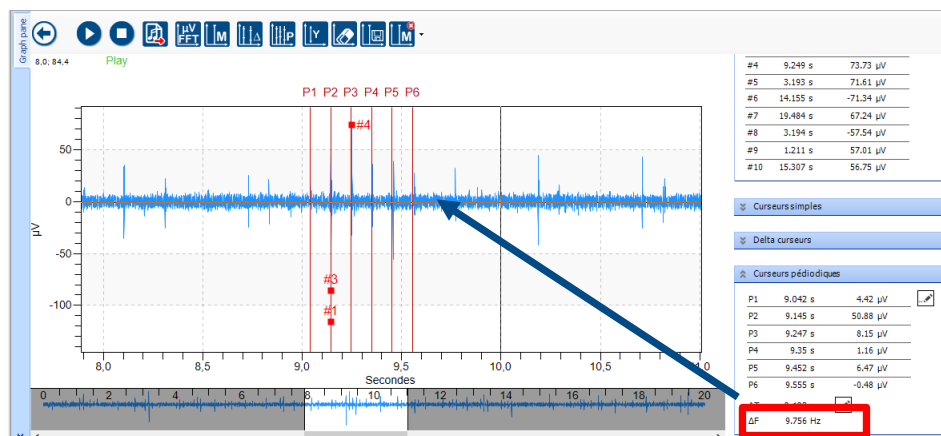
Below we focused on 3 seconds of the measurement, and we apply a periodic cursor to identify peak recurrences.

By looking at the envelope spectrum, one can observe repeated shocks at **9.756 Hz** (see the table of characteristic frequencies below) related to the frequency of the inner ring of the bearing of the low-speed reduction gear (opposite side of transmission).

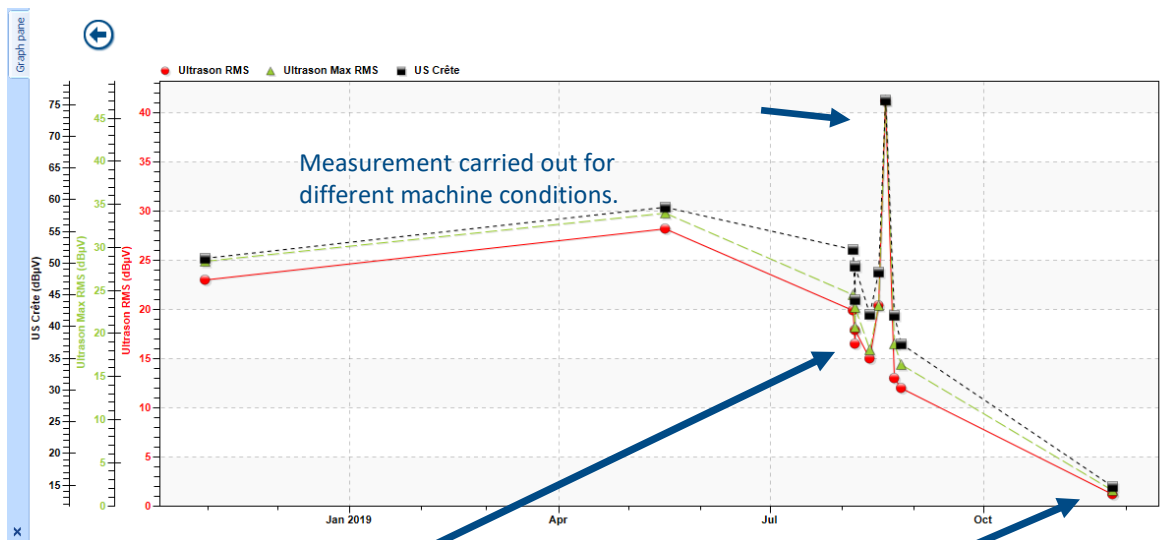
The trend curves show the decrease of the RMS value in red on the graph above, also confirmed by the other indicators, **from +12 dB $\mu$ V in 08/2019 to +1.2 dB $\mu$ V in 11/2019.**

Replacement of the reduction gear during a scheduled production shutdown, which avoided an untimely breakdown which could have generated significant expenses due to production losses.

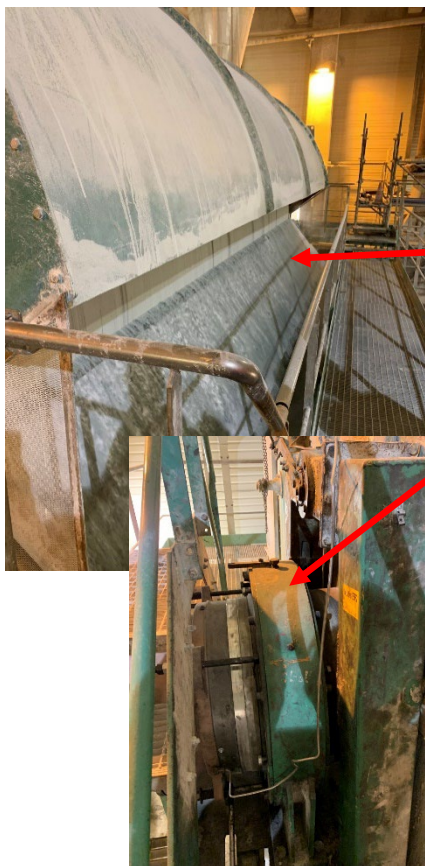
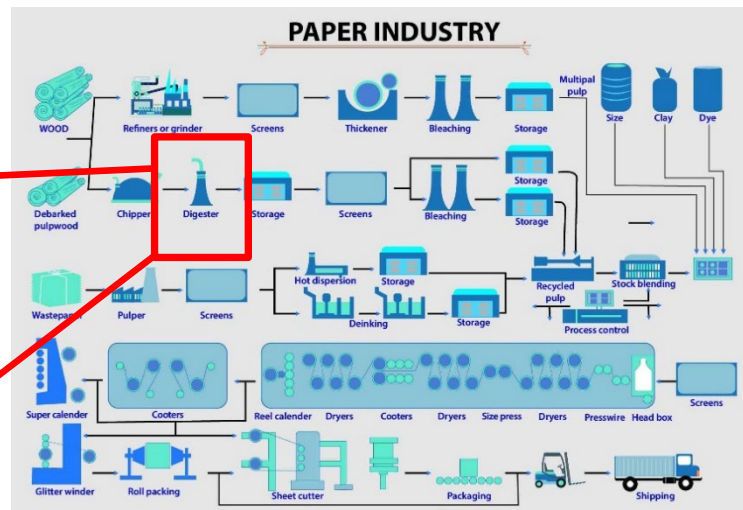
- Machine: Lime mud filter – Bearing opposite transmission 23140 CCK – 14.28 RPM

On the trend, one can observe the occurrence of high value in the RMS right from the beginning of the monitoring of this bearing. After replacement of the bearing, all shocks disappeared. The rolling elements were no longer held in their housings.

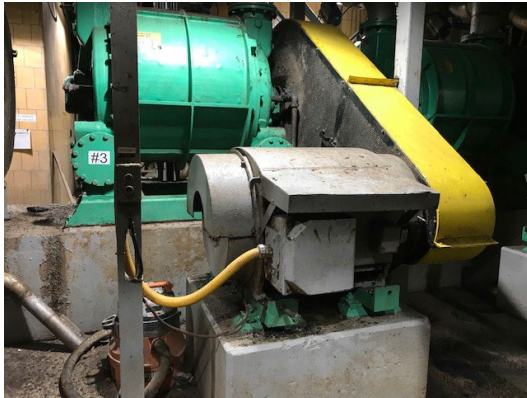
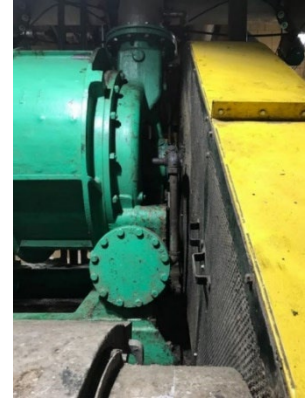
18-hour job to replace DE bearing on scheduled shutdown.  
Crest Factor Alarm

Recommended bearing replacement as soon as possible due to a signal containing high peaks indicating the lifetime span of the bearing.

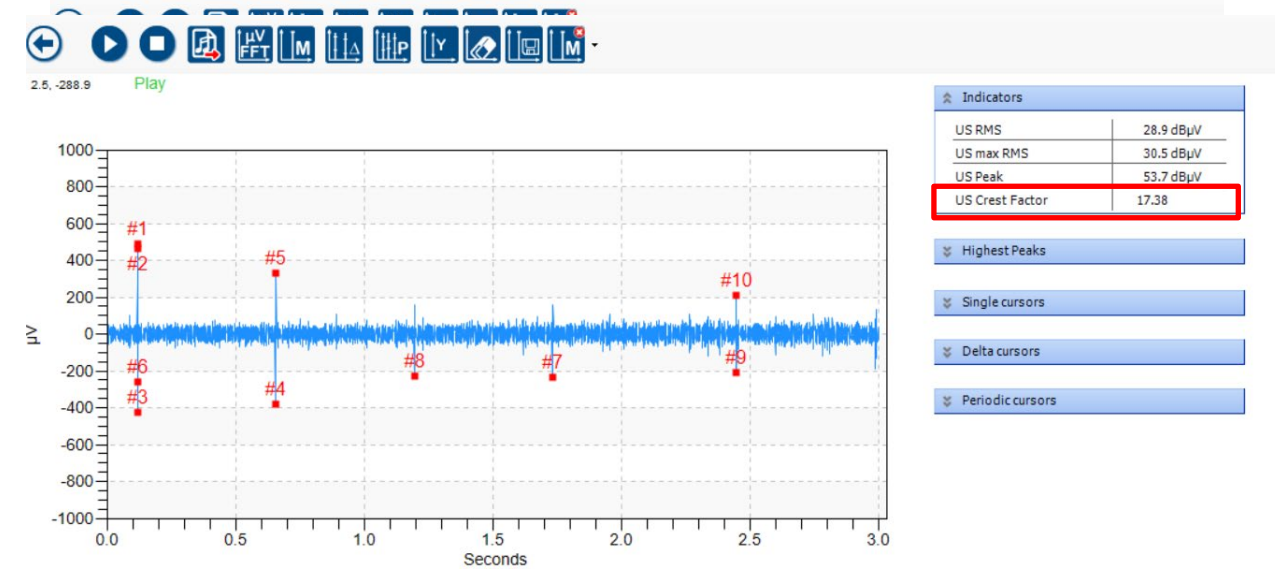
November 14, 2018 – Repetitive Impacting

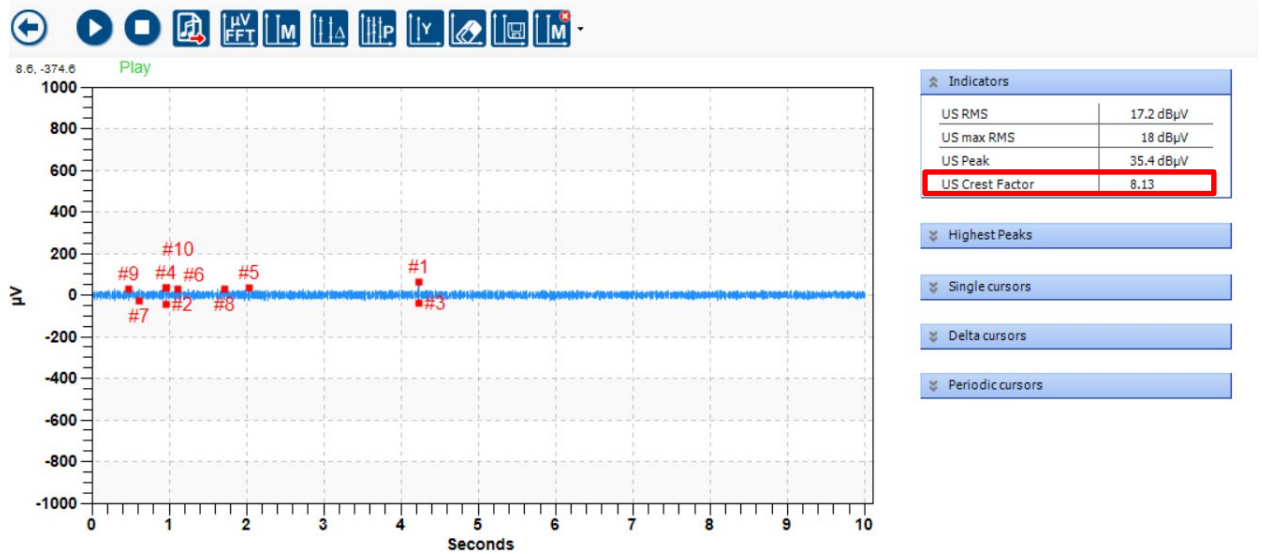
## February 4, 2019 – 3 days later

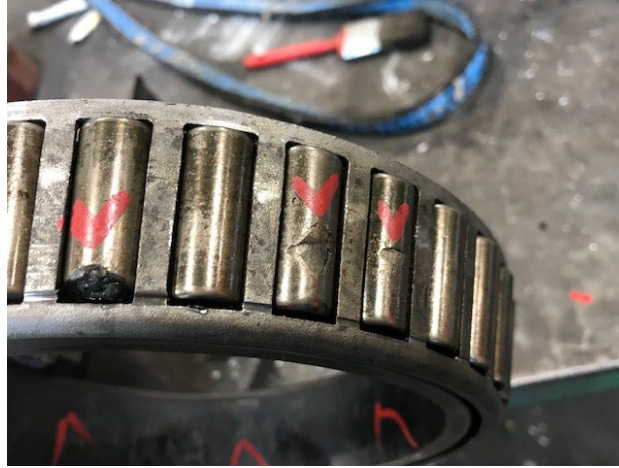
Rolling elements

Images of bad bearing – no secondary damage occurred:

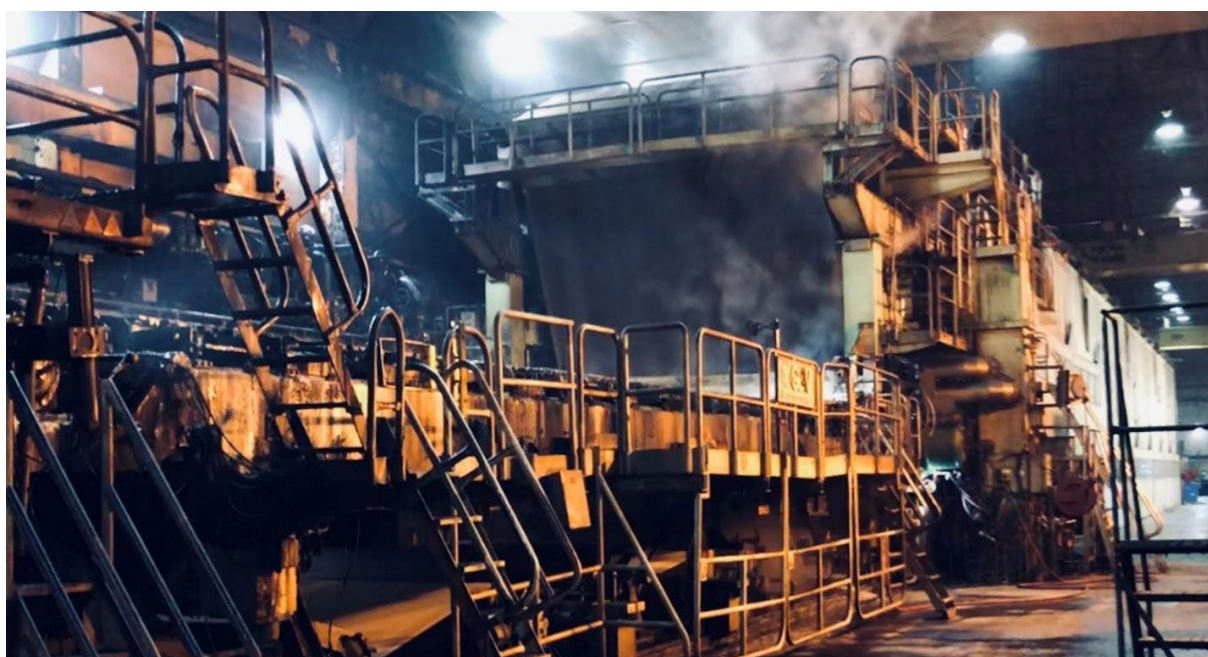
Dryer section felt rolls – previously greased on a time-based schedule delivering 40 grams of grease every 4 weeks before the ultrasound program was implemented.

Ultrasonic greasing program started; first dryer felt roll greased from an RMS of 14.1 dBμV down to 12.2 dBμV after delivering only 20 grams of grease.

One month later, approx. 4 weeks to respect the established lubrication program, ultrasound shows the RMS has increased to 17.2 dBμV, again the bearing is greased, this time delivering 25 grams total quantity to reduce to 11.7 dBμV.

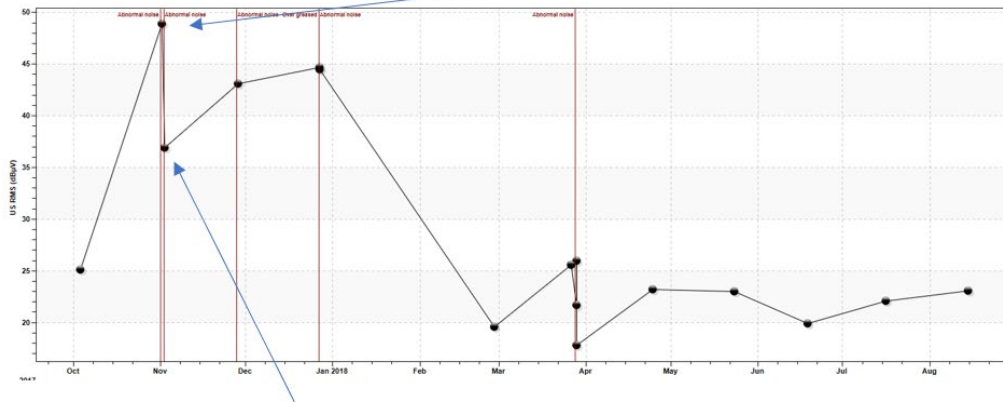
Problem identified by ultrasound on November 1<sup>st</sup>.

Ultrasound Trend - high RMS ultrasound values in early November

Bearing greased on November 2<sup>nd</sup>.

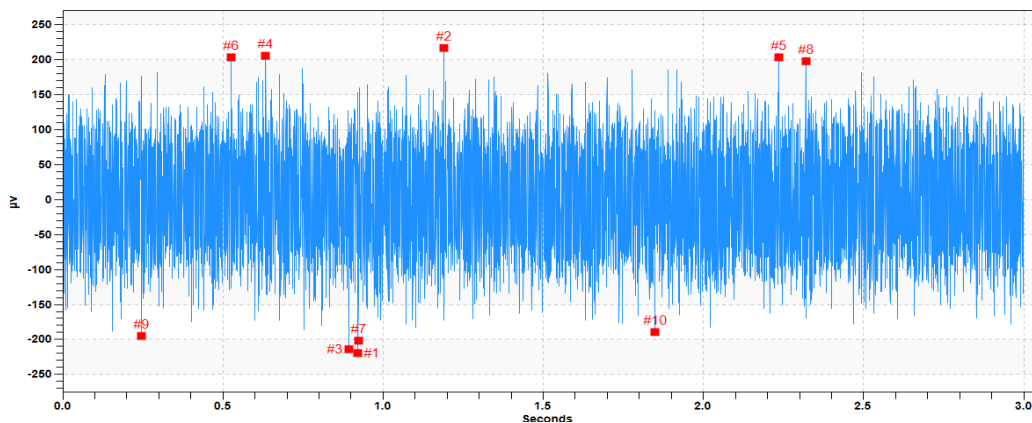
Ultrasound reading after greasing on November 2<sup>nd</sup>:

Ultrasound levels decrease as predicted.

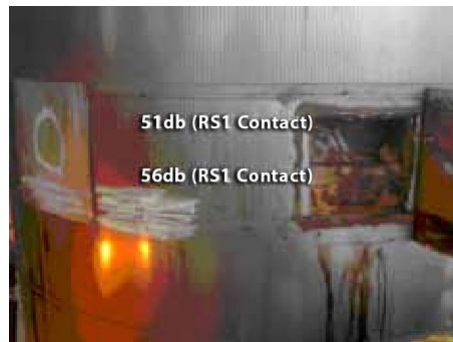
As the additional pictures below will show, there was a strong correlation between the locations of the leaks and the thinning of the wall of the stack. At the location of the highest ultrasound, 51 dB, the wall was found to be 0.091" thin. The thinnest area found on our initial survey.

**Wall thinning correlated to high dB values.**

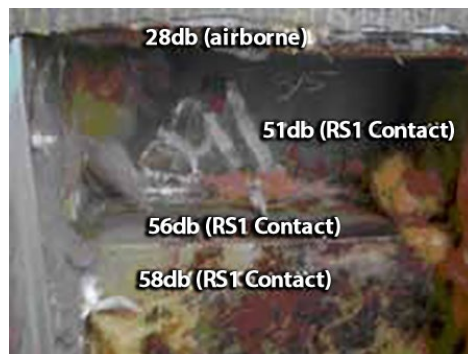
With the ultrasound level increasing as we recorded contacts close to the bottom, I changed from the contact probe to the airborne sensor. Ambient ultrasonic dB levels were 18 dB around the stack. When I brought the airborne sensor near the 51 dB access door, the airborne sensor jumped to 32 dB – 33 dB and gave the telltale whooshing sound of rapidly moving air. When I used my hand to separate some of the insulation away from the metal flange, the airborne sensor levels rose to 38 dB.

It was decided that we would need to have a larger area open for inspection.

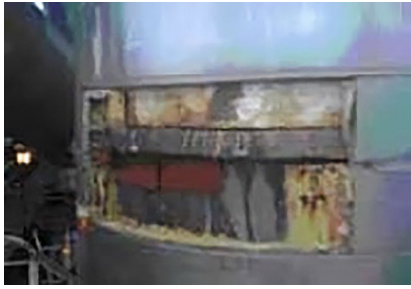
The exact number of holes was too numerous to count. Also, many of the holes had blended together from the corrosion.

Mr. Rose recommended applying Gor-Tex™ sheets sealed with silicone to affect a strong, yet temporary repair. The decision was to strengthen and seal the holes so that the process could continue until a planned outage in March 2010. At that time a complete repair/replacement could be implemented.

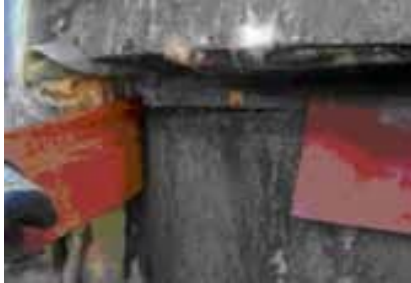
The areas below where the holes were discovered clearly show how the stack is wearing out. 0.077" was the thinnest area found without actually being a hole.

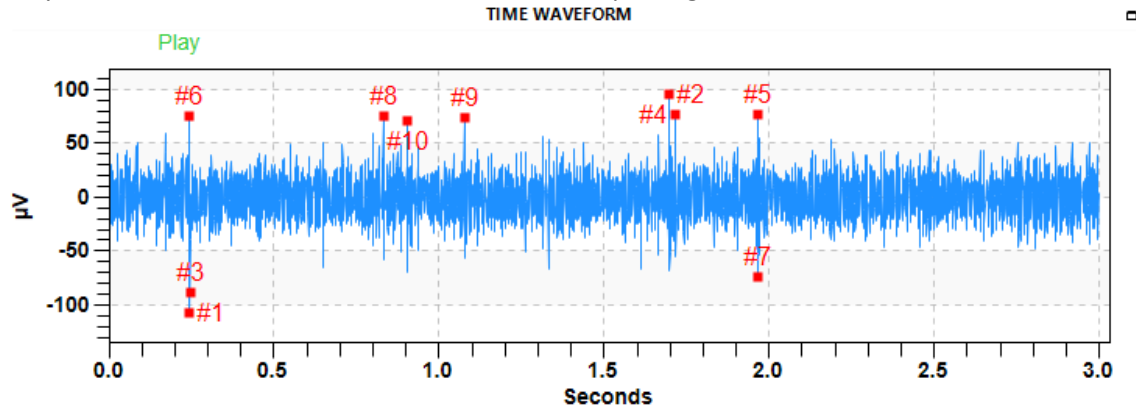
May 3<sup>rd</sup> – Greased Bearing. Reduced Friction.

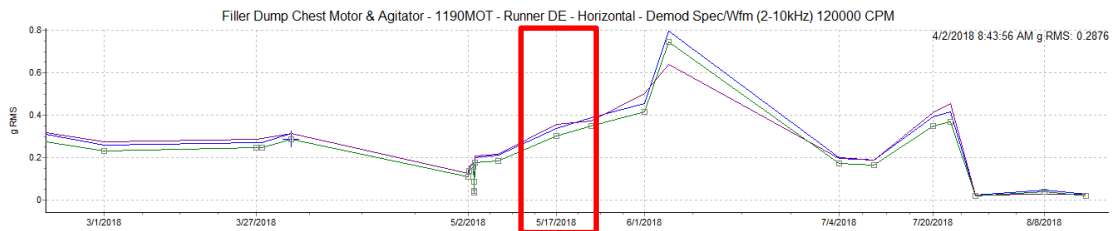
The g RMS trend from vibration shows increasing levels around middle of May confirming Ultrasound findings of a defective bearing.

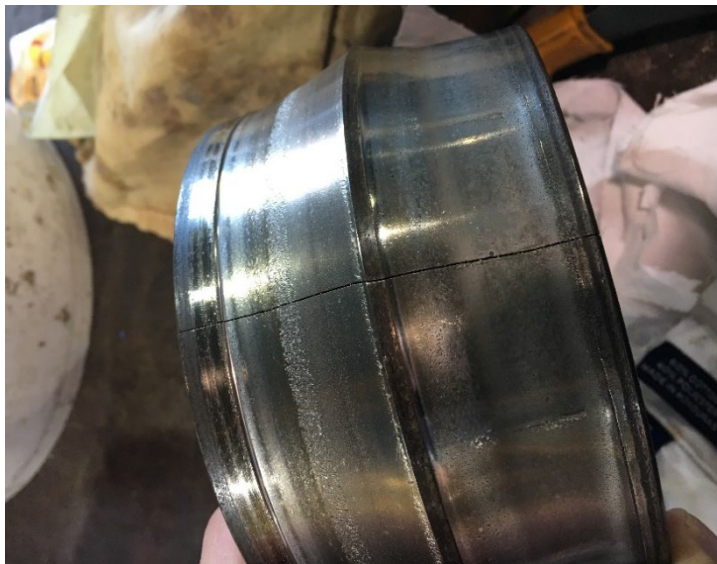
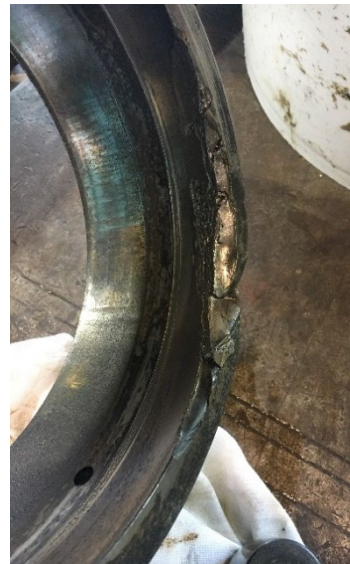
Pictures of the DE Agitator Bearing after it was removed on July 24<sup>th</sup> shutdown:

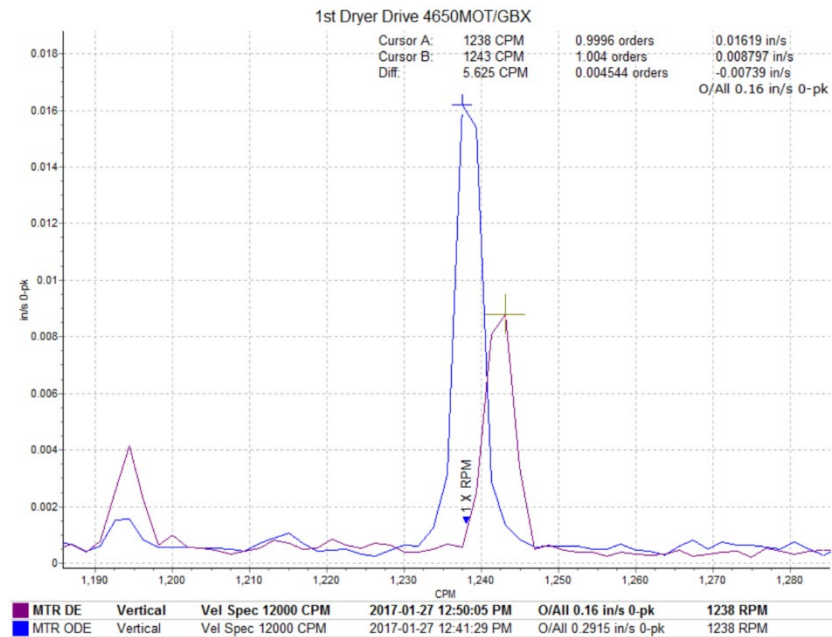
The two spectrums below illustrate the variation in speed on the motor. The first is on the DE and the second is on the ODE vertical.

It should also be noted that on this motor the encoder shaft coupling had been replaced due to a failure.

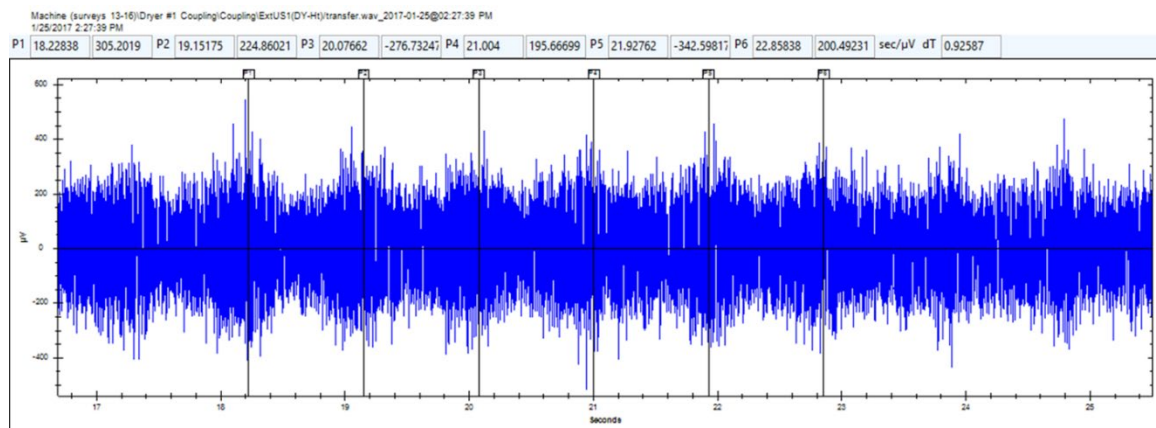
Ultrasound readings were also taken on the output coupling. It was generating a pulsating noise which was repeating every 90 CPM or at the output speed of the gearbox possibly due to the variation of the load on the coupling due to the variation in speed.

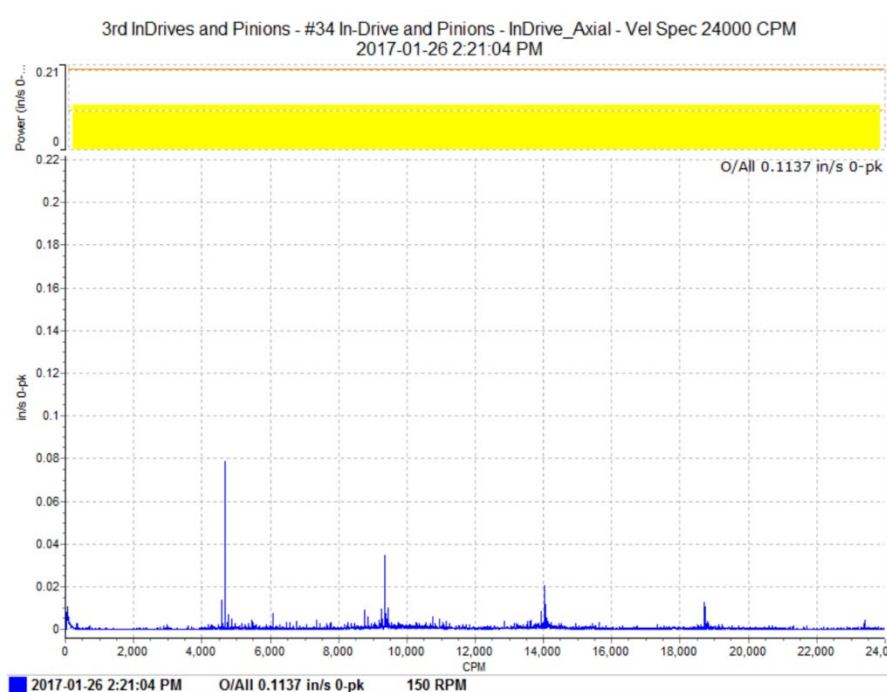
There is also evidence that there is a misalignment condition between the output of the gearbox and the In-Drive.

Gear Misalignment is probably the most prevalent cause of gear failure. Typically, this results from coupling misalignment between the input and/or output drive systems and the mating components. This produces Gear Mesh Frequencies (GMF) and sideband frequencies, spaced out at the rotating speed of the faulty gear. Gear misalignment can also occur internally if the gear shaft support bearings are not properly aligned with respect to one another. While not common, this problem will usually lead to premature bearing failure before gear problems are considered severe.

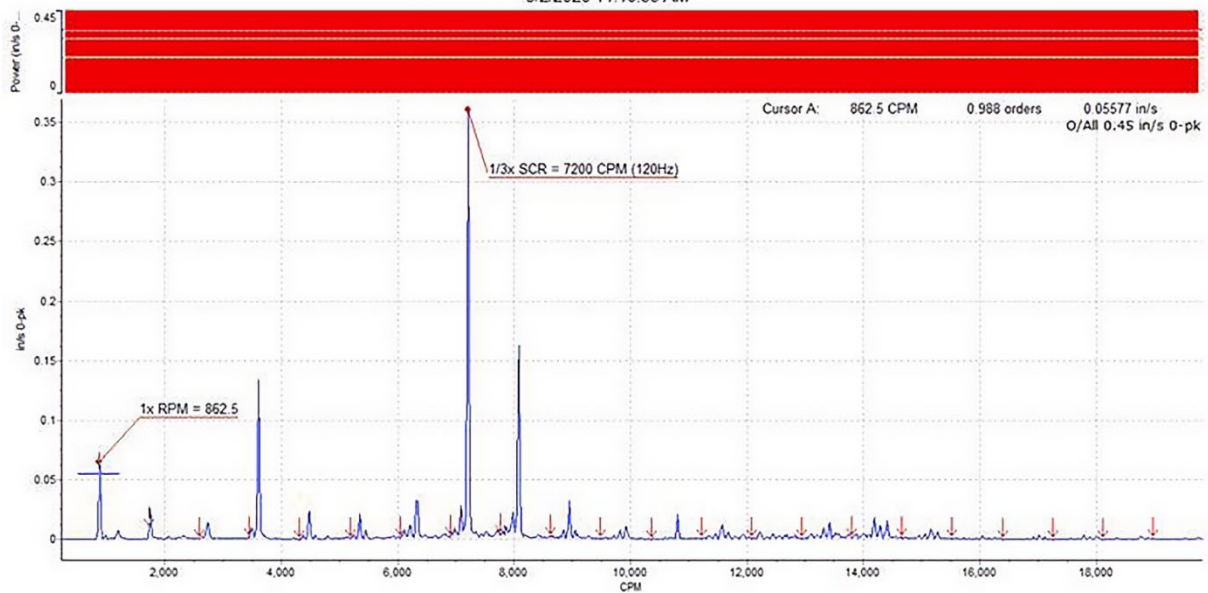
Fan Pump 52-31-08 A - MTR DE - Axial - Vel Spec/Wfm 120000 CPM  
9/2/2020 11:10:55 AM

When a firing card fails, then 1/3 of the power is lost, resulting in momentary speed changes in the motor's rotation. This can lead to high amplitudes at 1/3X and 2/3X SCR frequencies. As you can see on the vibration measurement this motor was firing at 1/3X SCR which is 7200 CPM meaning 2/3rds of the firing cards were faulty.

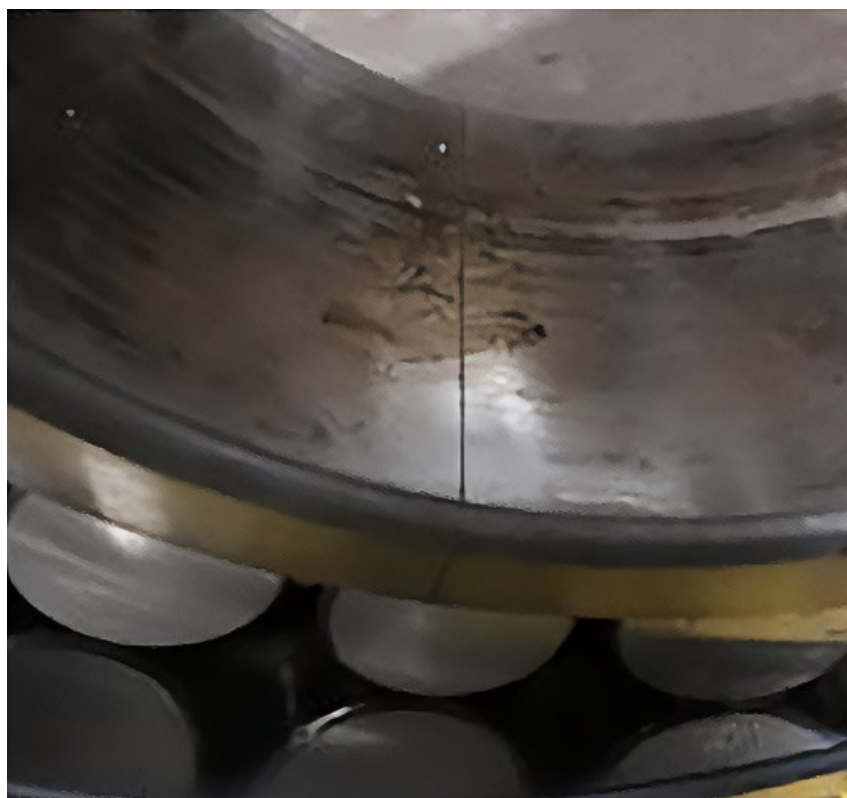
This defect and its cause were found by Gilles Lanthier, one of the members of our Partnered Ultrasound Team.

To prevent this, ensure that steam is reintroduced to the paper machine slowly, allowing for the temperature of the bearing to rise less rapidly, and therefore allowing its thermal expansion to not be so abrupt.

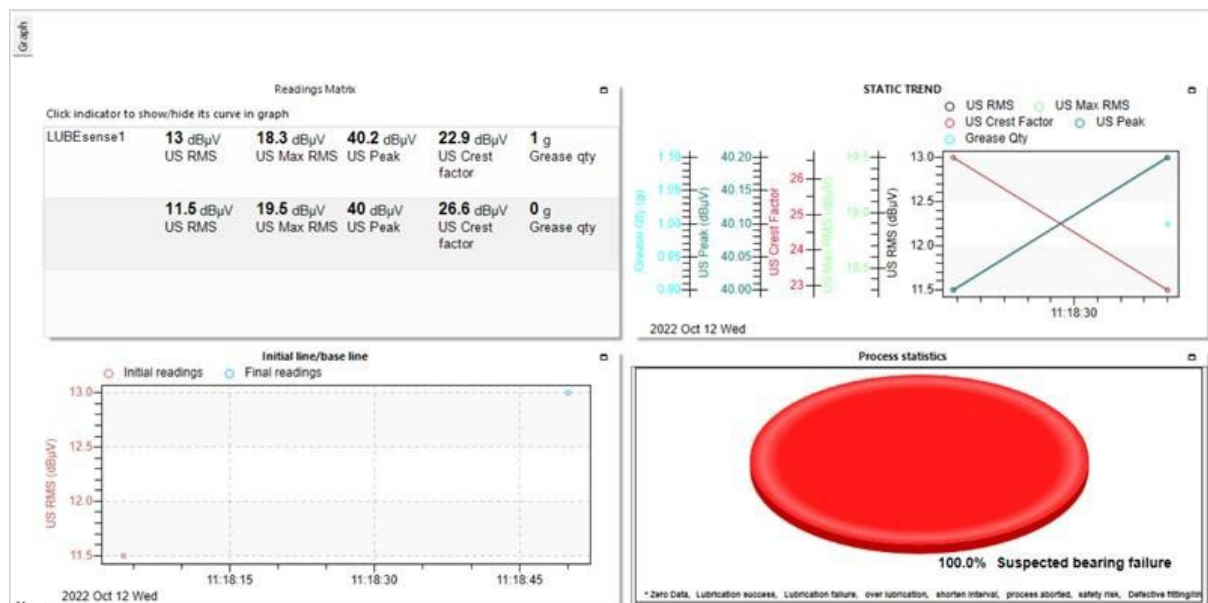
UAS3 LUBExpert Dashboard Configuration 1

After analyzing the dynamic ultrasound data in UAS3, it was confirmed that there was a suspected bearing failure.

A work order was promptly created to replace the bearing during the next planned shutdown.

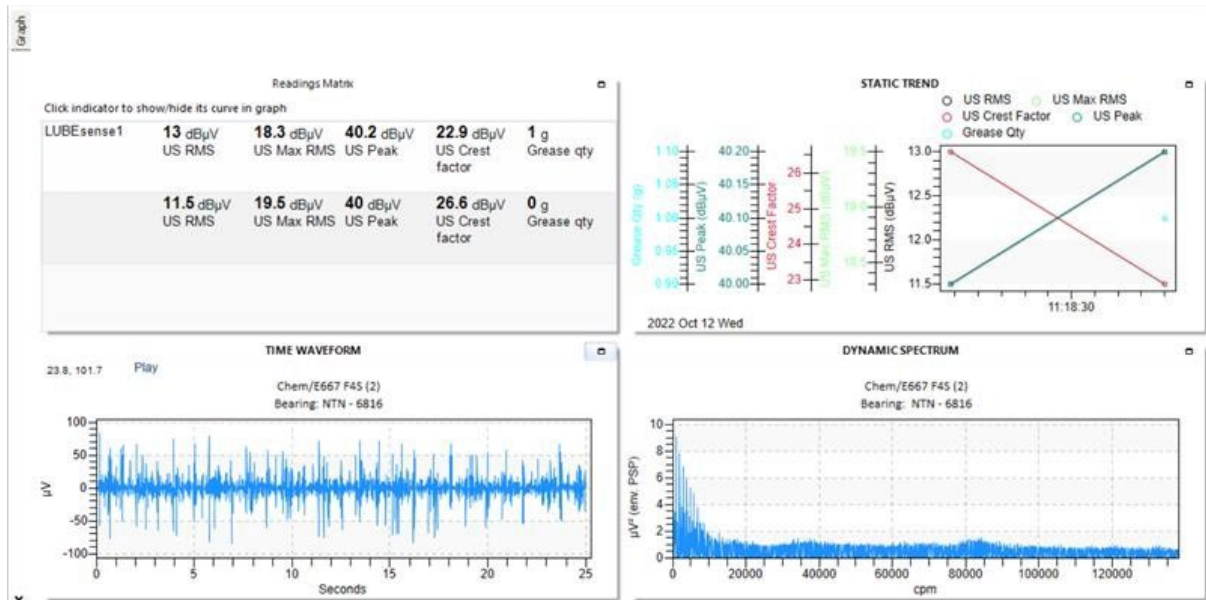
UAS3 LUBExpert Dashboard Configuration 2

Further analysis using the Bearing Toolbox found that the impact was caused by an outer race defect.

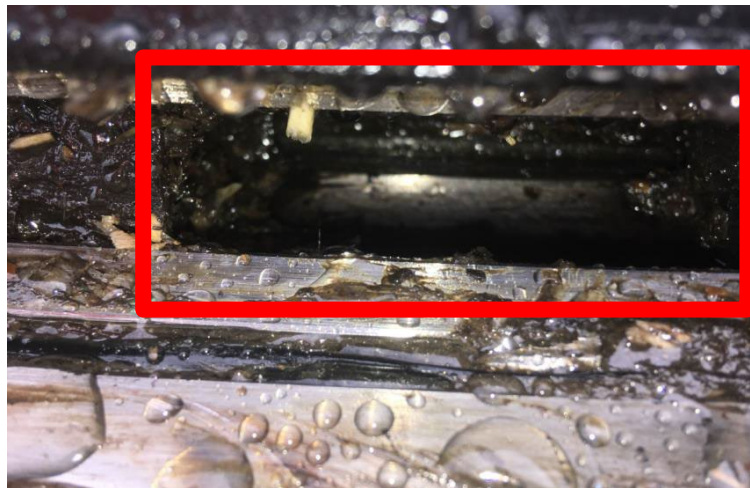
After extensive work, the team was able to determine that some equipment was missing a number of rolling elements essential to its proper functioning. The missing rolling elements were probably due to wear of the "spacers" between the balls acting as cages.

Thanks to this early discovery, the company was able to take corrective action to avoid a major malfunction that would have had serious consequences for the safety and efficiency of their products. They undertook immediate repairs and reinforced their preventive maintenance procedures.

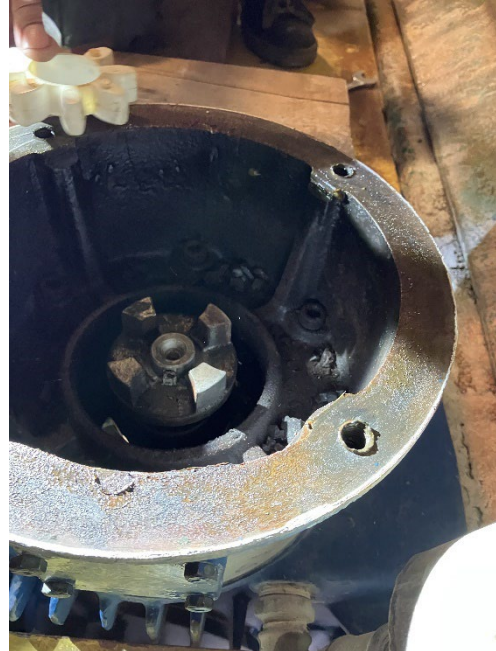
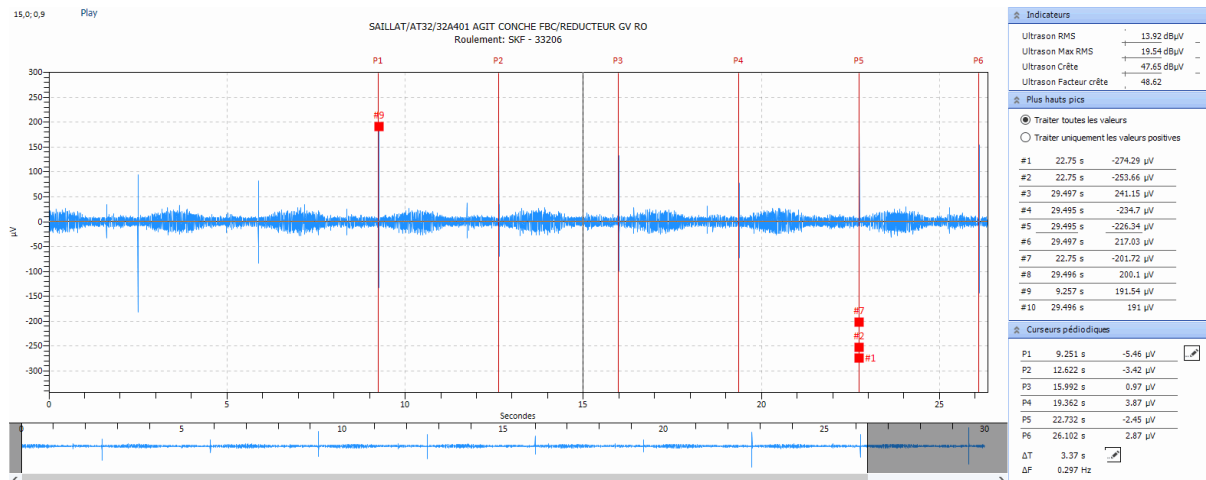
One day, the team in question decided to solve this noisy mystery using the SDT340, a state-of-the-art ultrasound measurement device. They positioned it strategically to investigate the sources of this annoying noise. After careful ultrasound listening, they discovered something interesting: shocks at a frequency of 0.3 Hz on the GV/PV points, visible in the UAS3 software in the image below.

The time waveform and frequency spectrum clearly showed a clear impact at 0.3 Hz on the GV and PV points. The maintenance team then focused their attention on the coupling location, as this was where the noise seemed to originate.

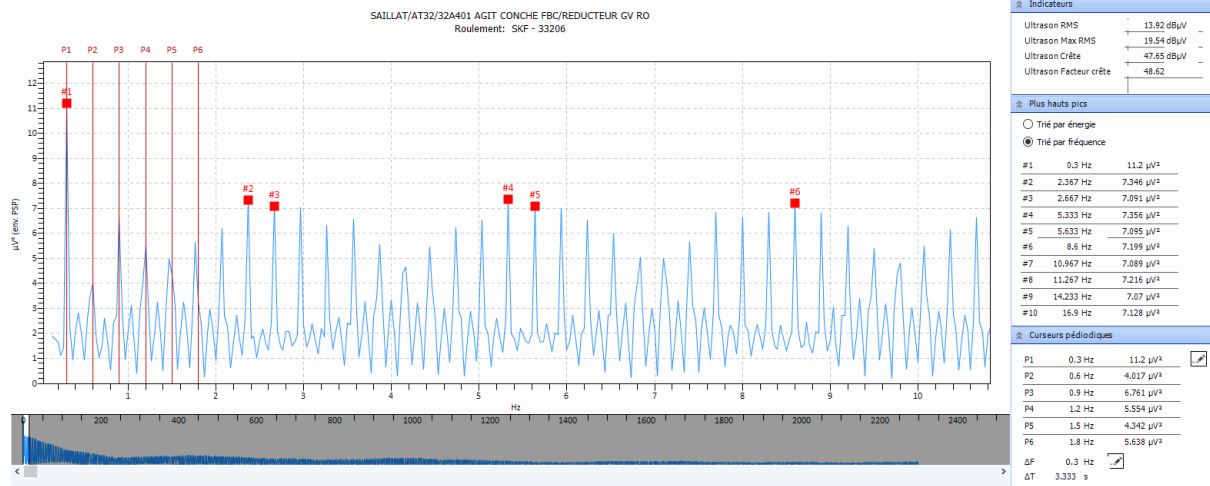
Initial diagnosis revealed that the problem affected both the PV and the GV. By moving the ultrasound sensor, they noticed that the noise was most intense at the coupling bell. On closer examination, they found that the flector was completely torn, as shown in the image below, which explained the shocks and noise. The shocks showed a coupling backlash, causing a modulation on the spectrum that even masked the GV rotation frequency.

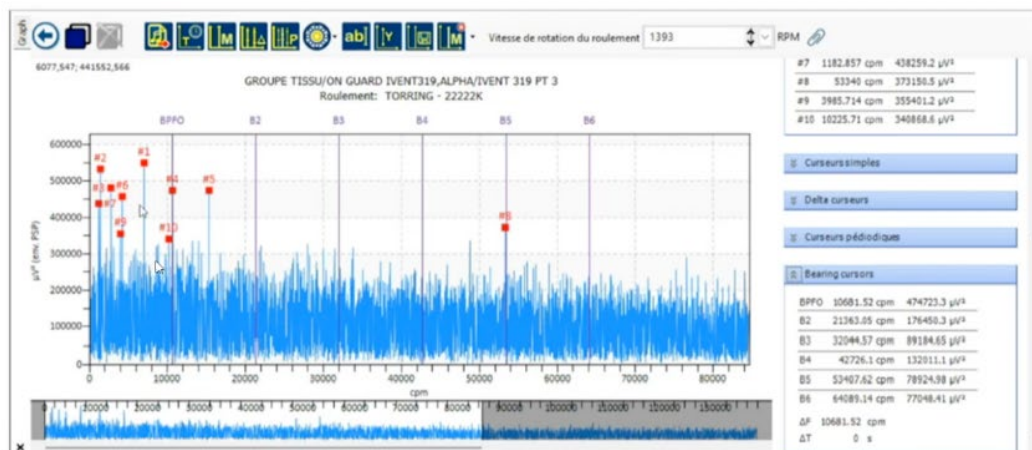
Figure 4: Dynamic Ultrasound Measurement Taken with the LUBExpert Handheld Data Collector & Analyzed in UAS3

In response to the Suspected Bearing Failure, additional follow-up dynamic measurements were recorded using a LUBExpert. We can observe this dynamic data in Figure 4 where we can see the suspected bearing failure was proven correct. The fault frequency cursors indicate this bearing had a BPFO.

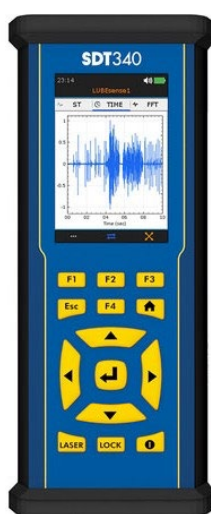
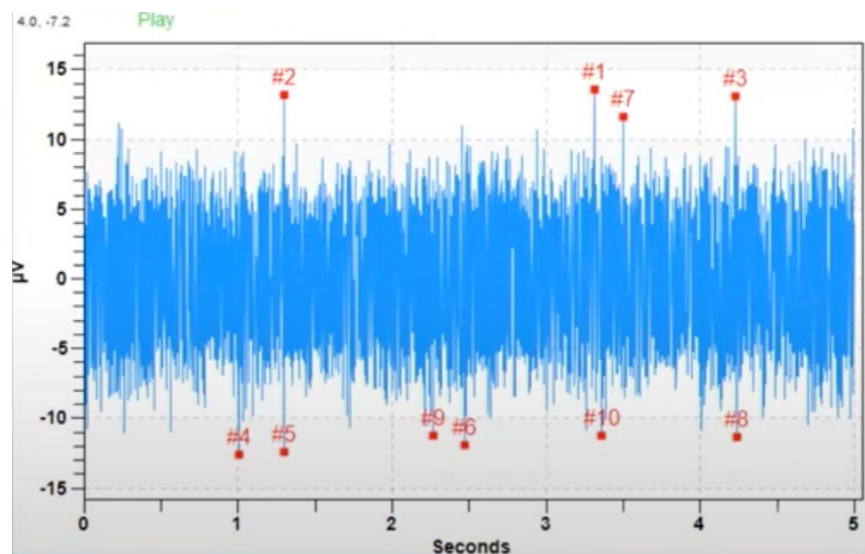
Figure 1 – Healthy Coupling Ultrasound Time Wave Form

Figure 1 is an airborne ultrasound signal captured of a healthy coupling. This coupling is emitting very low energy, and has a stable signal with no repeated impacting.
