# SUCCESS STORIES

## Steel

# John Garrison Main Hoist Input Shaft Bearing on Crane

# Predicting and preventing transformer outages in a steel mill

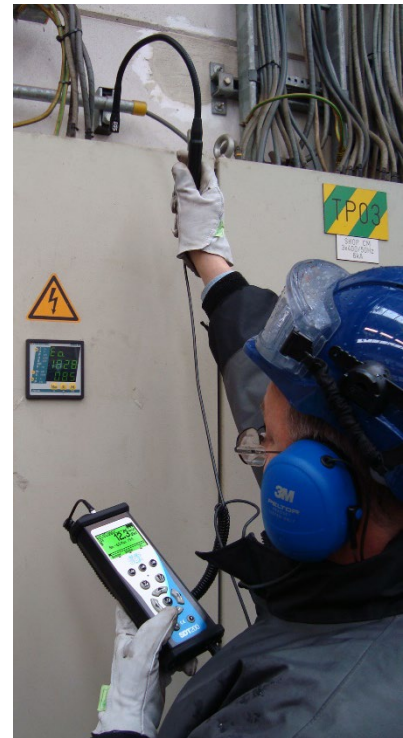
During an inspection, Skip Young detected the existence of a partial discharge on a phase of a transformer head using his SDT270 collector. By comparing the 4 condition indicators obtained after collecting static measurements, he was able to conclude that this was not a minor defect like nuisance corona. The thermogram showed no hot spot. Skip concluded that it was not a resistive defect of the arcing type.

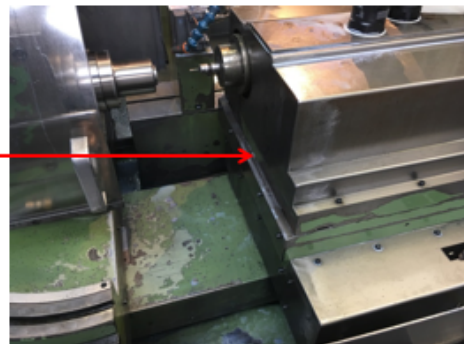
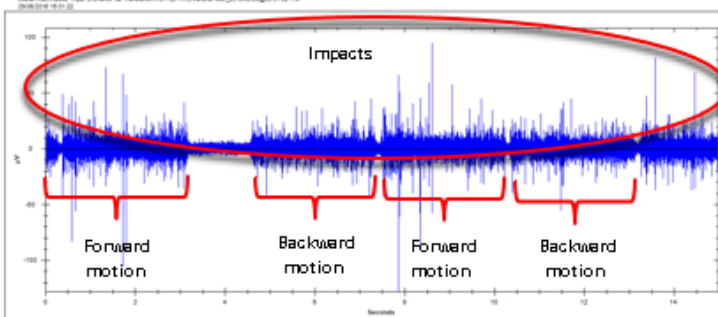
| US | dB $\mu$ V (RMS) | dB $\mu$ V (Peak) | dB $\mu$ V (Crest Factor) |
| Bearing 1 | 13,4 | 39,4 | 19,94 |

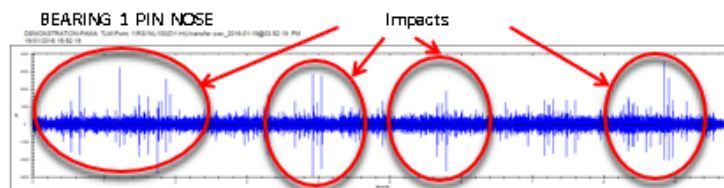
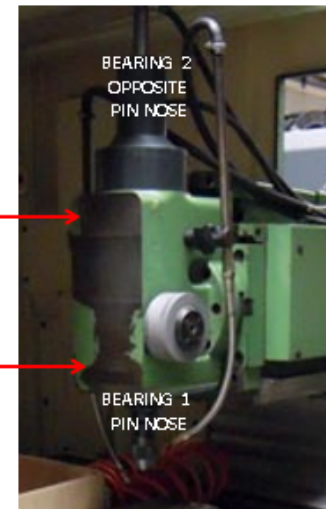
| US | dB $\mu$ V (RMS) | dB $\mu$ V (Peak) | dB $\mu$ V (Crest factor) |
|---|---|---|---|
| Bearing 1 | 45,8 | 70,9 | 17,99 |
| Bearing 2 | 42,3 | 62,3 | 9,23 |

1 X RPM harmonics in ultrasound spectrum from bearing shows looseness. Bearing fit tolerances are out.
